# Cause of and Measures against Leakage from Contaminated Water Treatment Facility's Desalination System (Reverse Osmosis Membrane System) RO-3 at Fukushima Daiichi Nuclear Power Station

< Reference >  
December 6, 2013  
Tokyo Electric Power Company

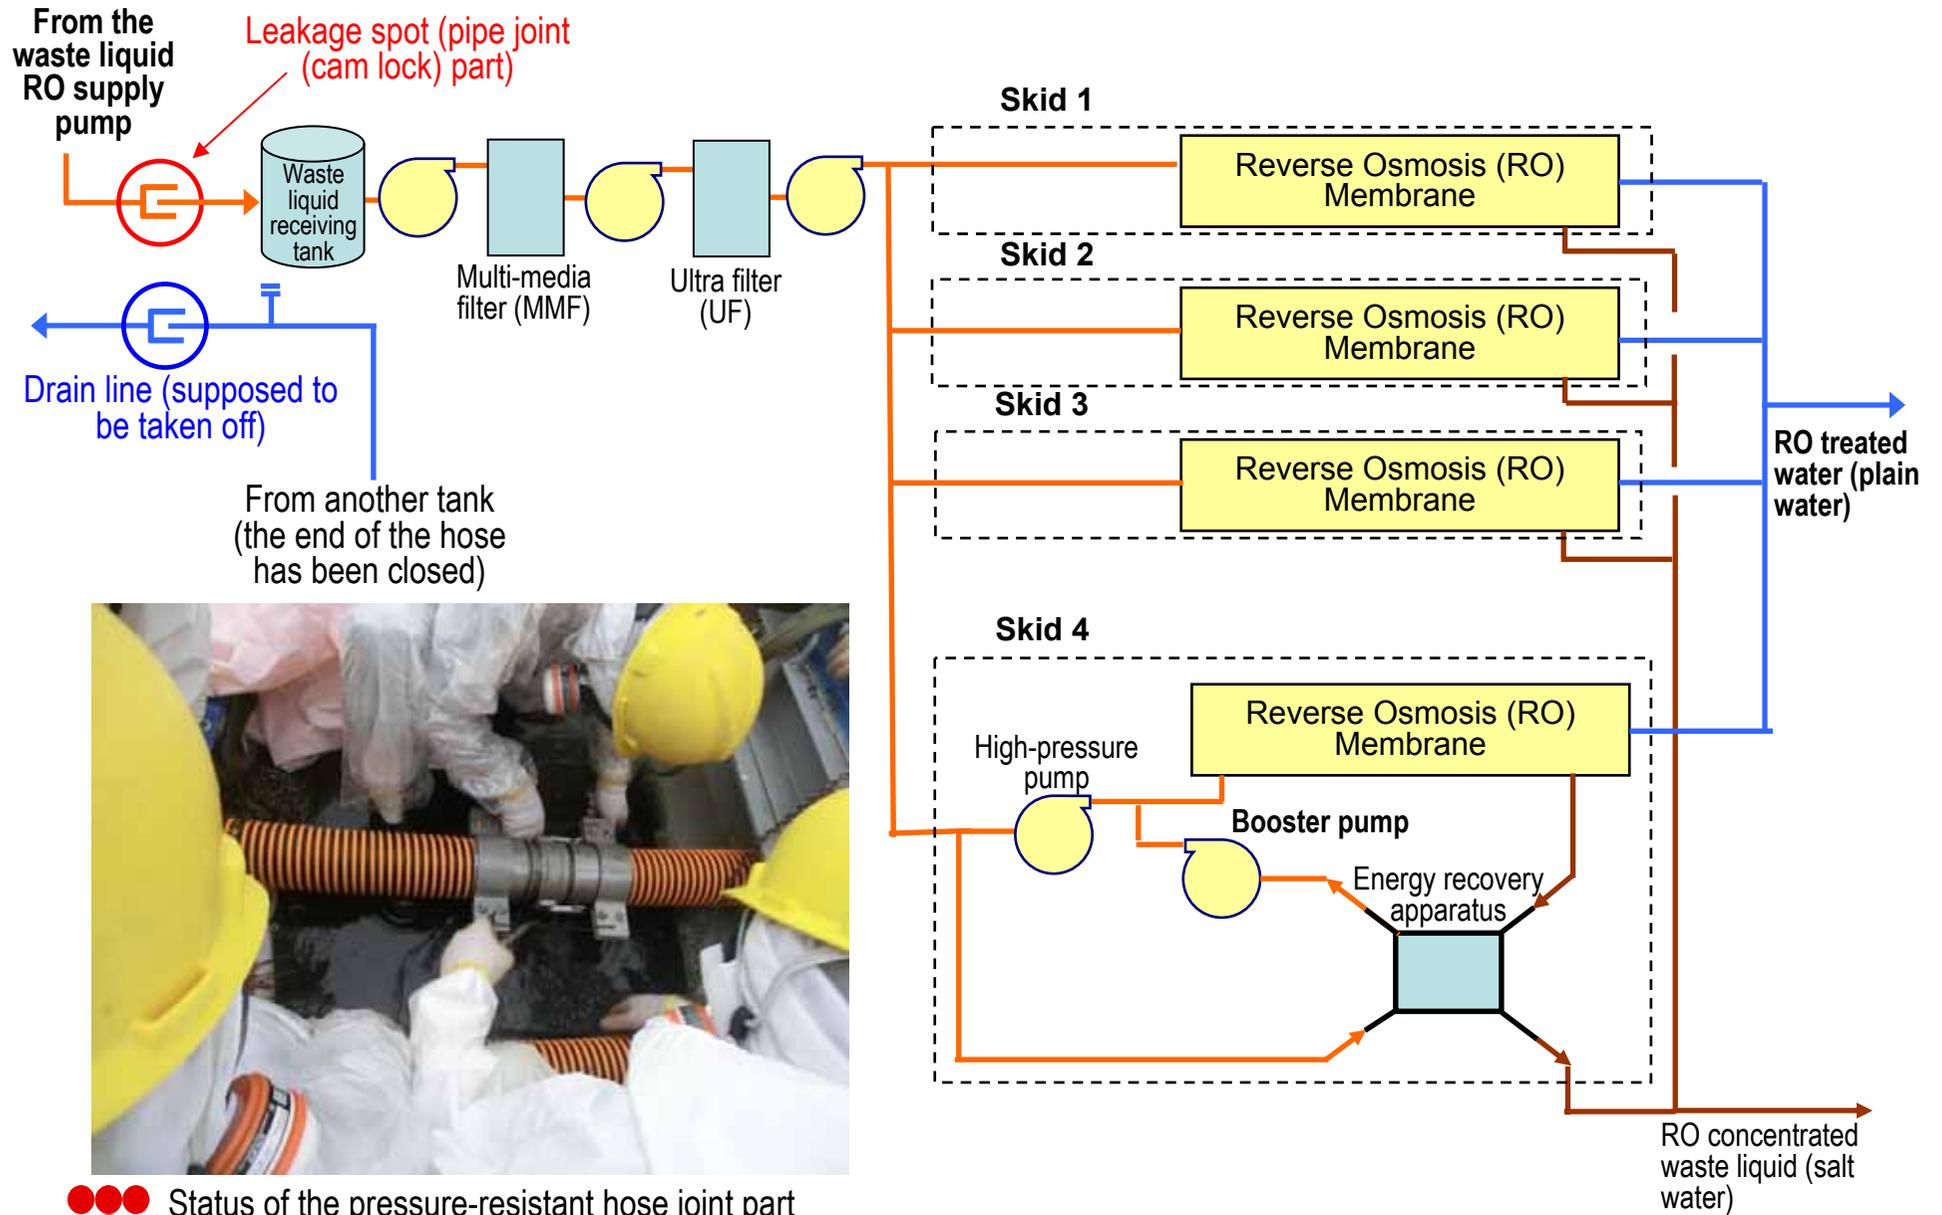
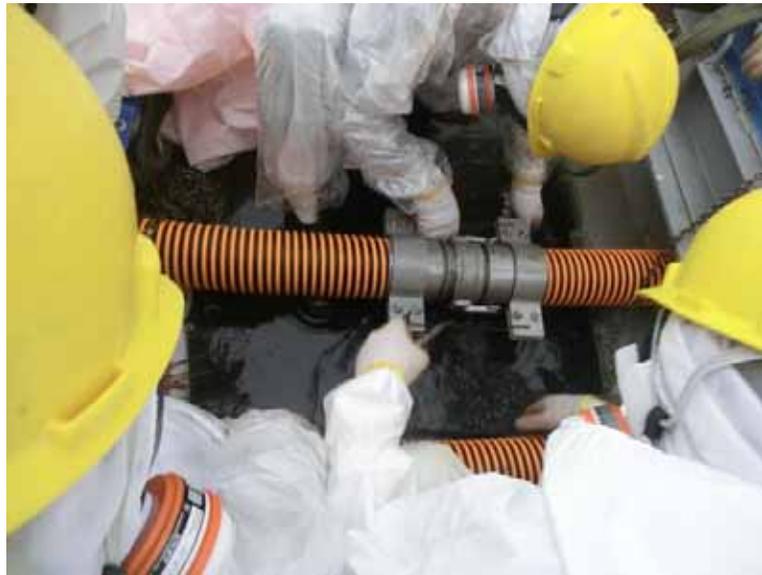
# Structures in RO-3 temporary warehouse and leakage spot

- **Time and date: At around 9:35 AM on October 9, 2013**
- **Location: Inside the temporary warehouse for the desalination system (RO-3)**
- **Leakage spot: A joint (cam lock) part of piping at the RO-3 entrance side**
- **Status over time:**

Around 9:35 During removal of pressure-resistant hoses in construction for replacement with polyethylene (PE) pipes, leakage occurred when a worker mistakenly took off a hose-connection cam lock part, which was not supposed to be taken off.

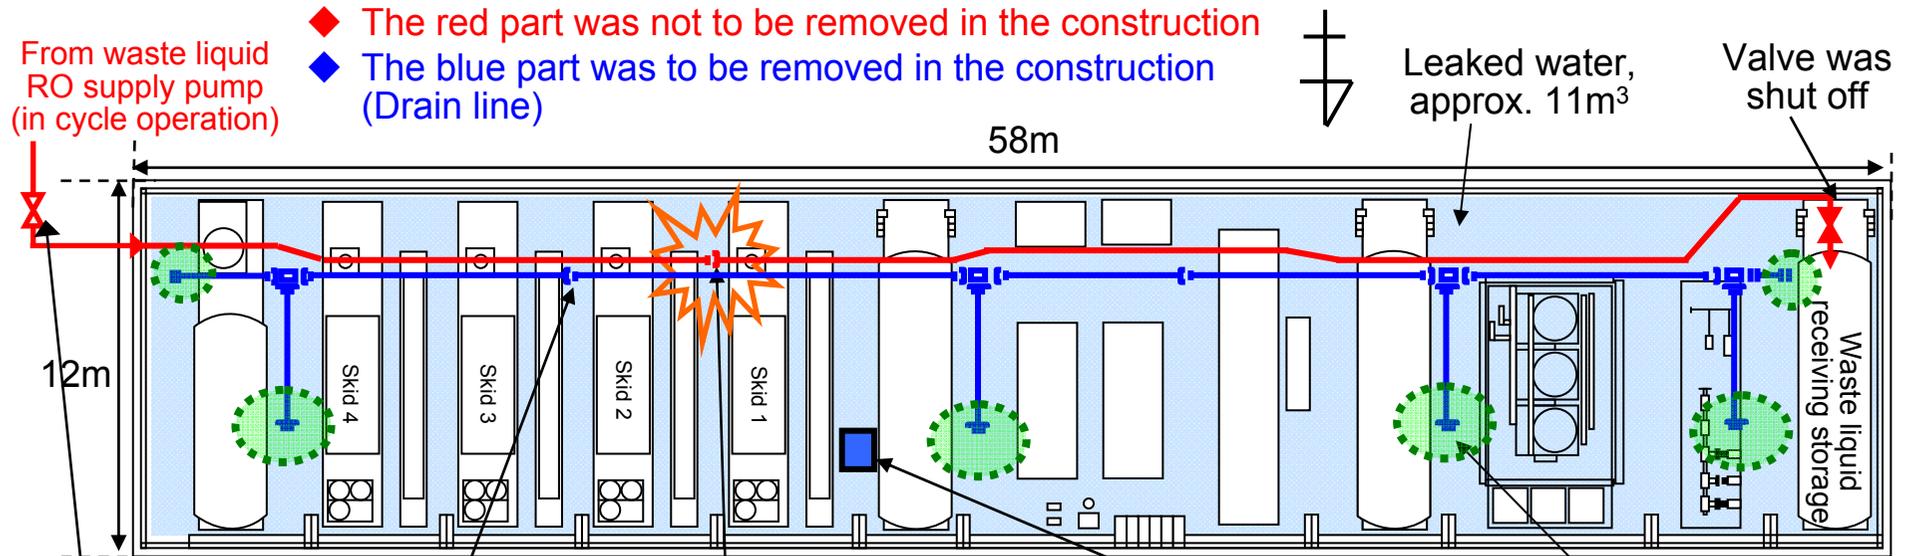
# Leakage-related conditions inside RO-3 temporary warehouse

Part supposed to be taken off (Pressure-resistant hose 100mm in diameter)

Leakage spot (Pressure-resistant hose 100mm in diameter)

Leakage detector

The end of each hose has been blocked off

This valve was shut off after the leakage

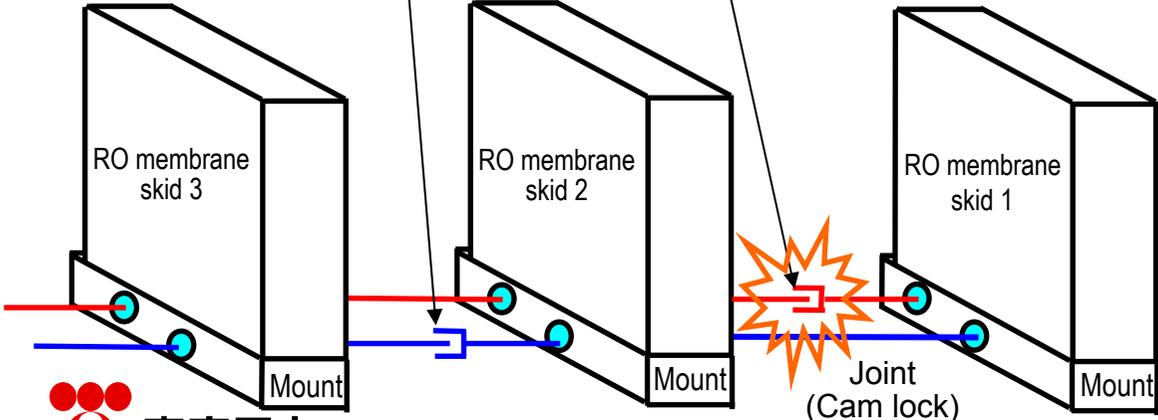
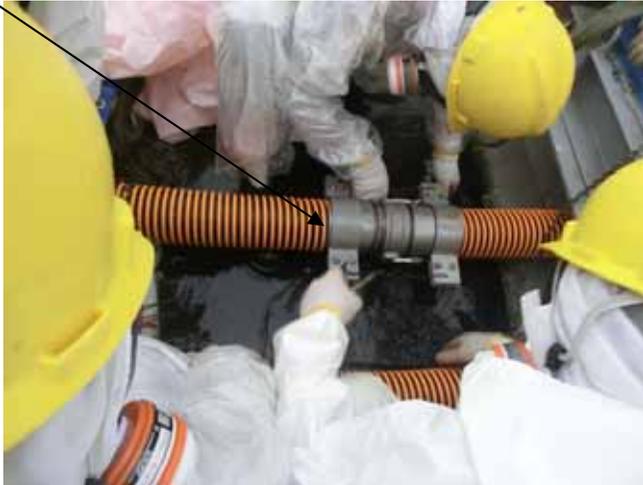
Cause analysis results	Measures
Direct causes	<p>&lt;Lack of identification marking to indicate what to remove, and false recognition&gt;</p> <p>① The cam lock to be taken off was not marked for identification.</p> <p>② Work Team Leader B took off the wrong cam lock thinking that was the correct one.</p> <p>&lt;Inadequate safety protection for the wrong cam lock&gt;</p> <p>The waste liquid transfer line was in service (was having pressure applied).</p>	<p>(1) Clarification of requirements concerning identification marking at the procurement stage</p> <p>① In a case where modification or other construction involves detachment or attachment of a component such as a cable or pipe of an important line, TEPCO stipulates in the construction common specifications or the construction additional specification that the component shall be marked for identification without fail and that a construction supervisor of TEPCO shall confirm the marking, so that the marking can clearly identify and prevent misidentification of the component.</p> <p>② TEPCO requests each contract company to, based on the procurement requests, stipulate in the construction manual procedure that the contract company shall regard meeting requirements concerning identification marking and having relevant components marked for identification as a hold point in quality management in the work process and shall have it confirmed by a construction supervisor of TEPCO whether the requirements have been met and whether the relative components have been properly marked.</p> <p>(2) TEPCO provides identification of the skid numbers (put up the skid numbers) at easy-to-see locations on the RO system with large-enough characters.</p> <p>(3) Clarification of how to determine the need to conduct a pre-work safety evaluation and how to conduct a pre-work safety evaluation</p> <p>In terms of attitudes towards how to determine the need to conduct a pre-work safety evaluation and how to rank a specific case in the evaluation, TEPCO revises the Fukushima Daiichi pre-work safety evaluation guide (hereinafter “the evaluation guide”) to enable the guide to function to appropriately detect risks in consideration of the 3 Hs. Specifically, the evaluation guide will be revised to include: a requirement that risks shall be detected at each step in a series of work steps in consideration of each of the 3 Hs; and case examples of pre-work safety evaluations, which are intended to serve as references in determining the need to conduct a pre-work safety evaluation and in selecting a rank.</p> <p>(4) Establishment of a scheme for conducting a safety measure examination</p> <p>TEPCO establishes a scheme (including an organization) by which a group responsible for facilities, the control of which is yet to be transferred to the operation section, can appropriately administer work permits.</p>

Indirect causes	<p>&lt;Lack of identification marking&gt;</p> <p>① A construction supervisor of TEPCO thought that identification marking, which was provided by Cooperative Company B for the purpose of clearly indicating the pressure-hoses to be removed, were applicable also to this work, which was conducted by Cooperative Company A.</p> <p>② While each cam lock was not marked for identification, Construction Chief A thought that he would be able to find the correct cam lock by tracking a line marked for identification.</p> <p>③ Worker Team Leader B knew beforehand the correct cam lock. However, the skid numbers on the RO system’s skids were so small that the leader had difficulty in having a clear view of the numbers and grasping the accurate positional relationship between each of the RO system’s skids and the correct cam lock.</p> <p>&lt;Inadequate safety measures for the line of the wrong cam lock&gt;</p> <p>① Because the line to be removed was marked for identification, the construction supervisor of TEPCO did not expect the risk of having the correct cam lock misidentified. Without considering the need to separate the nearby pressure-resistant hoses, the supervisor requested the operation management section only to stop RO-3 for the safety and protection of the facilities.</p> <p>② Safety measures prepared by the construction supervisor in the TEPCO’s primarily responsible group had not been fully examined.</p> <p>&lt;Inadequate conduction of a pre-work safety evaluation&gt;</p> <p>Despite their recognition that this work was to be carried out near important facilities and equipment and had characteristics called 3 Hs*, the members of the TEPCO’s primarily responsible group did not conduct a pre-work safety evaluation because they had considered that stopping the RO-3 system would be sufficient to eliminate risks of affecting the important facilities and equipment (the nearby pressure-resistant hoses in this case) around the work area.</p>	<p>(2) TEPCO provides identification of the skid numbers (put up the skid numbers) at easy-to-see locations on the RO system with large-enough characters.</p> <p>(3) Clarification of how to determine the need to conduct a pre-work safety evaluation and how to conduct a pre-work safety evaluation</p> <p>In terms of attitudes towards how to determine the need to conduct a pre-work safety evaluation and how to rank a specific case in the evaluation, TEPCO revises the Fukushima Daiichi pre-work safety evaluation guide (hereinafter “the evaluation guide”) to enable the guide to function to appropriately detect risks in consideration of the 3 Hs. Specifically, the evaluation guide will be revised to include: a requirement that risks shall be detected at each step in a series of work steps in consideration of each of the 3 Hs; and case examples of pre-work safety evaluations, which are intended to serve as references in determining the need to conduct a pre-work safety evaluation and in selecting a rank.</p> <p>(4) Establishment of a scheme for conducting a safety measure examination</p> <p>TEPCO establishes a scheme (including an organization) by which a group responsible for facilities, the control of which is yet to be transferred to the operation section, can appropriately administer work permits.</p>

Example of marking for removal identification
