Results of the Seventh Soundness Inspection for Unit 4 Reactor Building at Fukushima Daiichi Nuclear Power Station

December 18, 2013

Tokyo Electric Power Company

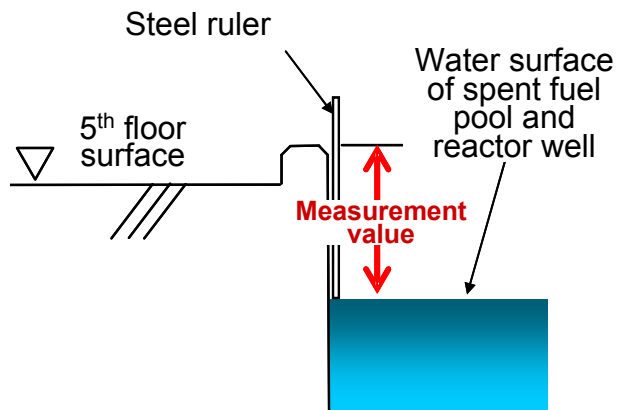
Considering that the water level measurement values on the four corners were about the same, it has been concluded that the 5th floor surface and the water surfaces of the spent fuel pool and the reactor well are parallel and the building is not tilted similarly to the past results.

Water level*2 measurement results

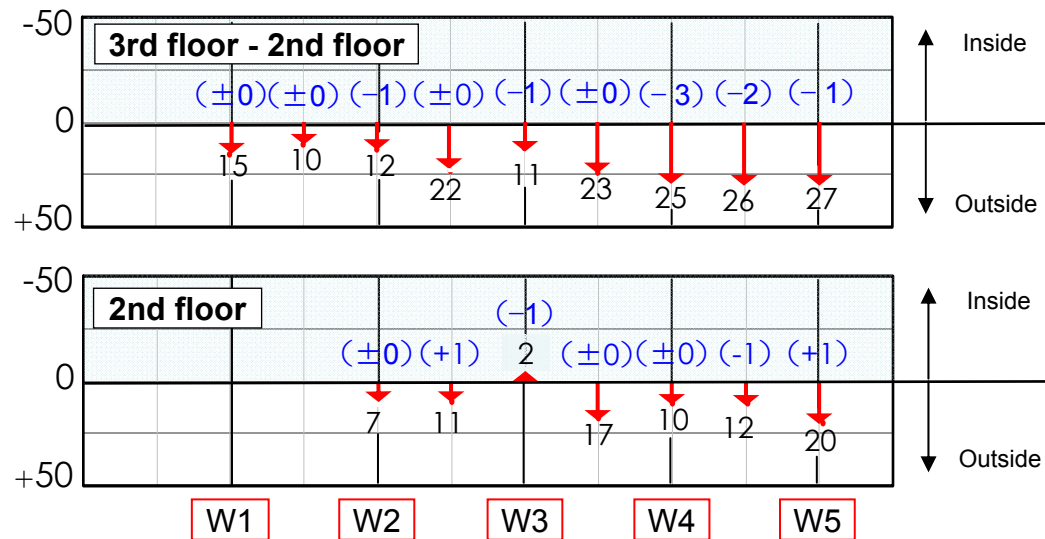
Horizontal difference*1 calculation results (Unit: mm)

- The horizontal differences measured this time were about the same as those in the first to sixth inspections, and the deformation characteristics on the measurement points were also similar.

- The small difference from the previous measurement results may be due to factors such as error of the optical equipment (Measurement error of $\pm 2\text{mm}$ may cause approx. 4mm (Max.) error in horizontal difference) and thermal expansion of concrete (thermal expansion coefficient: Approx. $7-13 \times 10^{-6}/^{\circ}\text{C}$) which may cause approx. 5-9mm error because of the difference of average monthly temperatures between August and November.

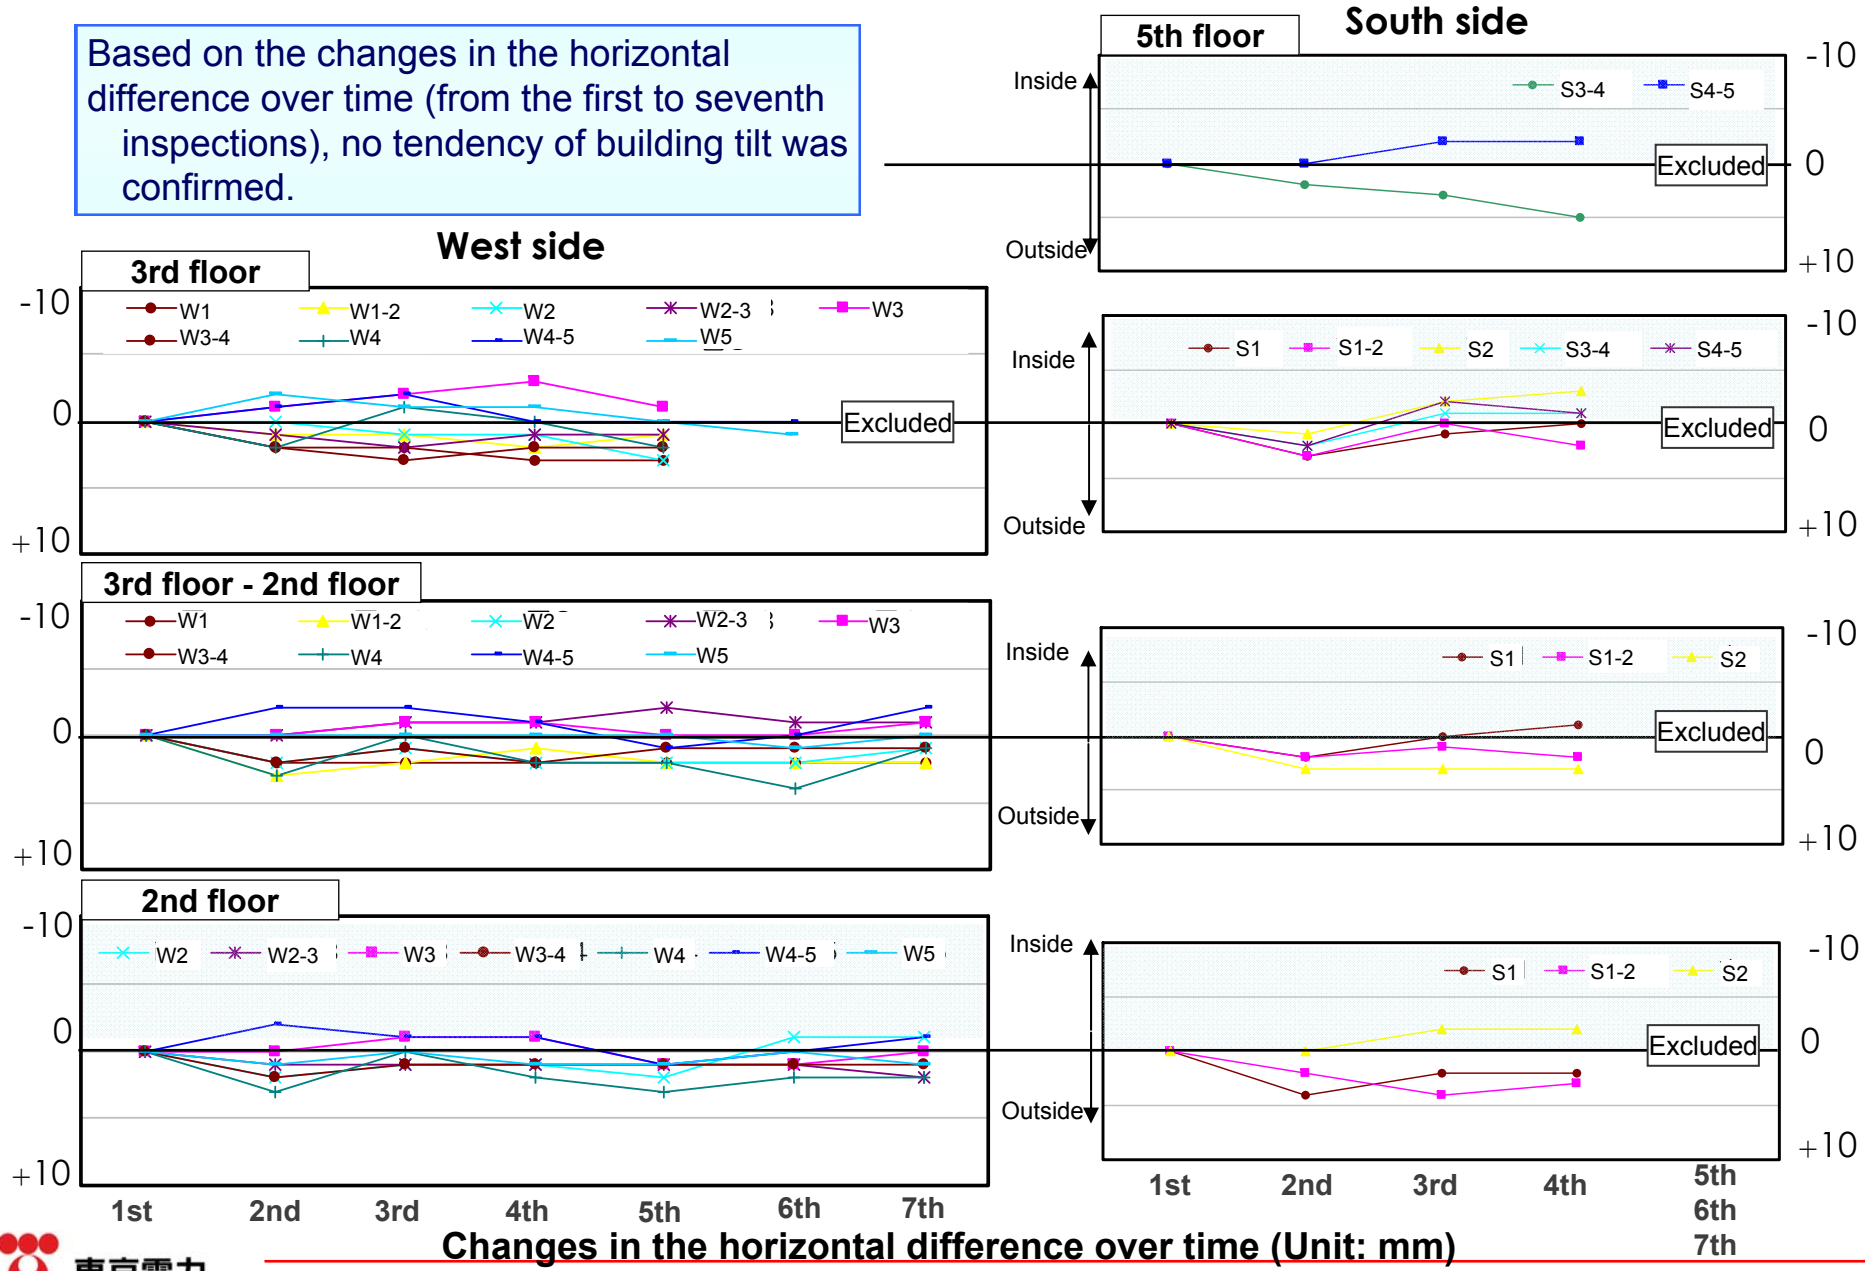
Based on the changes in the horizontal difference over time (from the first to seventh inspections), no tendency of building tilt was confirmed.

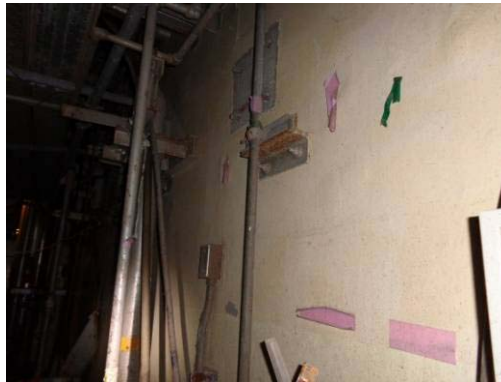
① West wall
(inner
surface)

Since no crack of a width of 1mm or more or with possible rebar corrosion was found as a result of visual inspection (similarly to the past results).

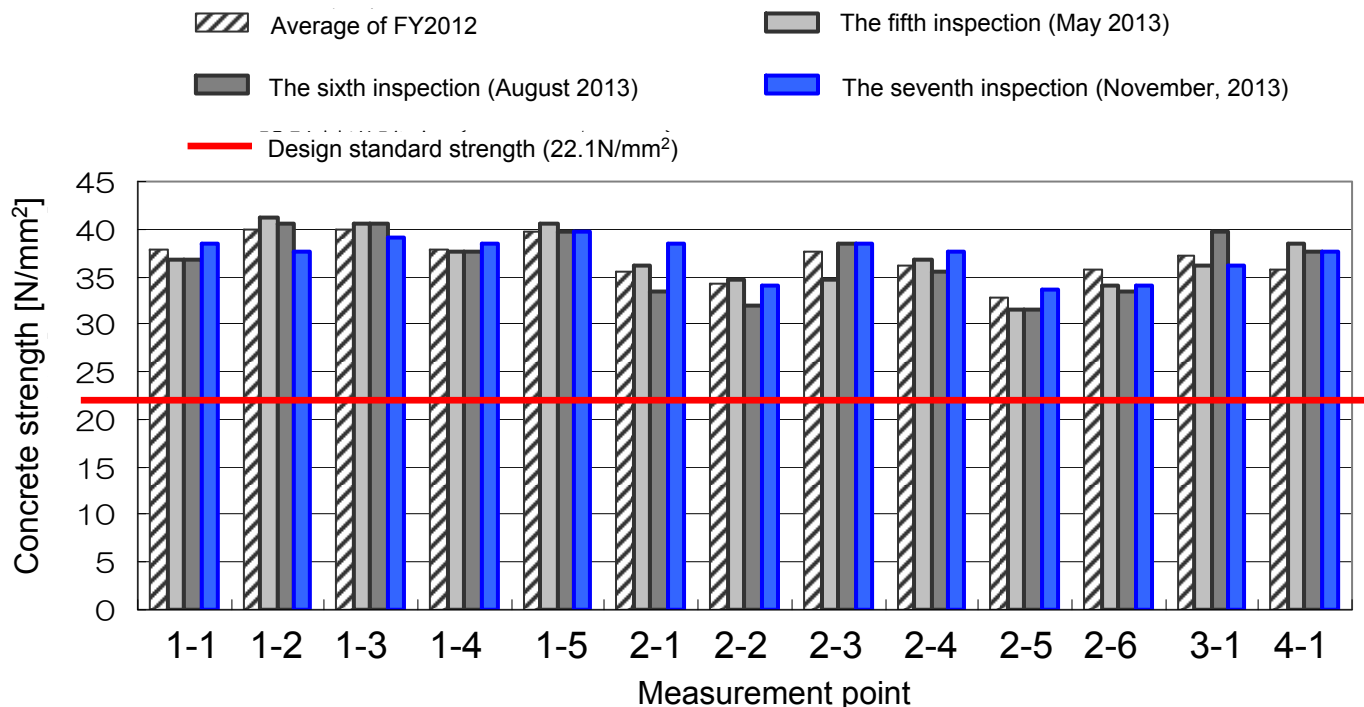
Concrete strength evaluation results

As a result of measurement, the concrete strengths on all the measurement points were above the design standard (22.1N/mm²) similarly to the past results. The concrete strength is considered to be about the same as the past results taking into considerations the error of Schmidt Hammer*¹ and that the measurement points were set at slightly different locations from the previous ones.
