Leak from the dikes at H5 tank area and G6 north tank area

<Reference>
December 24, 2013
Tokyo Electric Power Company

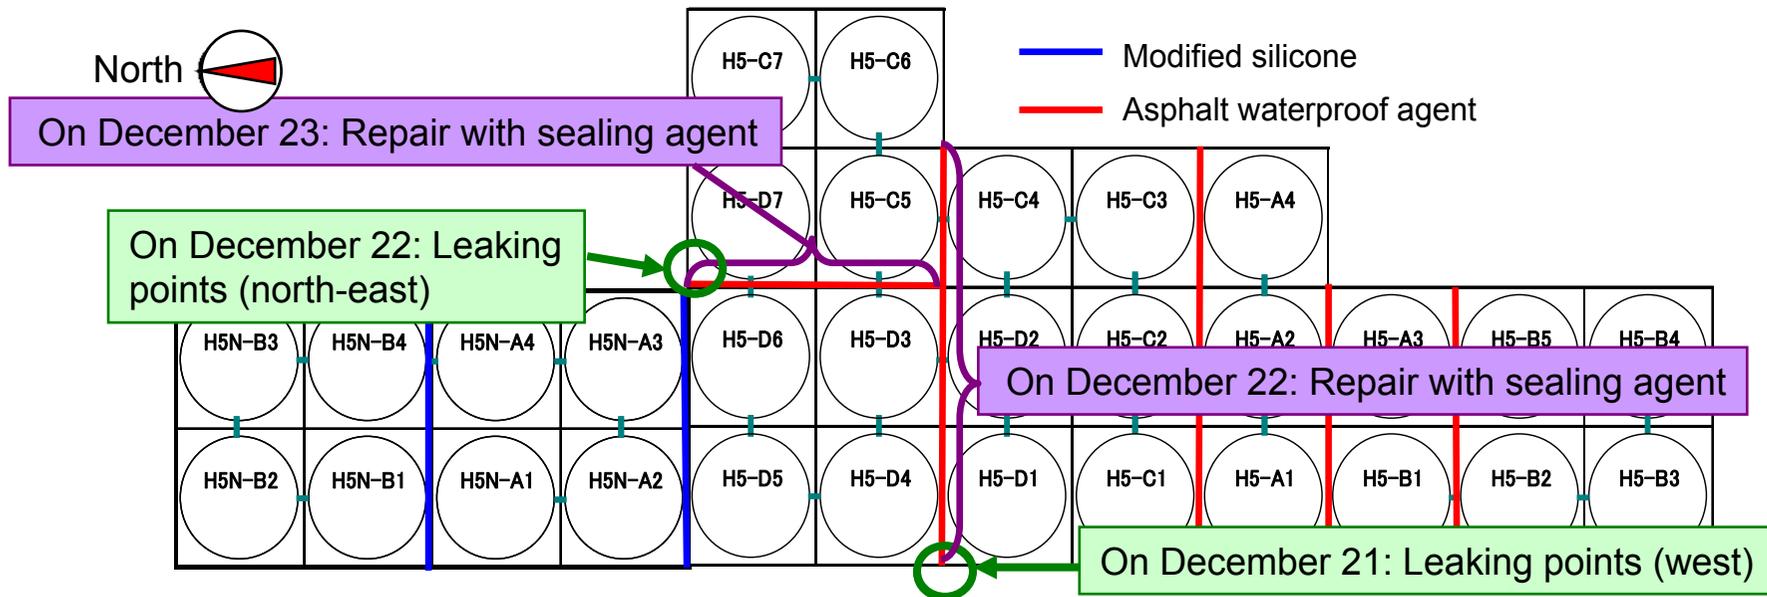
2. The leaking points from the dikes at H5 tank area etc.

*The concrete foundation is divided into 8 parts at the construction joints on the blue line or red line.

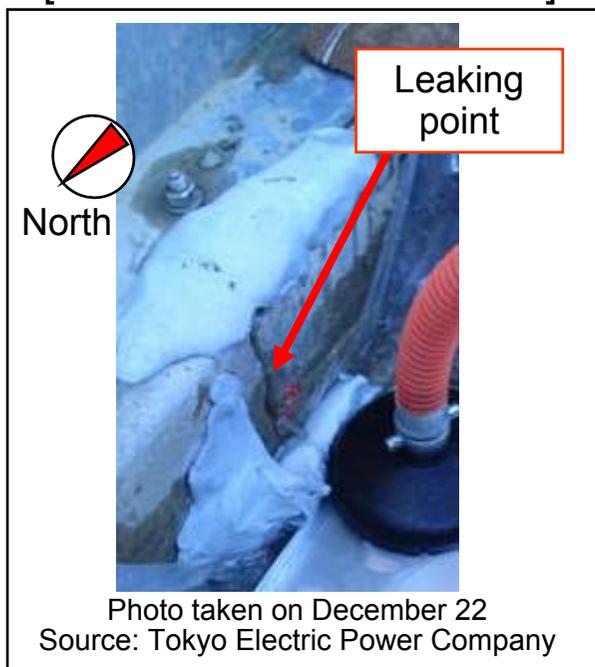
[West dike at H5 tank area]

- The water stop seals applied on the concrete construction joints are estimated to have deteriorated.
→ After the dike filled with water, the seals are estimated to have gone hydrophilic (easily familiarized with water), and it accelerated the deterioration of the seals.
- ↓
- From the deteriorated parts, rainwater inside the dike is estimated to have soaked into the construction joints, and have leaked into the outside the dike via construction joints.

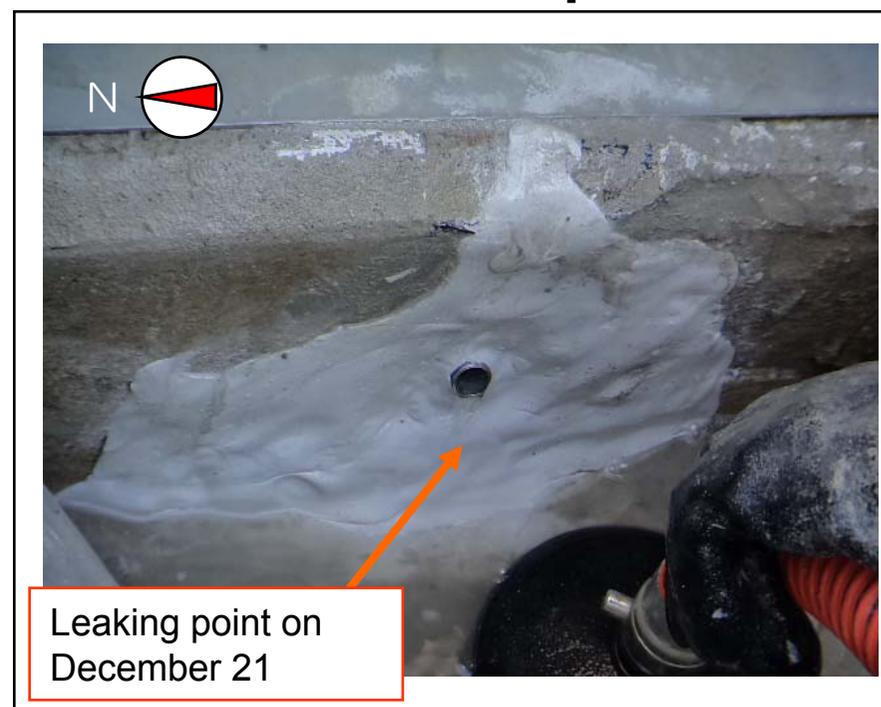
[Repair with sealing agent at the west dike at H5 tank area]*

At around 4:15 PM: A TEPCO employee confirmed that water was leaking from the bottom part of the west dike at H5 tank area, after receiving a report on the water leak from the dike at H5 tank area from a patrolman of an associated company

→The amount of the water leak from the west dike at H5 tank area decreased, but did not completely stopped.

From 8:00 to 10:00 AM: The construction joints of the concrete foundation (the leaking point) was repaired with sealing agent.

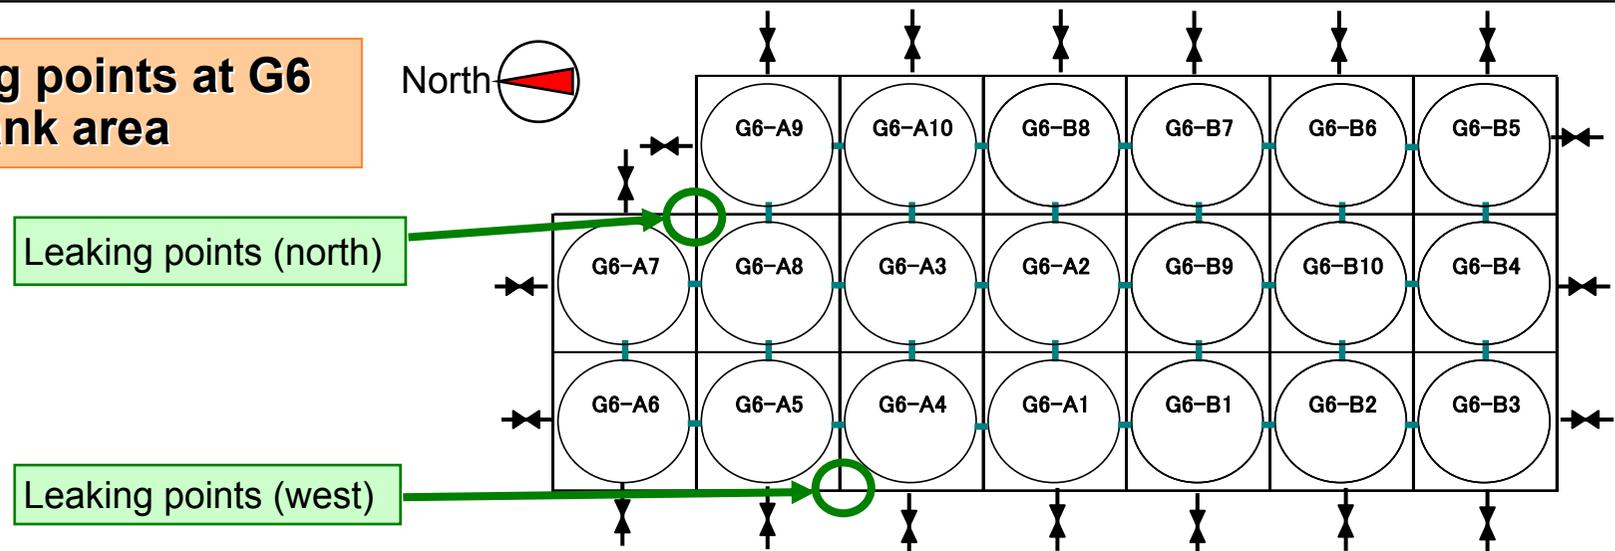
6. Leaking points at G6 north tank area

At around 4:33 PM: A patrolman of an associated company found the water leak from the bottom part of the north dike at G6 north tank area.

At around 6:40 PM: The patrolman of an associated company found another water leak from the crack on the west dike at G6 north tank area.

- ✓ Sand bags and plastic sheet were installed as a water pan at the leaking point (the outside of the dike) at G6 north tank area.
- ✓ The crack on the west dike at G6 north tank area (which caused the leak) was repaired with caulking agent. (The leak from the west dike stopped.)

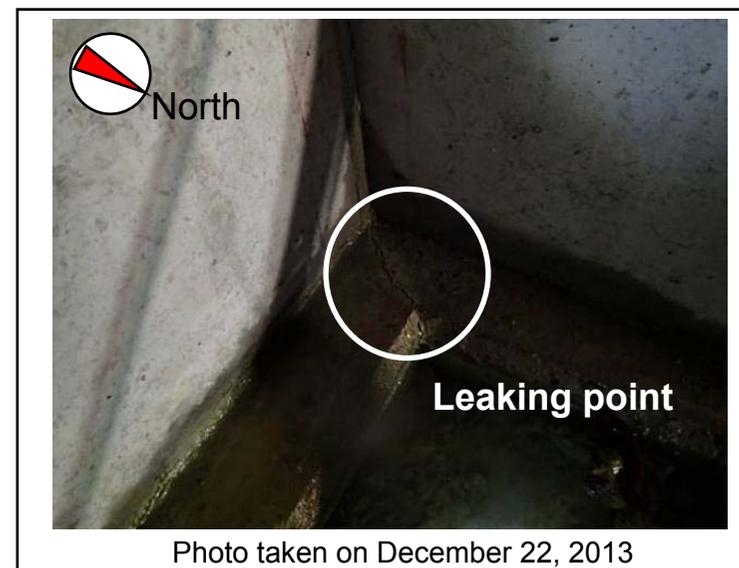
[Crack on the north dike at G6 north tank area]*

- The crack on the concrete enlarged, as the temperature lowers, and it is estimated water inside the dike leaked from there.
→ Generally speaking, cracks on concrete have tendency to enlarge, as the temperature lowers.
- The water stop seal will be applied to the crack on the surface of the concrete foundation.
