Cause Investigation of Water Level Decreases inside H4 East Area and H4 Area Dikes

< Reference >
December 27, 2013
Tokyo Electric Power Company

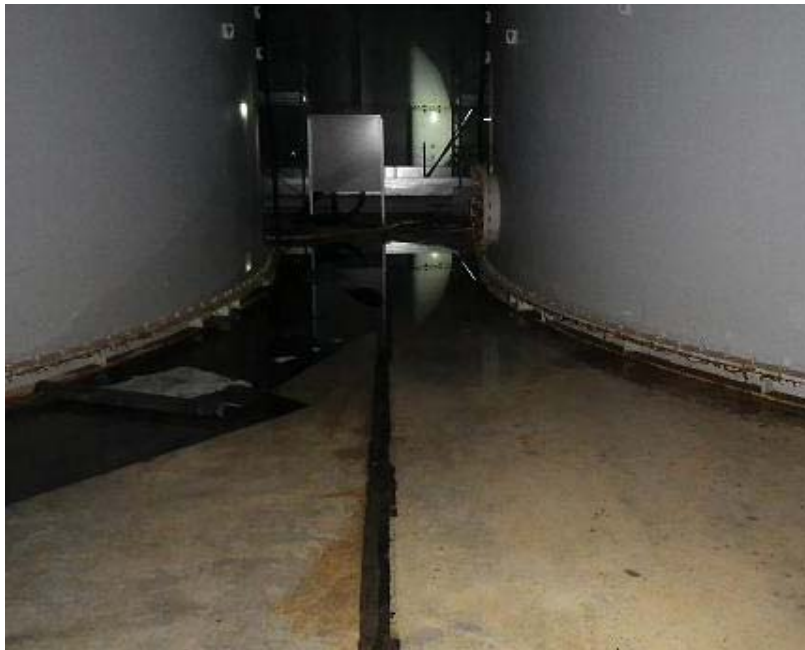
- Investigation result
 - The concrete dikes and foundations have no damages such as a crack that may have lead to leakage.
- Likely causes
 - Deterioration of water stop seal applied to concrete casting joints, as in the case of leakage from the H5 area dike (which occurred on December 21, 2013)
 - Leakage of rainwater inside the dike to the outside of the foundation and dike as a result of its penetration into a casting joint through a deteriorated part and its traveling through crashed stones underneath the costing joint or the foundation.

Condition of the concrete casting joint
(H4 East area)

- As an **emergency measure**, deteriorated water stop sheets for casting joints were removed, and epoxy putty caulking was applied.
 → After this emergency measure was taken, a test using water was conducted inside the dike, which proved that water level decreases had stopped (on December 26 and 27 in the H4 and H4 East areas).
- As a **mid- and long-term measure**, the inside of the dike will be covered with urethane waterproof coating so that leakage from a crack, a casting joint, etc. can be prevented.

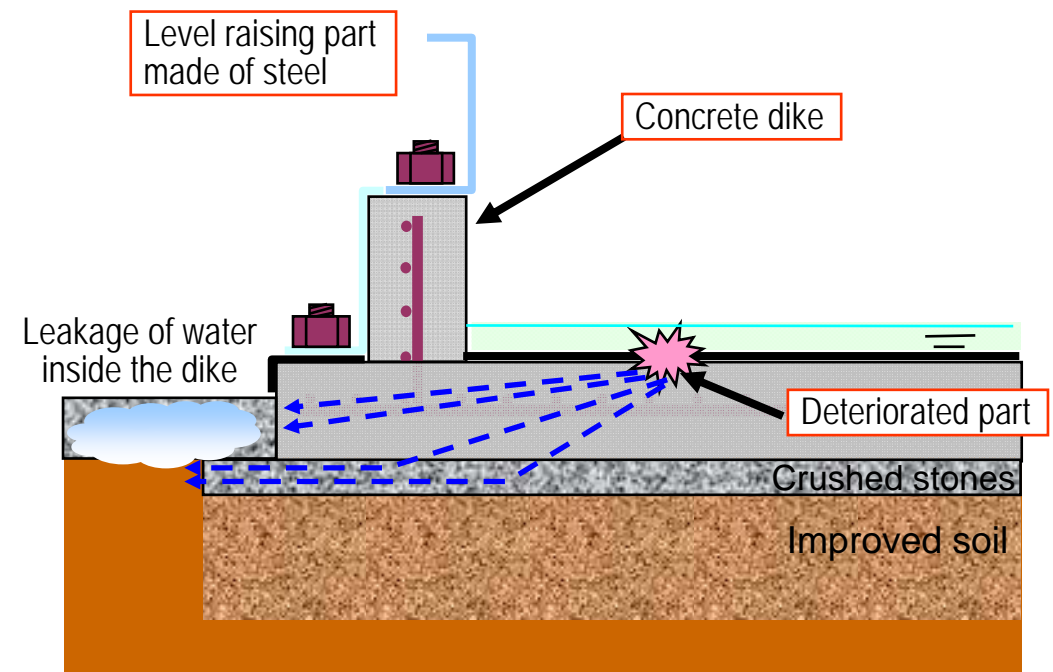
Illustration of the leakage
(leakage of water inside the H5 area dike)

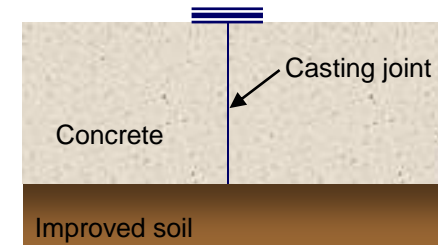
Before the measure was taken:
Provided with asphaltic waterproof material
