# **Water Overflow from the flange of the top panel on the upper part of H6 tank area**

**Revised Version**

February 20, 2014

Tokyo Electric Power Company

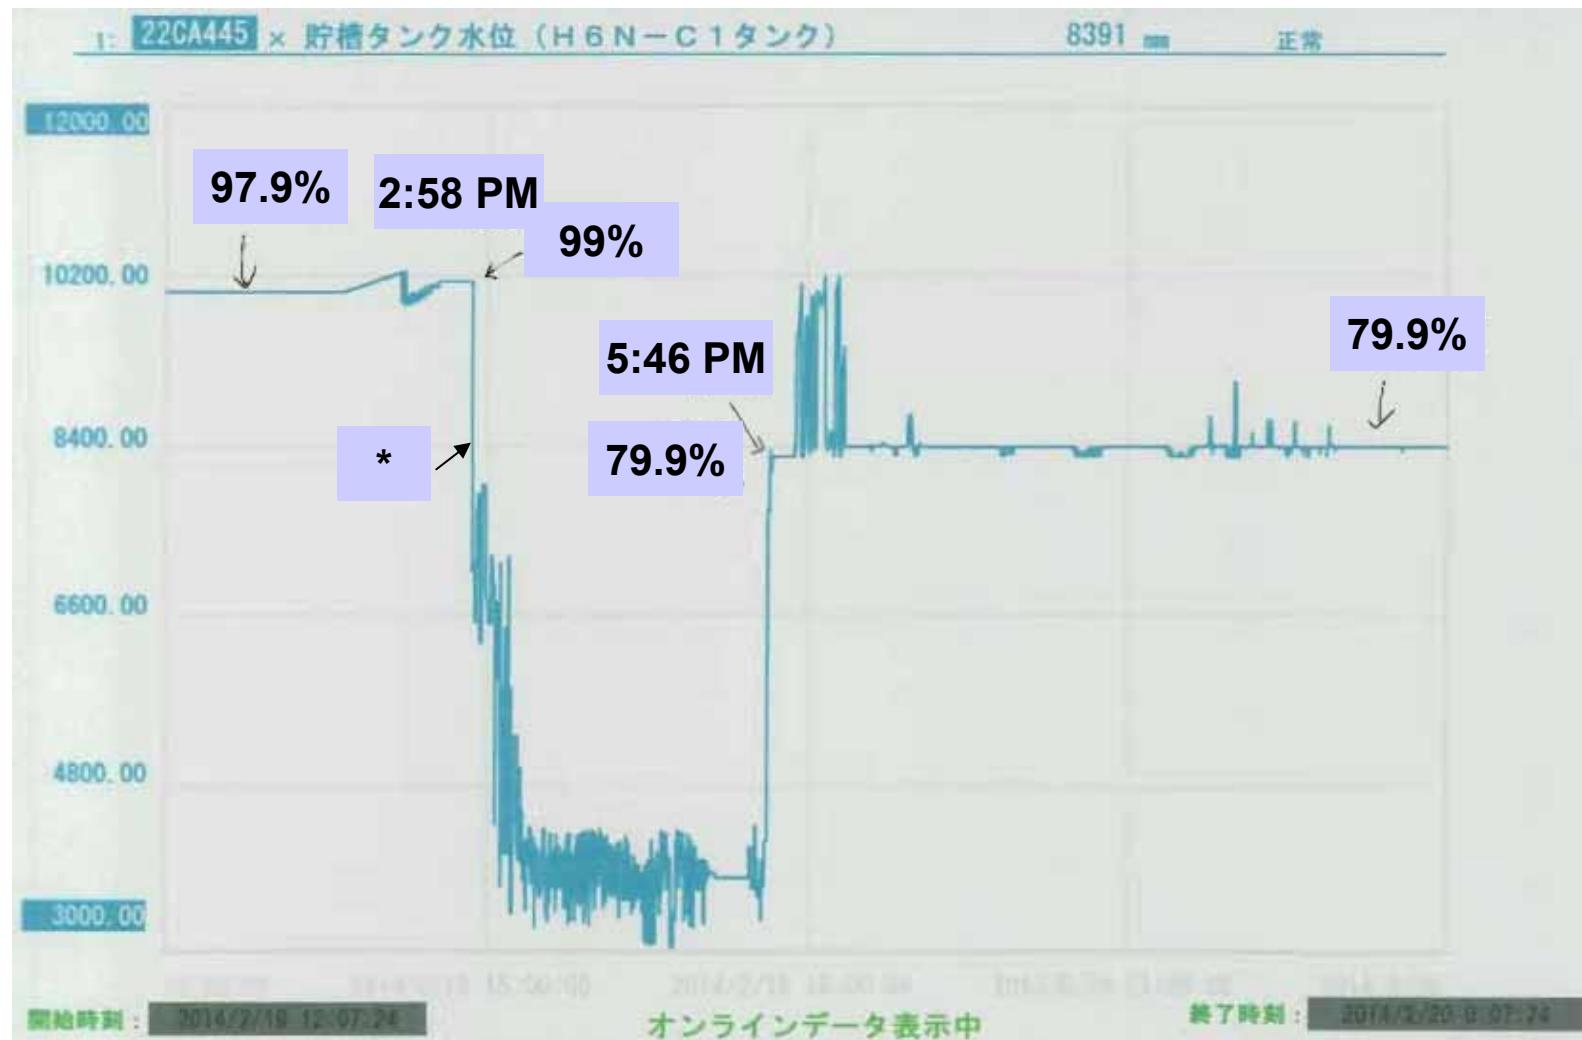
# Water Level Trend of the Overflowed Tank (H6N-C1)

- 02:01 PM Alarm was issued for high-high water level at the H6N-C1 storage tank.  
Alarm set value; High water level refers to 96.3%, and high-high water level refers to 98.9%.
- 02:05 PM An associate company which found the alarm contacted a TEPCO employee.  
Immediately, the TEPCO employee contacted the tank patrol men, and secured that there was no transfer, inspection, or maintenance work for gauges. Therefore TEPCO determined the problem was caused by measurement system.
- 03:00 PM For making sure, a TEPCO patrol man checked the surrounding of the tank and found no abnormality.
- 04:00 PM An associate-company worker patrolled the tank and found no abnormality in the area.
- 11:25 PM An associate-company worker found that water was overflowing from the top of the tank in H6 tank area during the tank area patrol.

- At around 05:40 AM TEPCO secured that 1) the overflow stopped, and 2) the water level of C1 tank lowered to the point (47 cm from the top plate).

- At around 03:30 AM Communication valves connecting to the other tanks in H6 area C-Group were opened, so that the water level of the tank can be lowered.

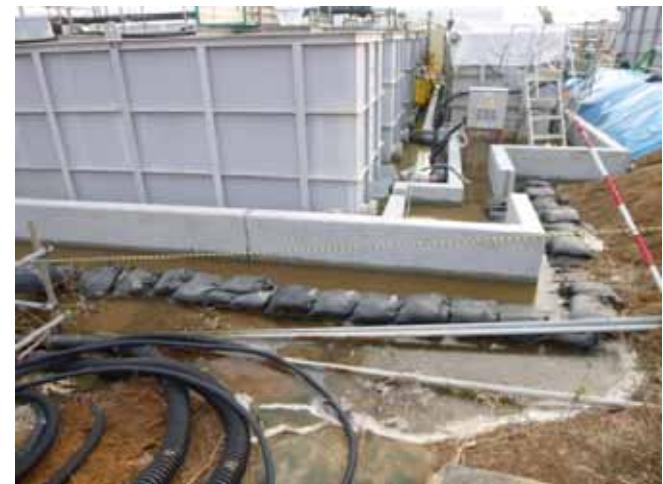
Condition of the overflow  
(Area (1))

- The area which where the overflowed water of approx.  $100\text{m}^3$  flowed to is the below three areas.
  - (1) Area where the desalination system (evaporative concentration) is installed
  - (2) U-shaped gutter where electric cable is accommodated
  - (3) Area near the H6 tank area dike
- Overflowed water which still remains inside of the dike is approx.  $10\text{m}^3$

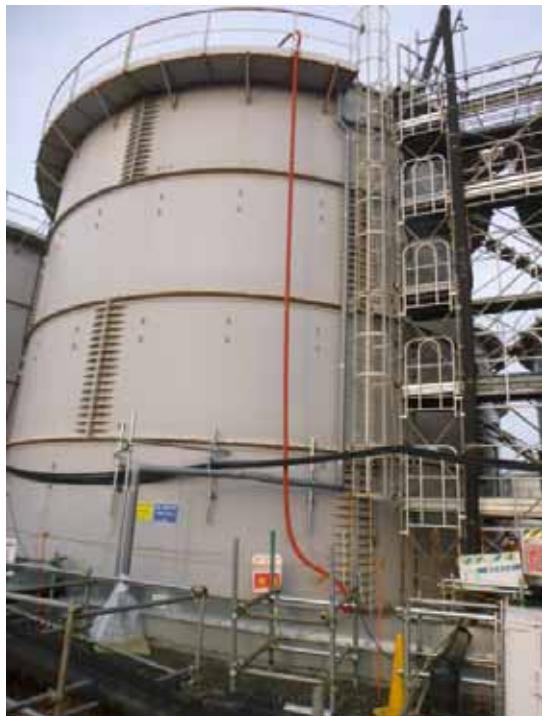
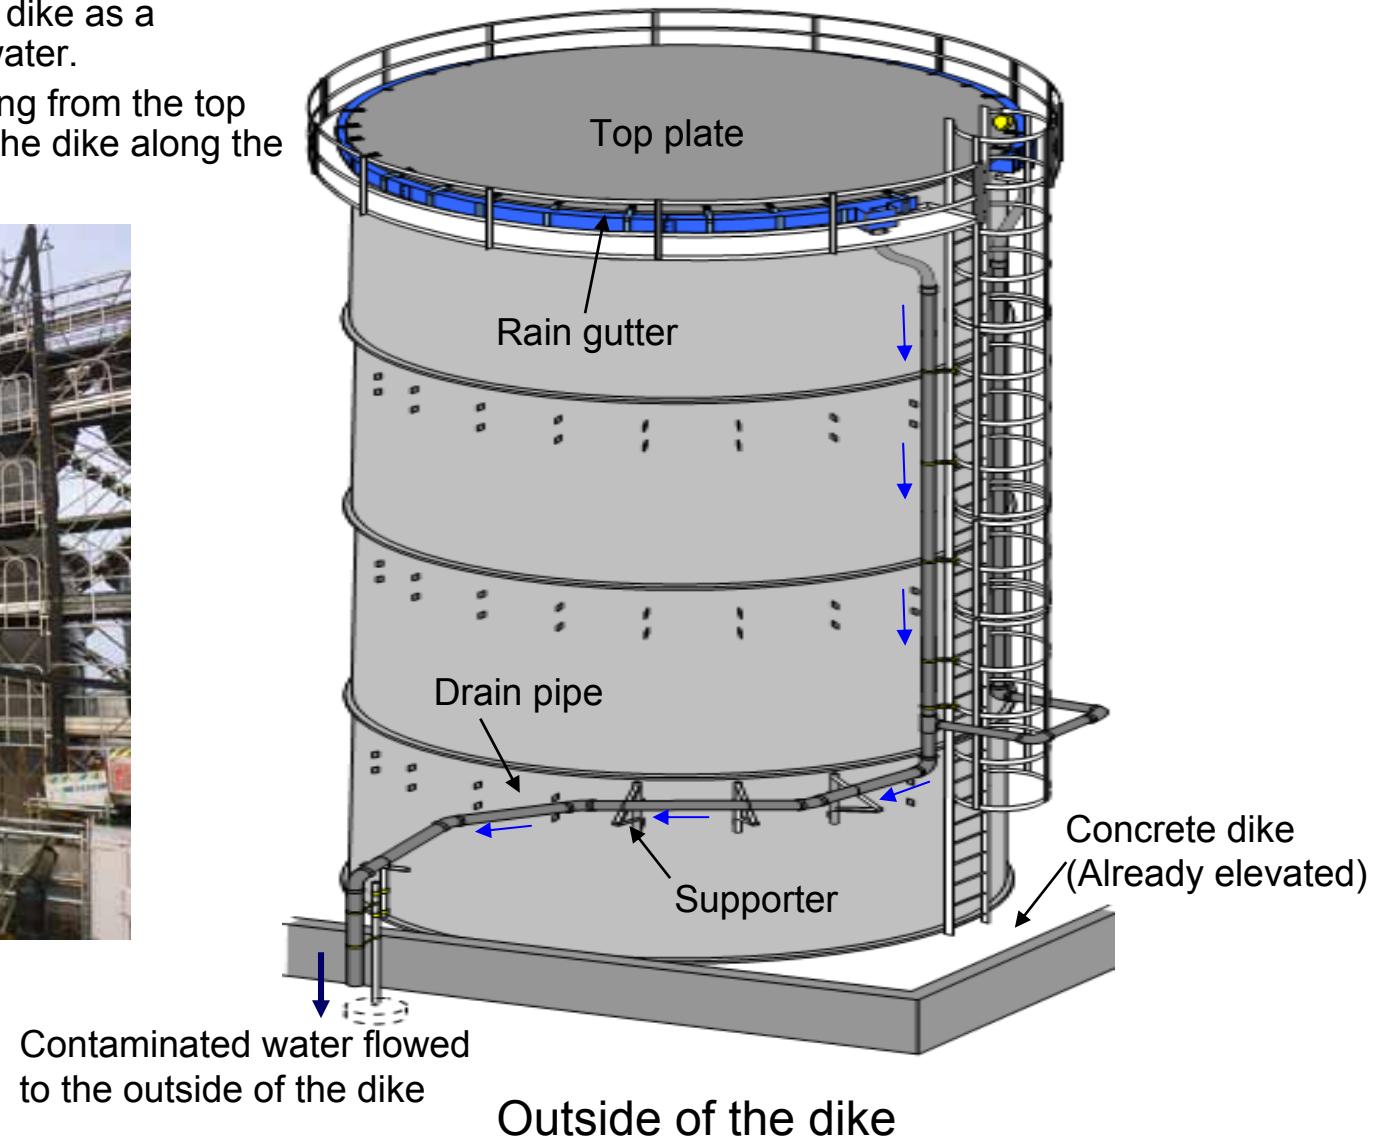
# Mechanism of the Outflow of Contaminated Water

- A rain gutter was installed in order to drain rainwater to the outside of the dike as a countermeasure against rainwater.
- Contaminated water overflowing from the top plate flowed to the outside of the dike along the rain gutter.

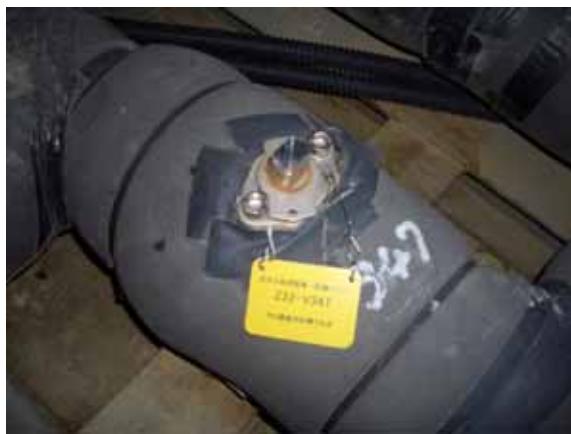
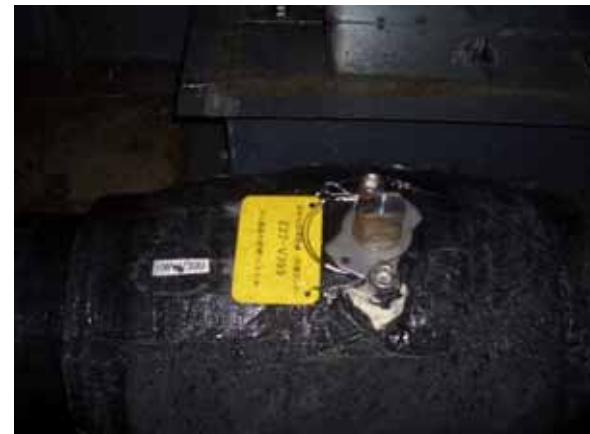
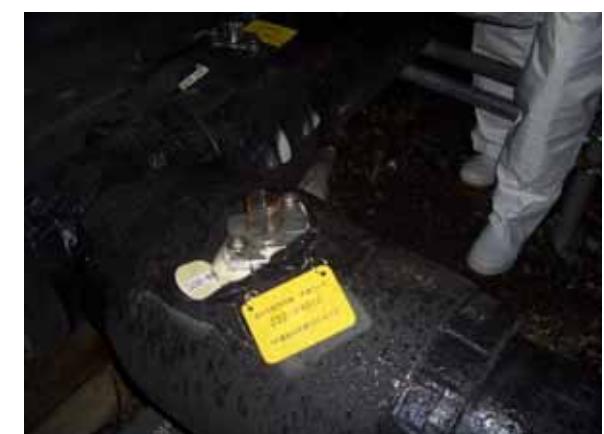
## Inspection result

- Valves corresponding to each tank section of H, G, and J1 areas.

Result: No abnormalities found
