# Water Overflow from the flange of the top panel at the upper part of H6 tank area

<Reference>  
February 21, 2014  
Tokyo Electric Power Company

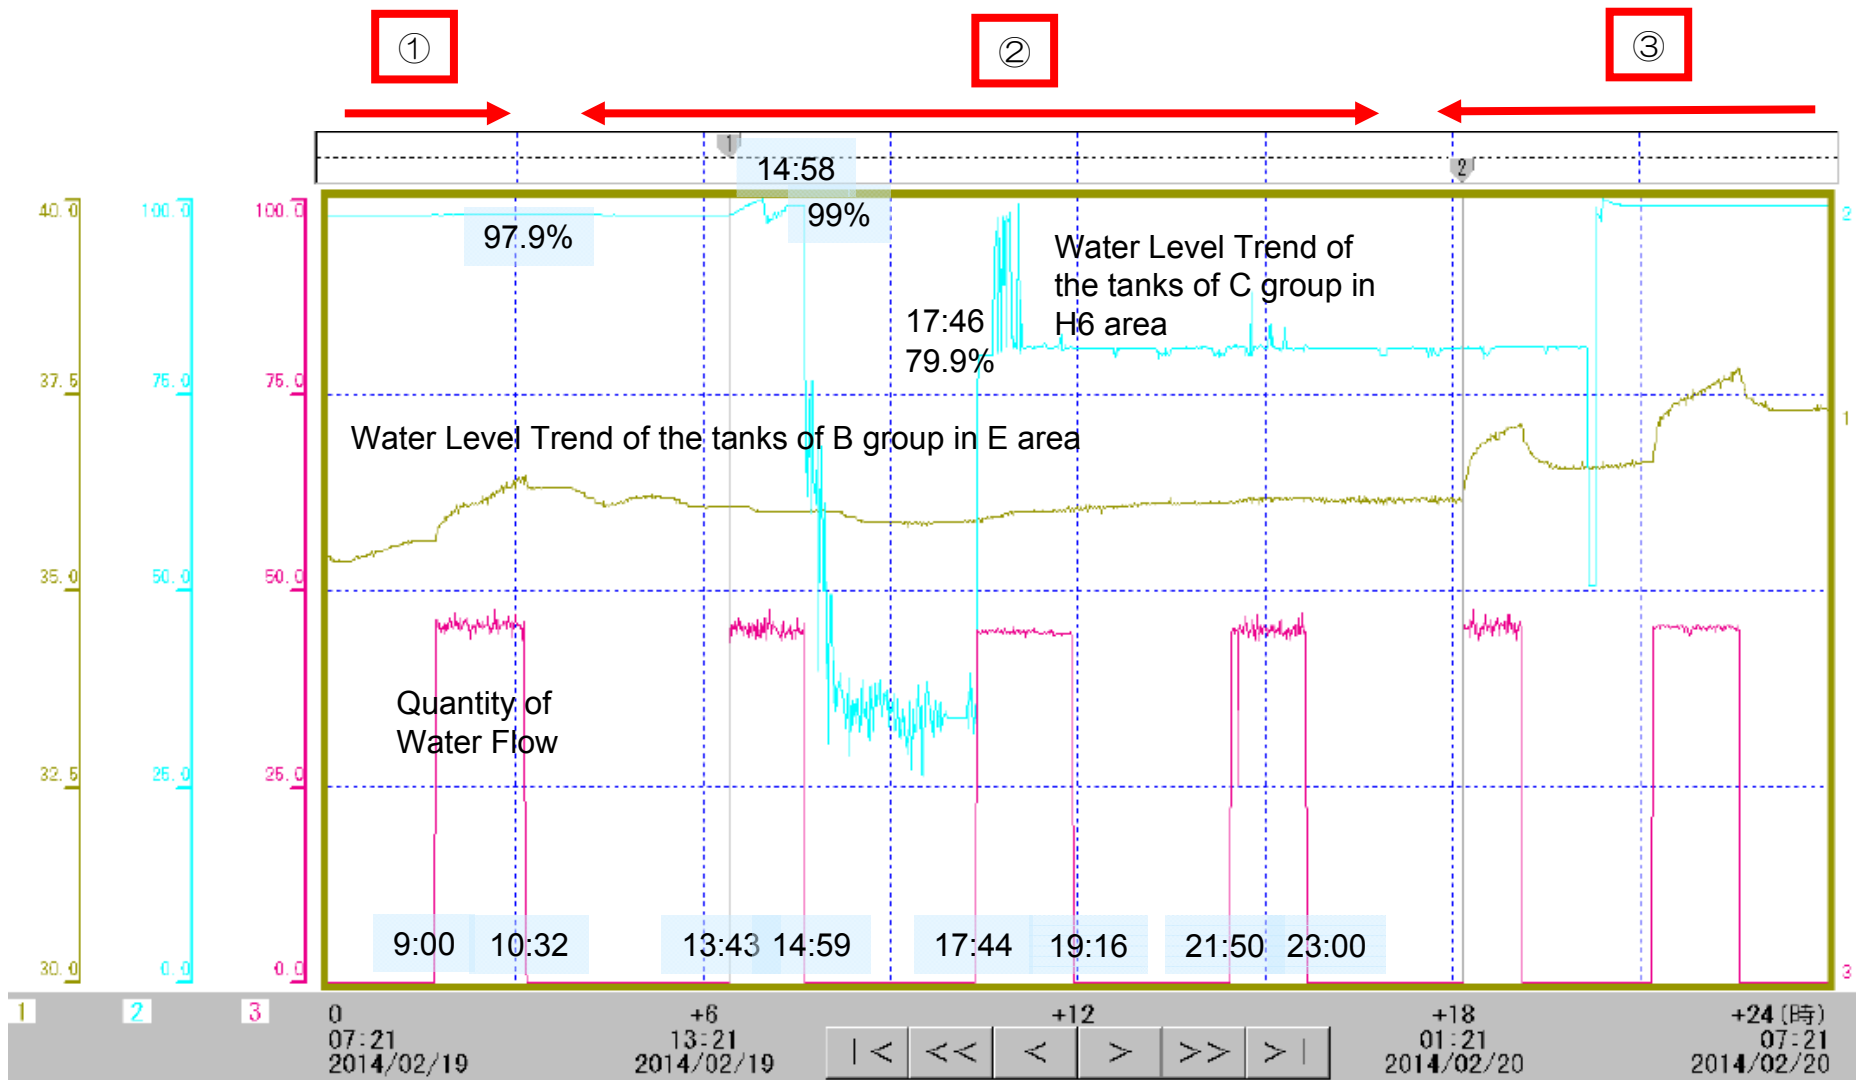
# Water level Trends of the Tanks and the Status of the Pump Operation

- The actual water level should have been checked after the water gauge alarm sounded
  - Indication of the problem should have been found earlier and measures should have been taken based on the operating status of the pump and the trends of the tanks

- The below measures will be conducted as immediate measures:
  - Constantly check the water level of the tanks to which contaminated water is to be transferred when the transfer pumps are being operated
  - When the connection between the operation of pumps and water level of the tanks is found to be abnormal, perform a site investigation to check the switching condition of valves and the structure of the transfer line
  - When a tank's "High water level" alarm sounds, investigate the water level from the top panel of the tank on-site, and confirm whether any problem is occurring

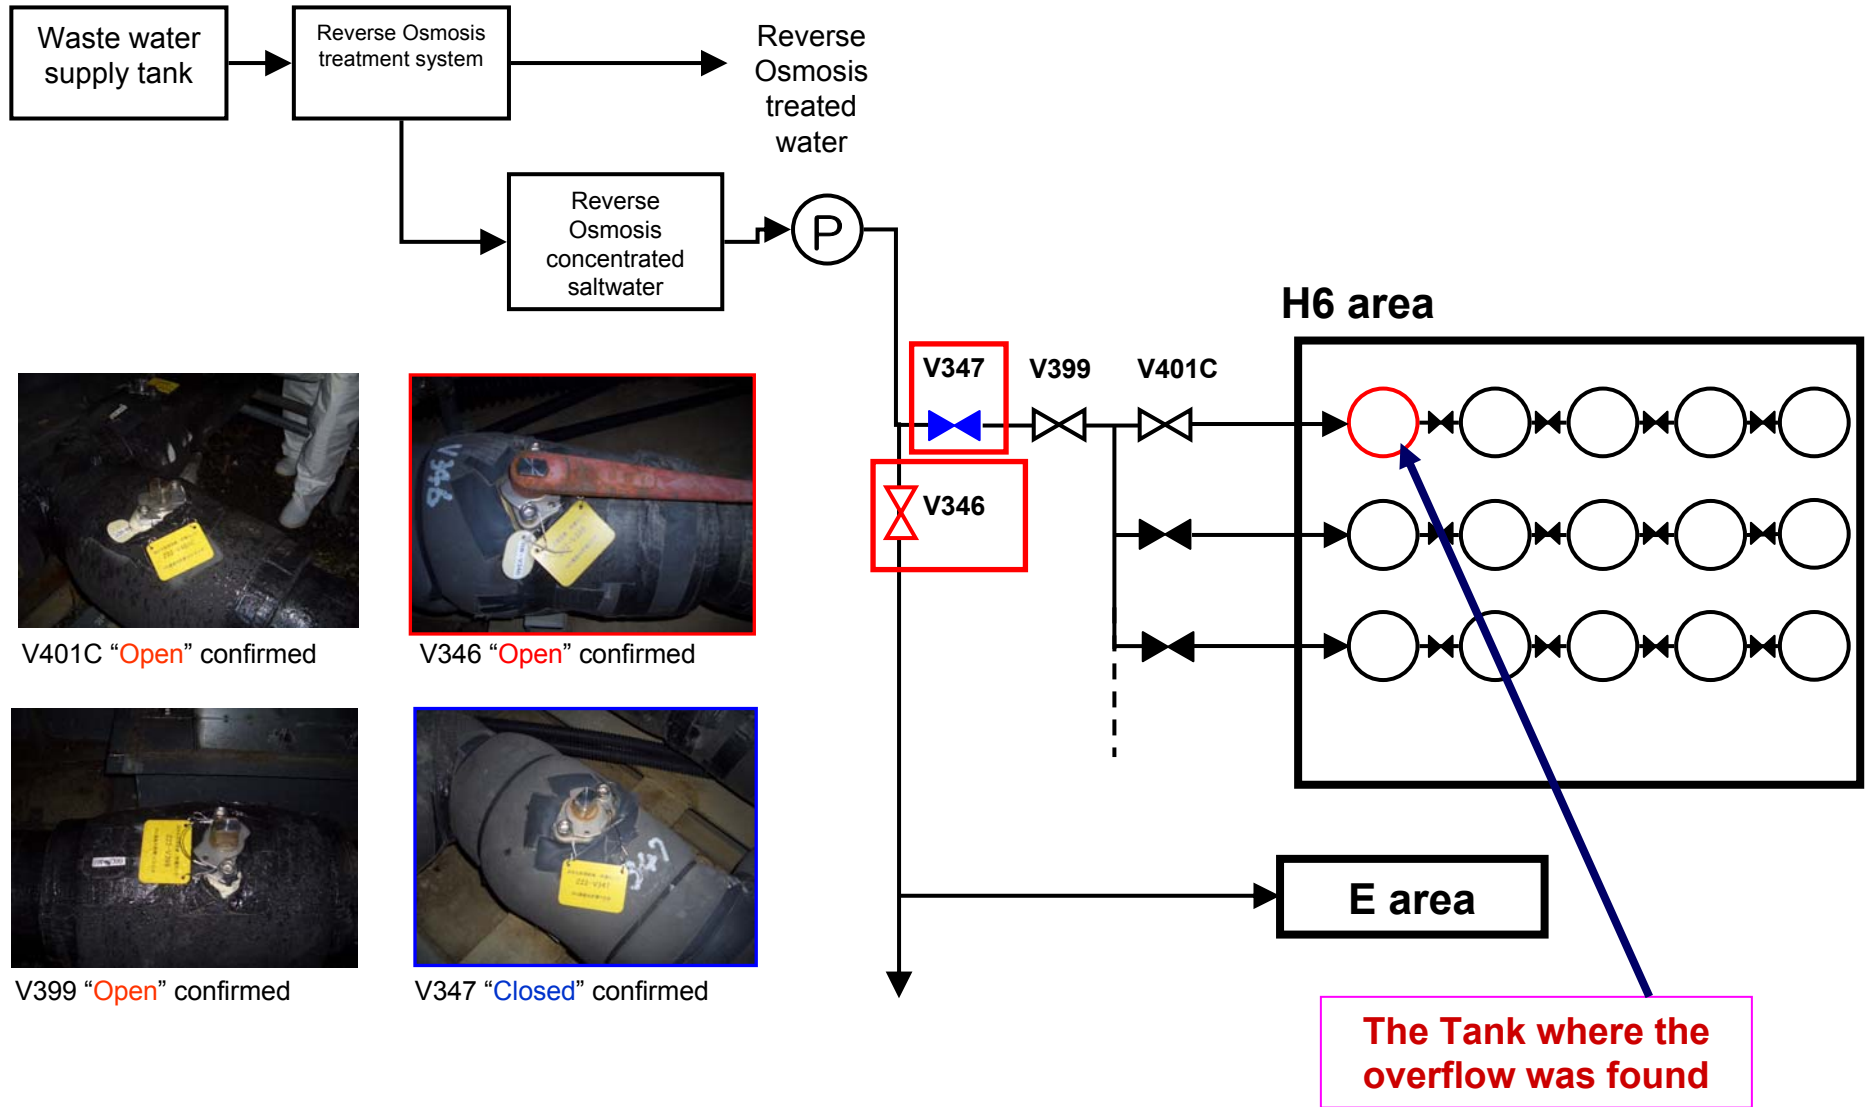
# Schematic Diagram of Pipes Transferring Water Treated by the Desalination System (Concentrated Saltwater) (Feb. 20, Status ③)

- The latest investigation shows that the valve which we announced on Feb. 20<sup>th</sup> as “being closed” was likely to be “opened” for a certain period of time.

- Investigation concerning the status of the switching condition of the valves is continuing.
