“Development of a technology to investigate inside the Reactor Primary Containment Vessel (PCV)”

- Results of site test “Investigation B1” on grating around the
pedestal inside Unit 1 PCV -**

April 30, 2015

Tokyo Electric Power Company

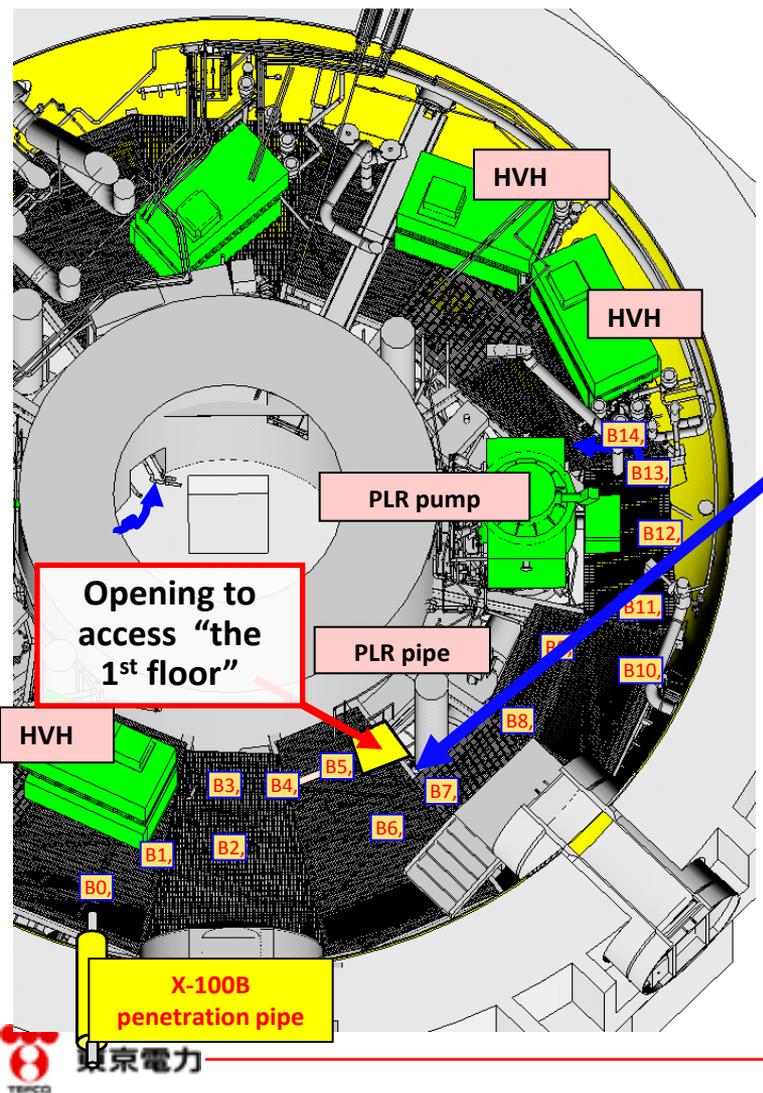
Taken from B4

- It was confirmed that there is an accessible opening at the basement for B2 investigation planned to be conducted, and thus, there are no obstacle objects existed around it.

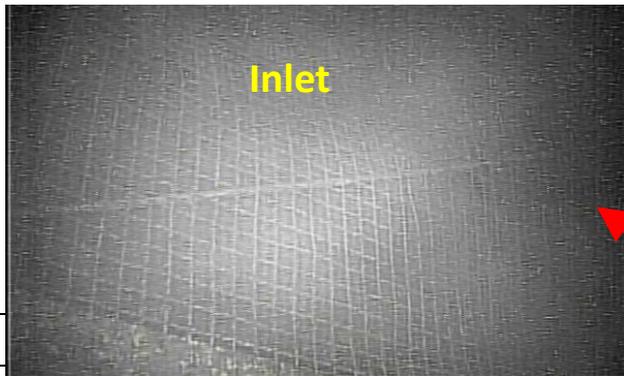
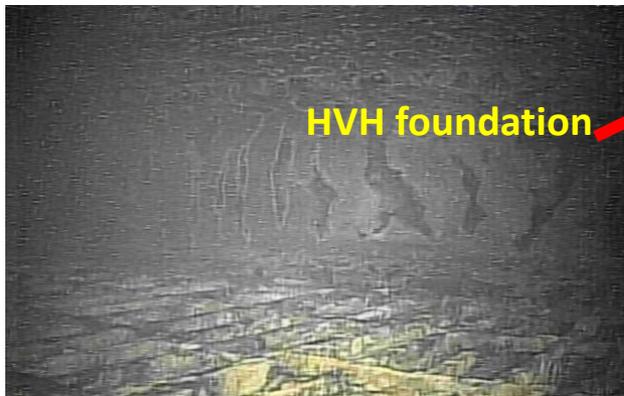
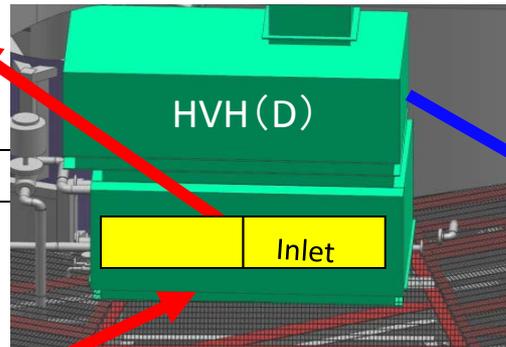
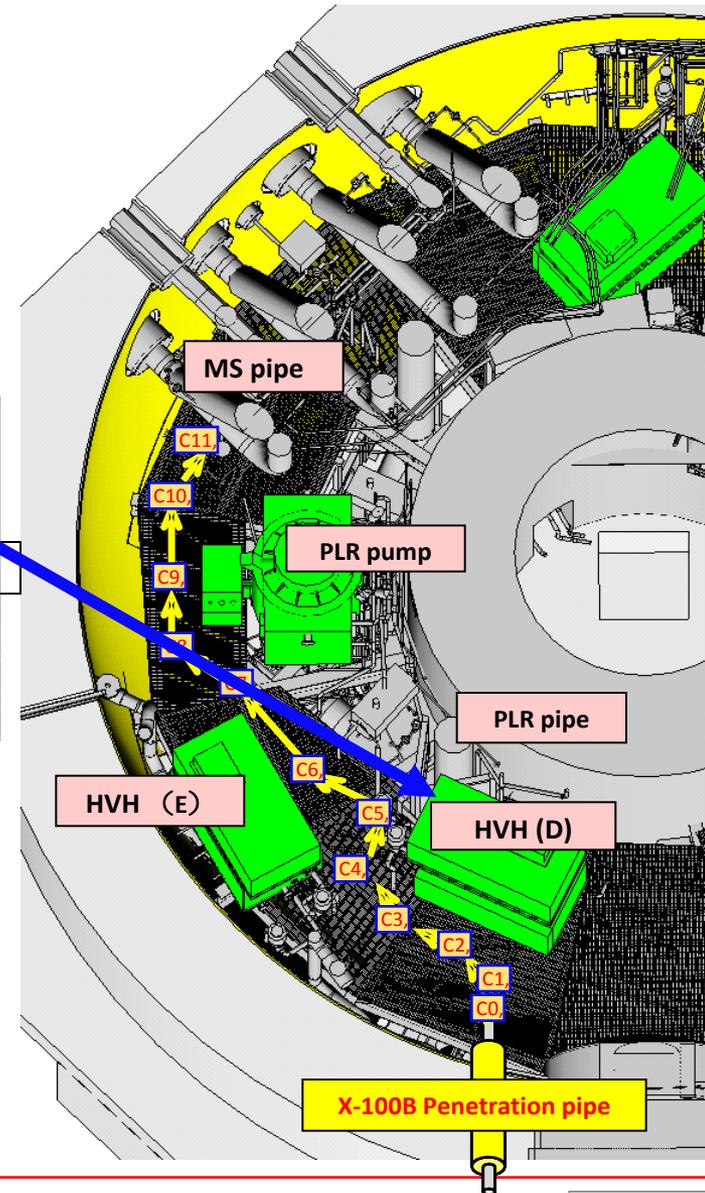
Taken from C2

No significant damages are found on HVH (D)

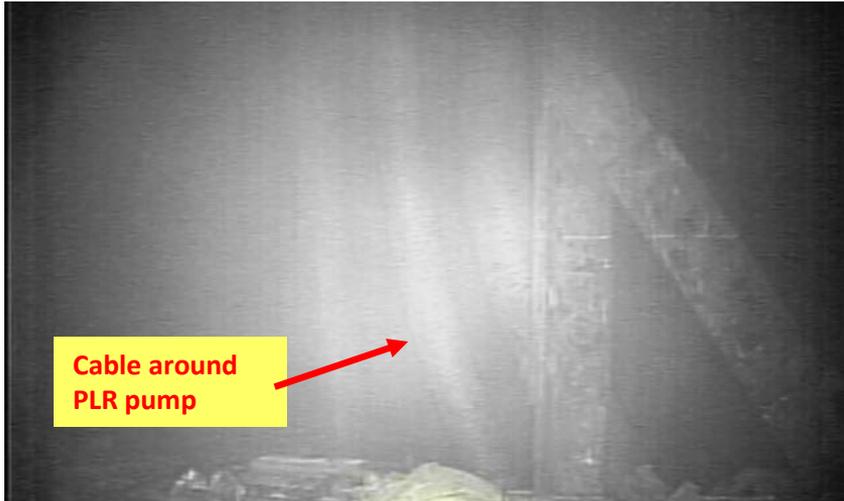
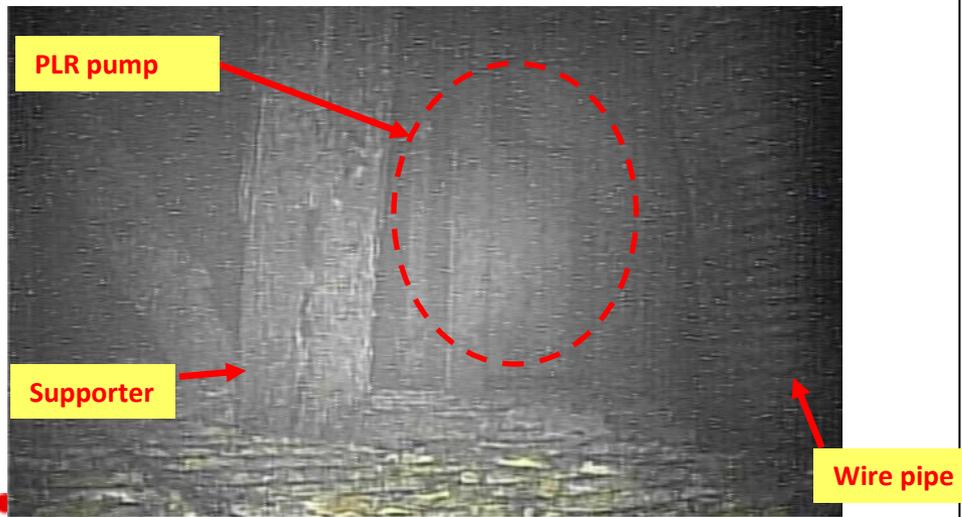
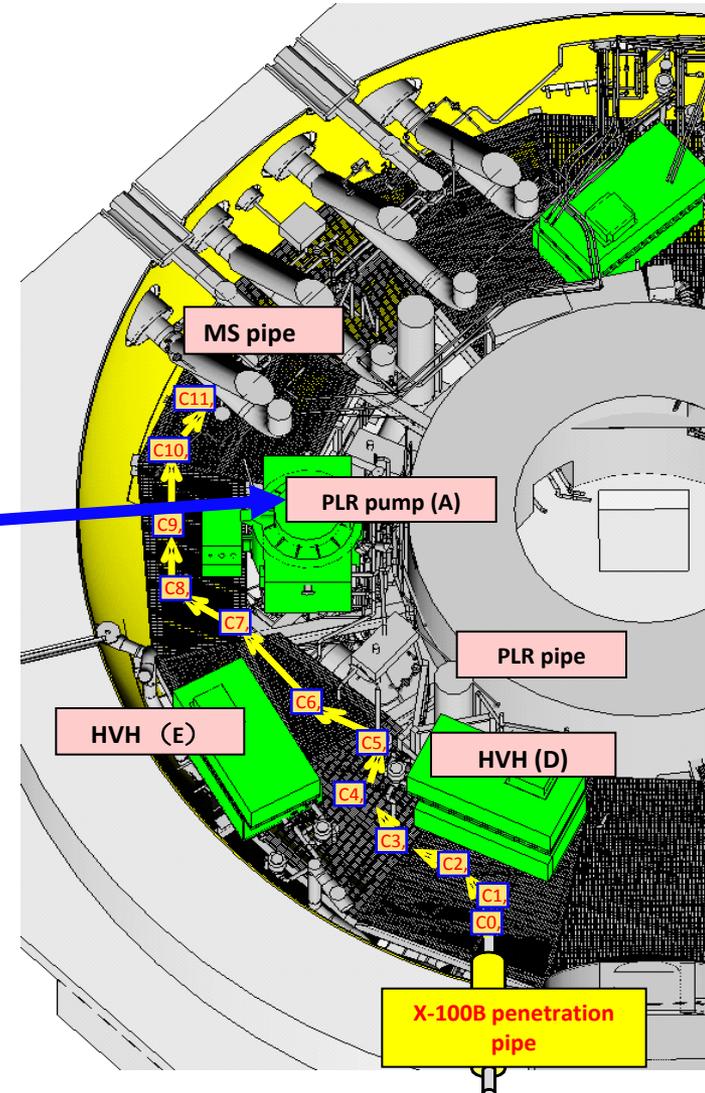
Taken from C2

No significant damages are found on PLR pump (A).

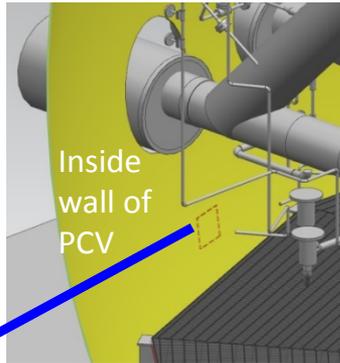
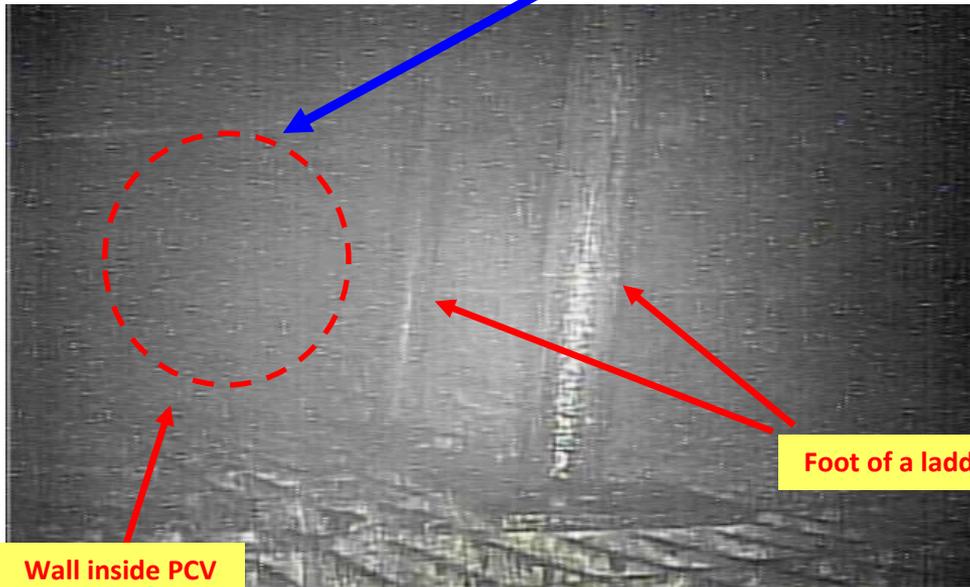
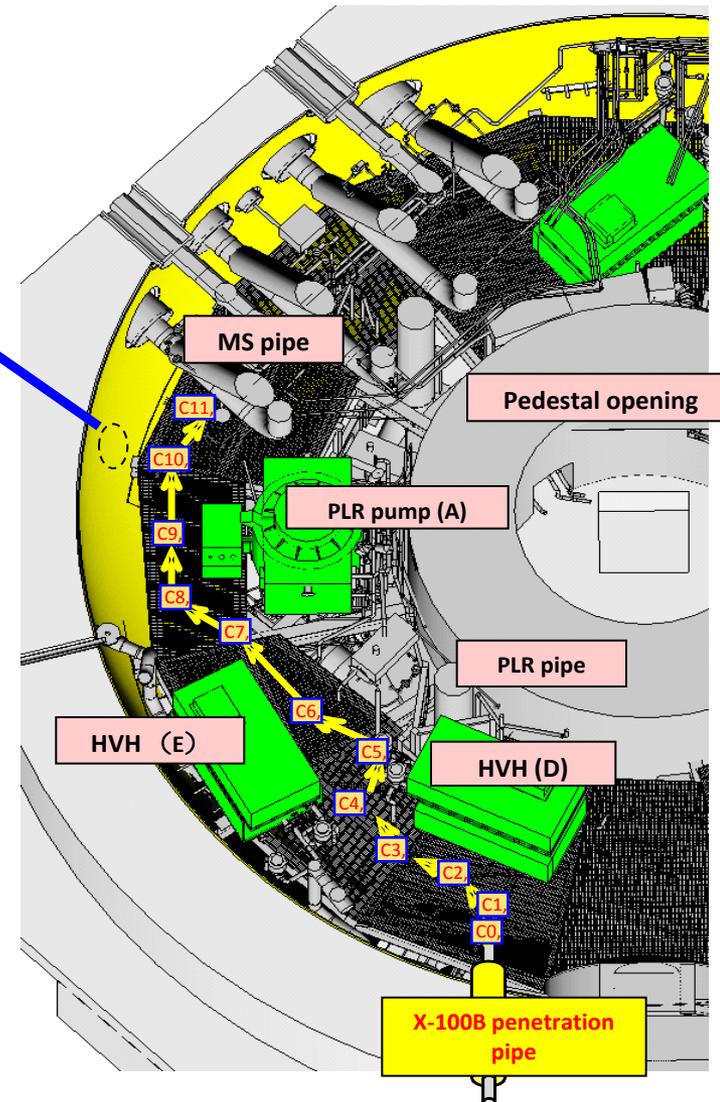
Taken from C10

No significant damages are found on the wall inside PCV.

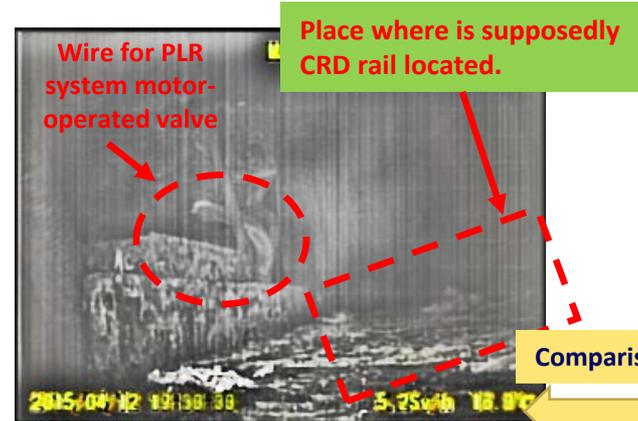
Image (taken at 6:00 PM, Apr. 12)

■ Shooting was performed towards the direction of CRD rail at the end point where the device reached at (around B14) during the investigation along counterclockwise route. The images taken were processed but CRD rail could not be visually identified.

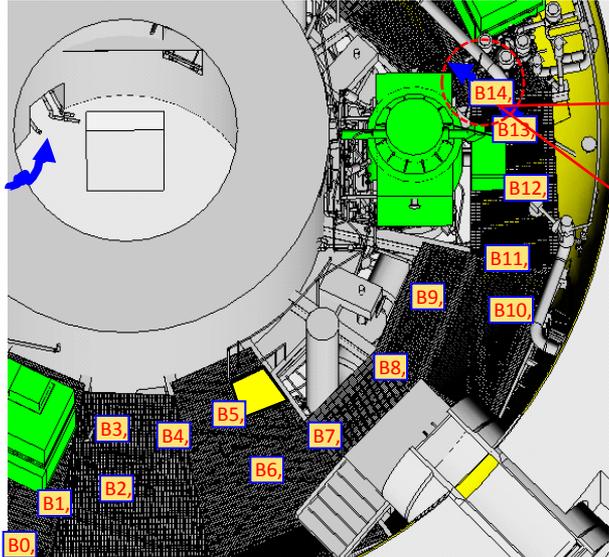
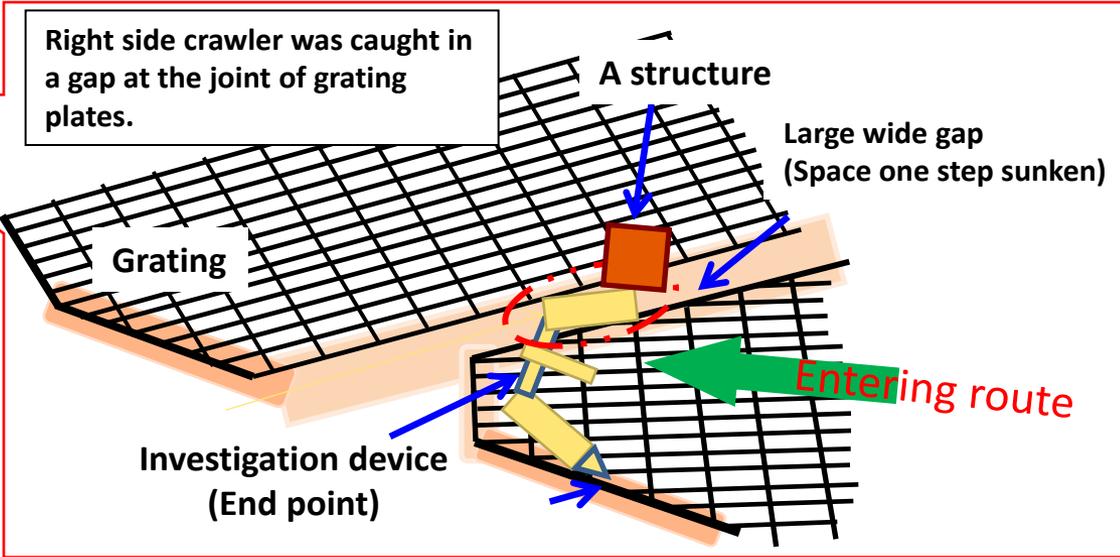
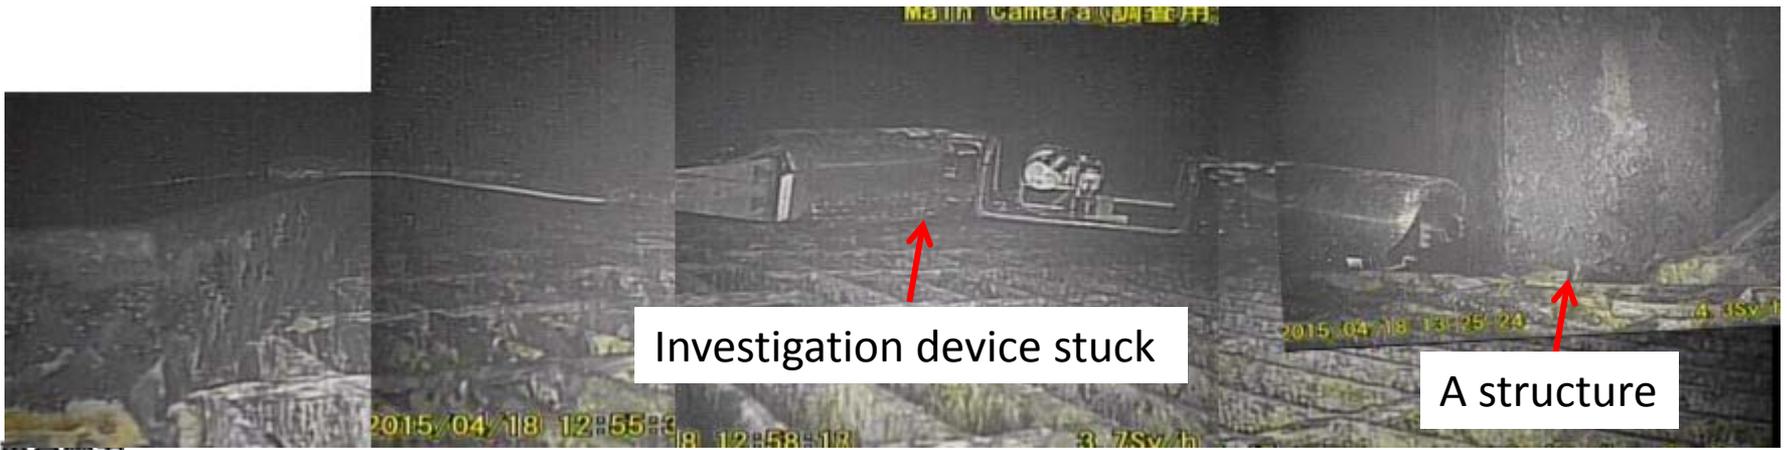
Investigation point	Investigation results
Check the route of the cable remained	<ul style="list-style-type: none"> The cable being left around the opening to access the basement is confirmed of having no problem with B2 investigation.
Investigation device stuck	<ul style="list-style-type: none"> Checked on the condition of the crawler of the device stuck.
Check the access route up to CRD rail	<ul style="list-style-type: none"> The access route up to CRD rail goes through a narrow part between structures, which resulted in the investigation device having been disabled to pass through.

■ The status of the investigation device stuck was checked.

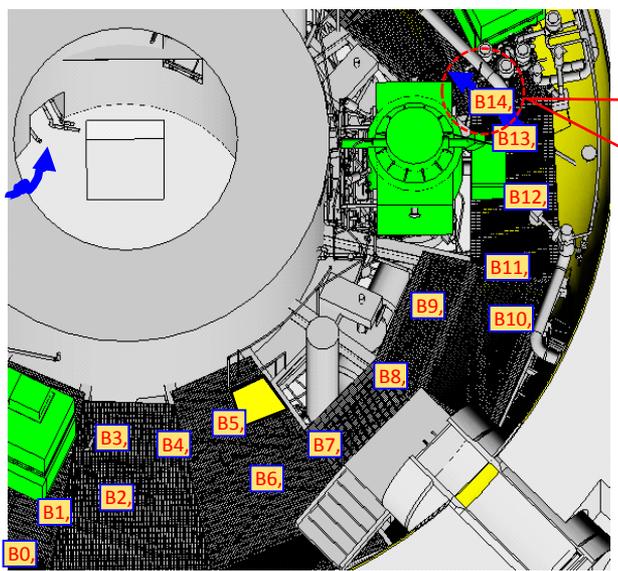
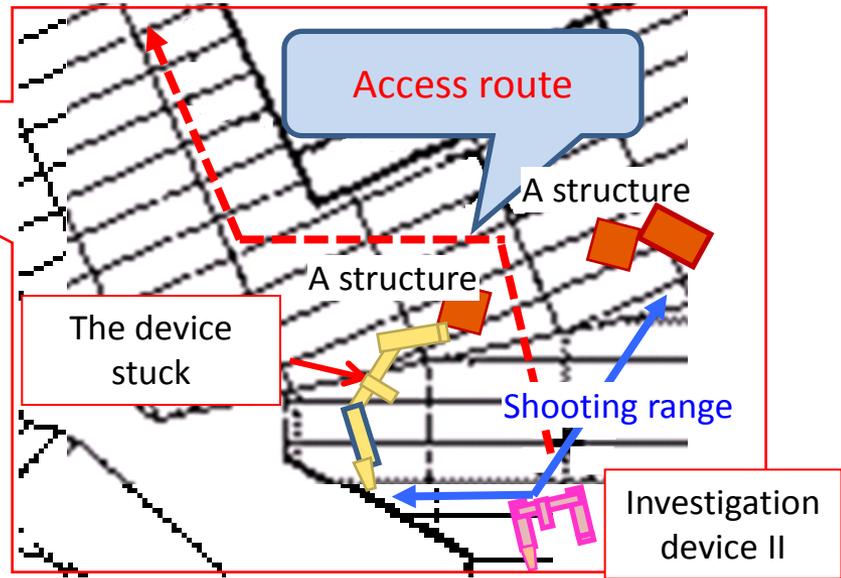
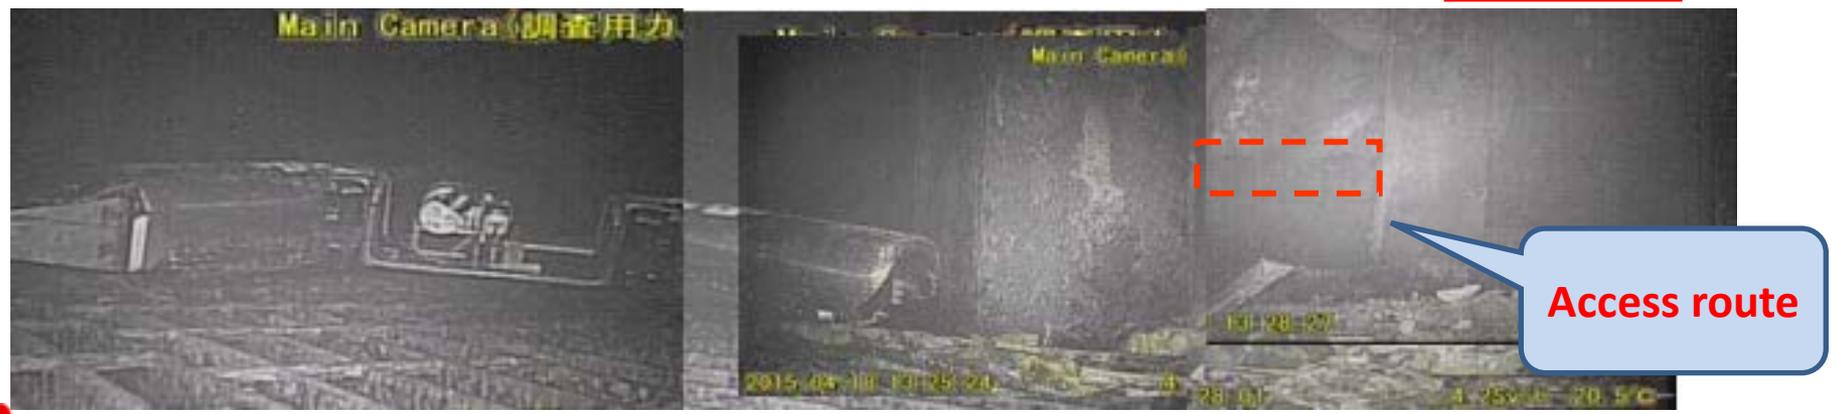
■ It was **concluded** that the access route up to CRD rail is **too narrow** to get the device pass through.

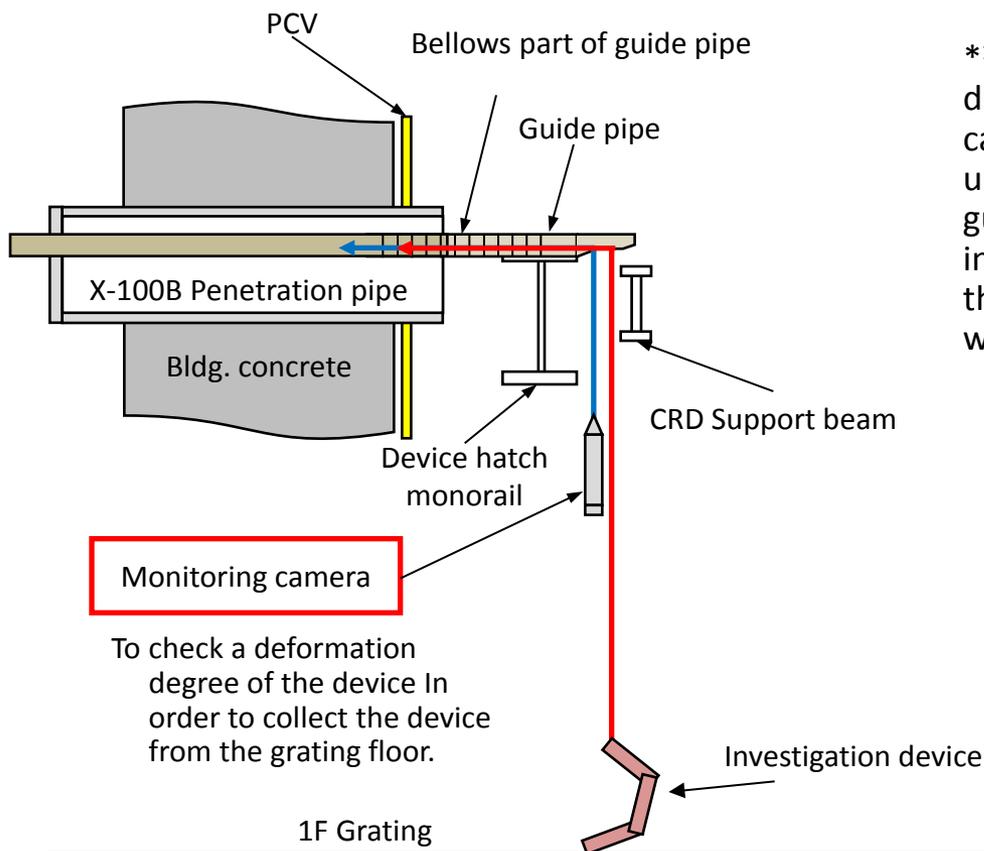
■ Due to the deterioration of the monitoring camera with radiation (assumption), the camera's visibility was extremely dropped to the point disable to perform a deformation check on the device at the time of retrieving it from the vessel. Accordingly, the collection of the device to outside the reactor primary containment vessel was judged as risky. (*1)

*1 Judging from the facts that the deterioration of the monitoring camera and that there was a slight unevenness at the bellow part of guide pipe for inserting the investigation device, there is a risk that the device might get caught when passing though the bellows.

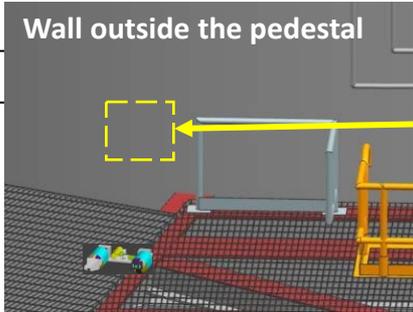
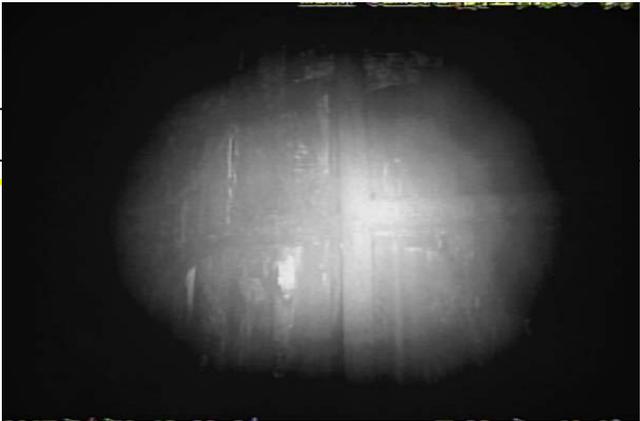
Taken from B3

No significant damages were found on the wall outside the pedestal .

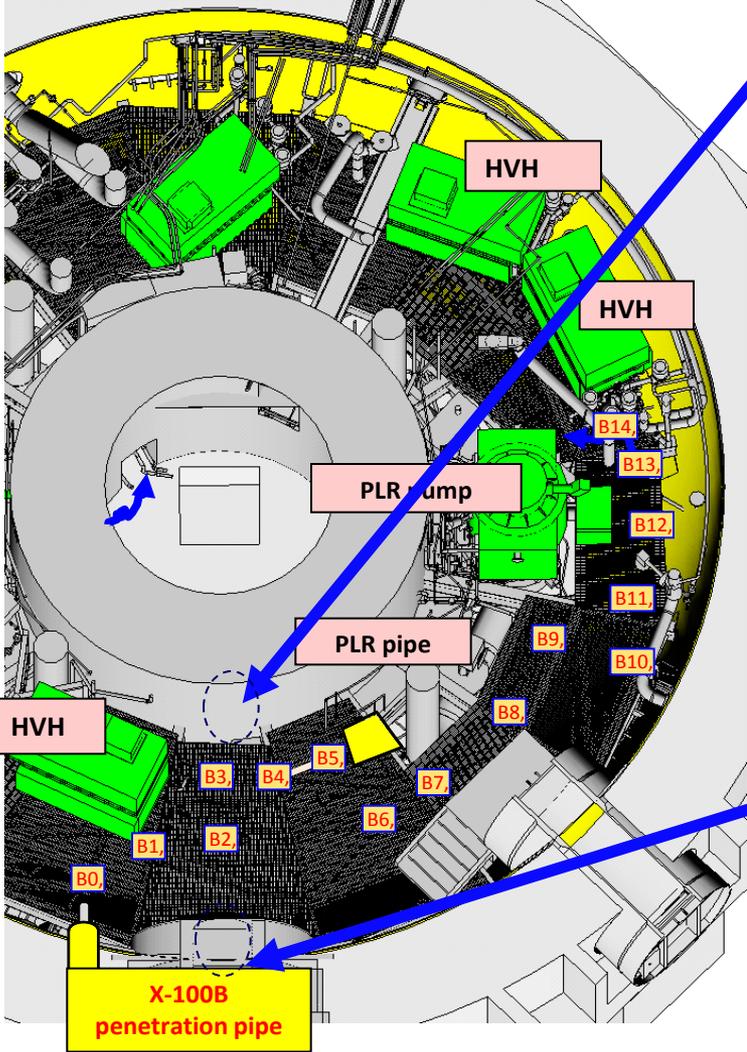
Taken from B2

No significant damages were found on equipment hatch.

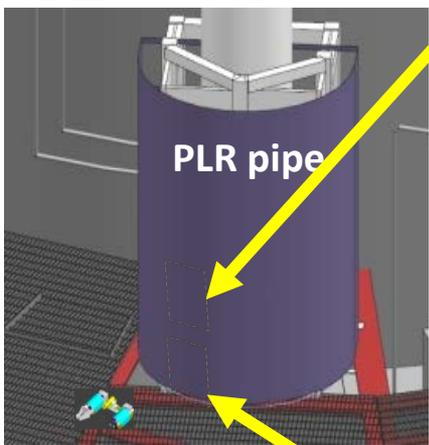
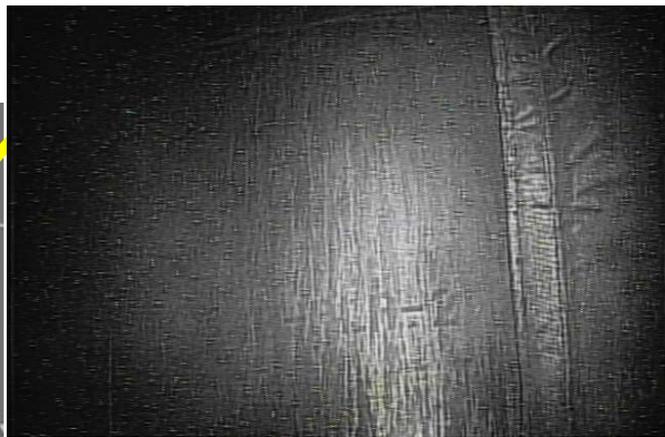
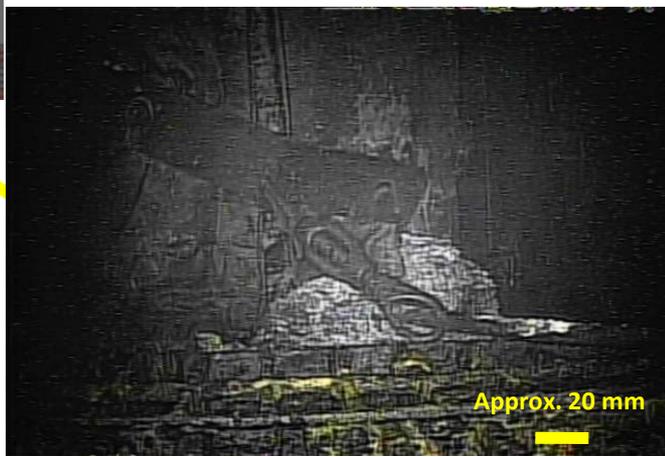
Taken from B7

- No significant damages were found on PLR pipe (heat insulation)
- Pieces of the shield of the pipe was found to be fallen off.
