Progress of Landside Impermeable Wall freezing: Phase 1 of the first stage

Landside Impermeable Wall Freezing Progress Report: Soil Temperatures (Temperatures in Thermometer Pipes) (as of 7 a.m. on April 26)

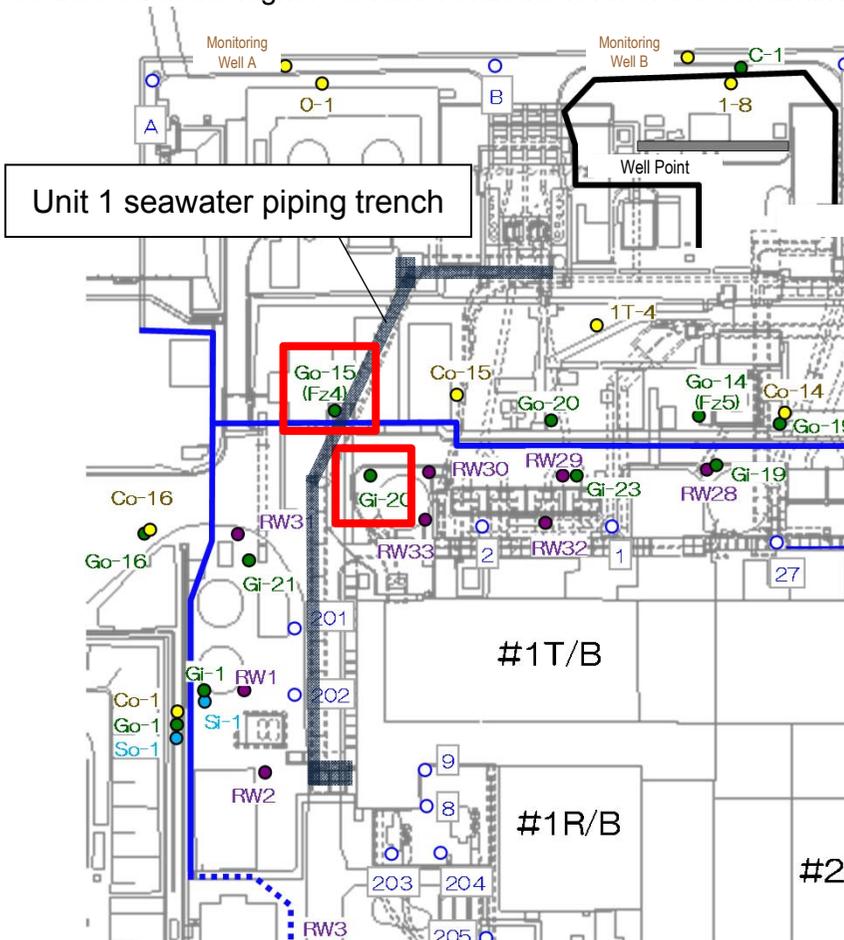
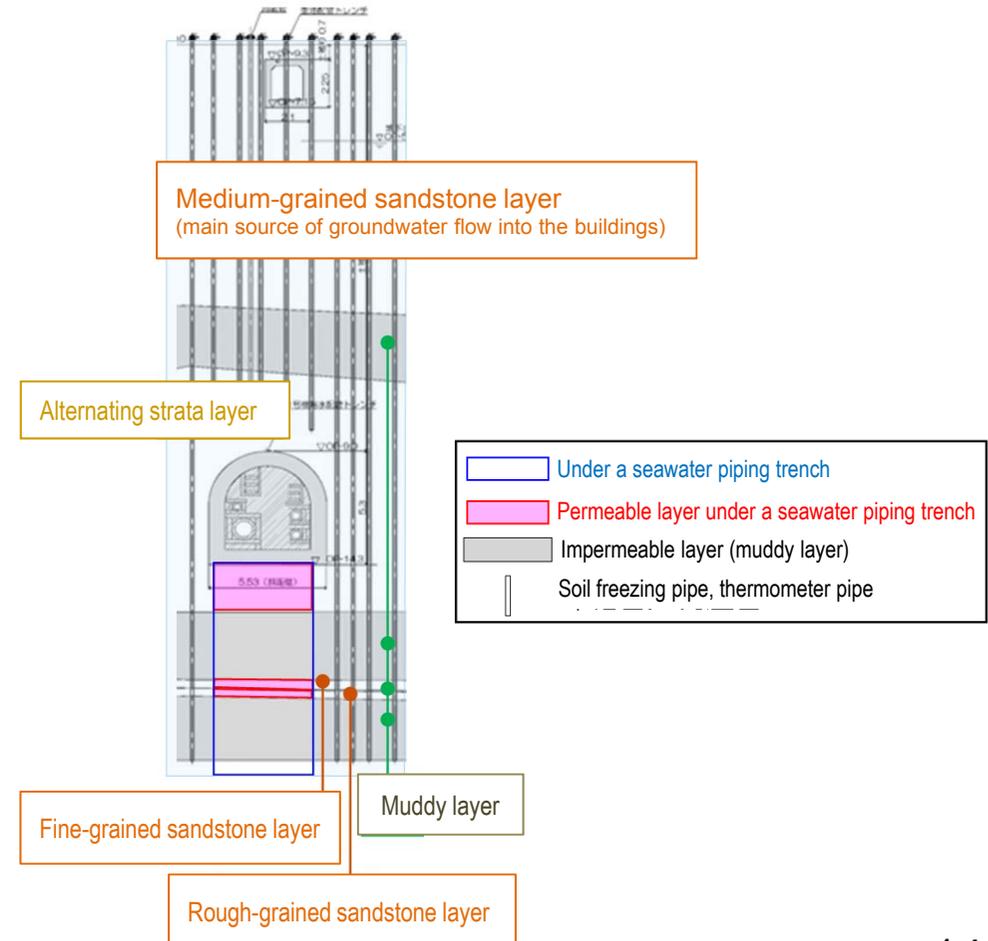
Underground objects near the groundwater level monitoring wells Go-15 and Gi-20 (1/2)

- The Unit 1 seawater piping trench is located near the groundwater level monitoring wells Go-15 and Gi-20. (Refer to the location map on the left below.)

- As shown in the image on the right below, at the crossing area with the seaside line of the Landside Impermeable Wall, the soil freezing pipes are buried up to the depth 1m above the top of Unit 1 seawater piping trench no to damage the underground object. The bottom of the trench will not be frozen.
- Unlike Units 2-4 seawater piping trenches, the accumulated water inside Unit 1 seawater piping trench is not transferred and the inside of the trench is not filled with cement. Contaminated water retained in the buildings has not flowed into the trench because the mouth of the trench is connected at the higher elevation than the level of the contaminated water in Unit 1.

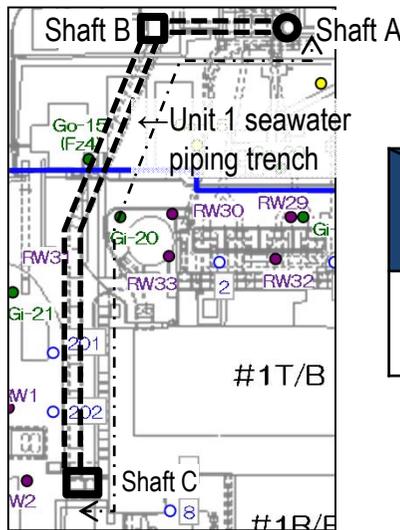
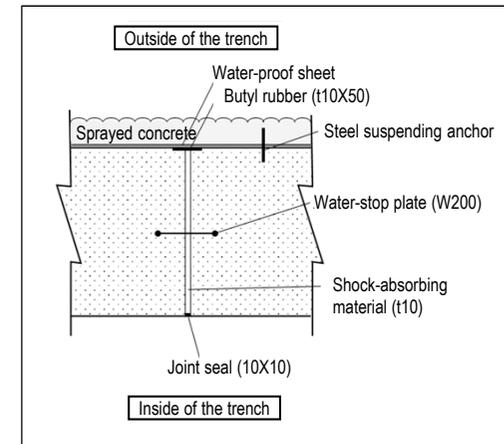
Underground objects near groundwater level monitoring wells Go-15 and Gi-20 (2/2)

- Around the seaside line of the Landside Impermeable Wall, there are concrete joints created when the trench was constructed.
- A water-stop plates is installed at each concrete joint to prevent the groundwater inflow into the trench.
- As shown below, the water level in the trench remained lower than the groundwater levels in the medium-grained sandstone layer and the alternating strata layer for a long period of time. It is believed that the groundwater has rarely flowed into the trench.

- The hydraulic heads at Go-15 and Gi-20 could have declined due to the nearby groundwater that flowed into the trench reflecting some influences from Unit 1 seawater piping trench after the freezing operations started.

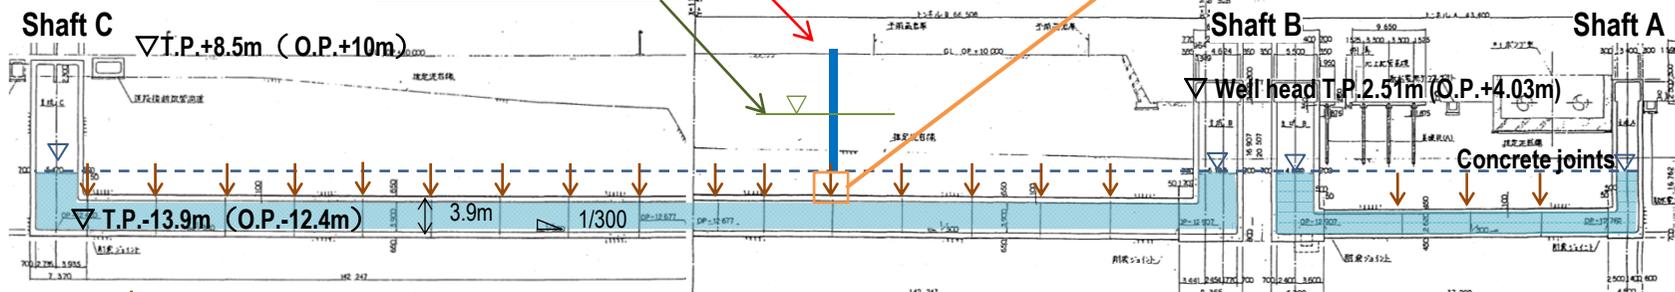
Concrete joint locations of Unit 1 seawater piping trench

Water head in the alternating strata layer around the joint area with Seaside Impermeable Wall
T.P.0.9m (O.P.+2.4m) (Go-15,4/18 12:00)

Water level: O.P.-8.04m (measured on Dec. 2015)

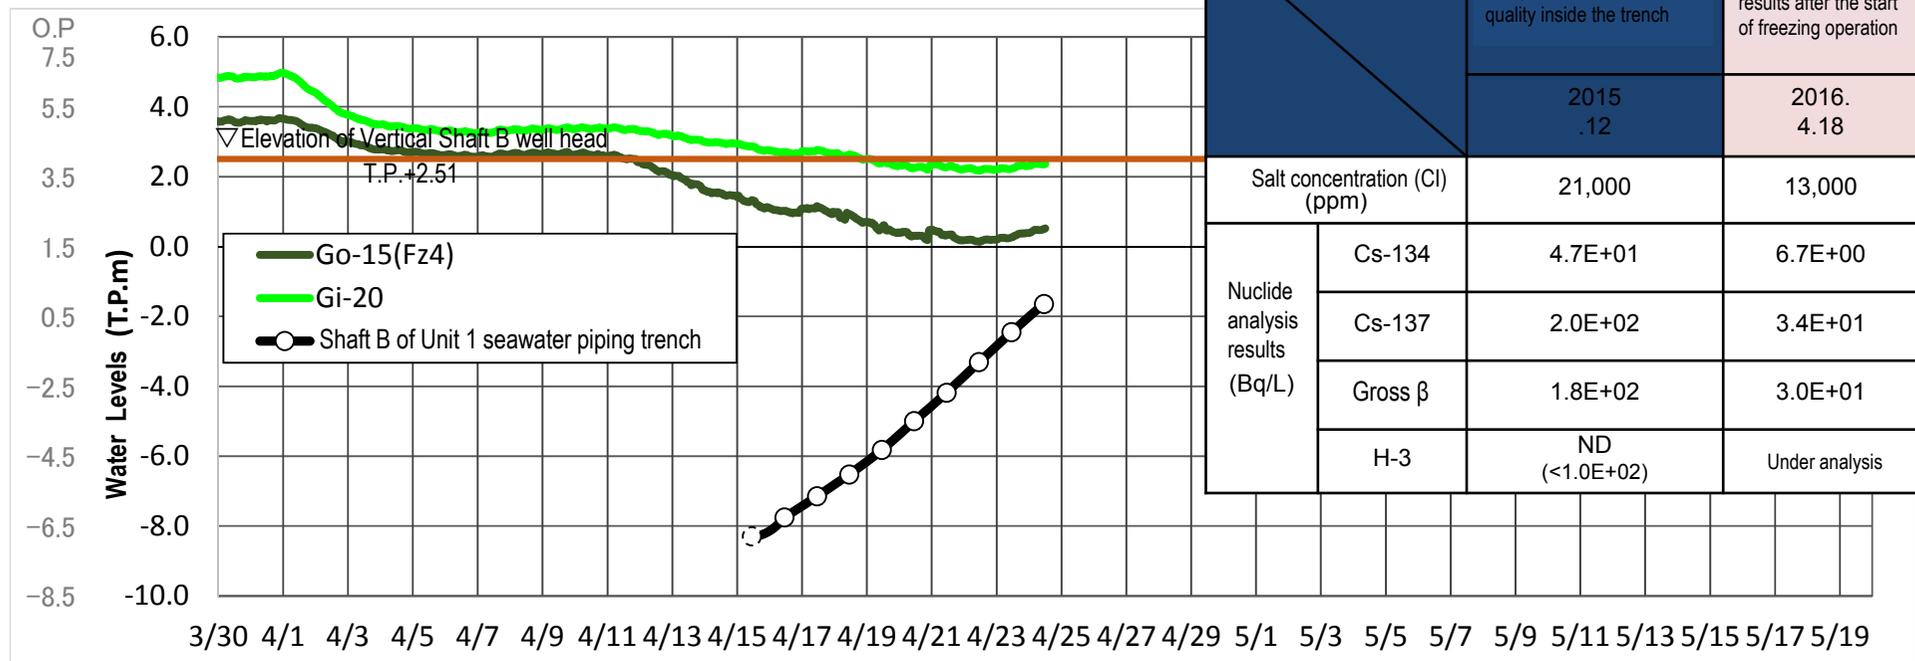
Water quality in a shaft of Unit 1 seawater piping trench

- The water level in the vertical shaft B of the Unit 1 seawater piping trench stayed around T.P.-9.5m (O.P.-8m) after the monitoring of water levels started in February 2012, as shown in the previous page. After the freezing operations started, however, the water level has been rising.

- The salt concentration and radioactive concentrations of the accumulated water inside the trench are declining compared with those before the freezing operations started. This does not conflict with the assumption that the groundwater in the alternating strata layer has flowed into the trench due to some reasons.

- Currently, the water level is measured by hand. Preparation for continuous measurements with an automated water level recording device is underway. (The operations will start at the end of April.)

- Besides, preparation work to transfer accumulated water in the trench (if necessary) is in progress by installing a water transfer facility around the vertical shaft B well head. (The preparation will be completed at the end of April.)
