# Unit 3 Primary Containment Vessel Internal Investigation

November 30, 2017

# 1. Overview of the PCV internal investigation

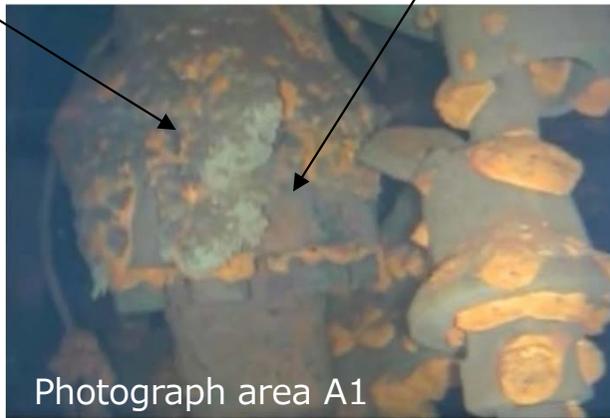
Melted object that has solidified on the CRD flange

- The CRD housing brackets were damaged or have fallen off at multiple points.
- CRD flange surfaces have different level and pitch from adjacent ones.
- A disturbance on the water surface was seen from a gap in the CRD housing (suggesting that water may be dripping from above) (Refer to Supplement 1 for the other places where disturbances on the water surface were observed) .

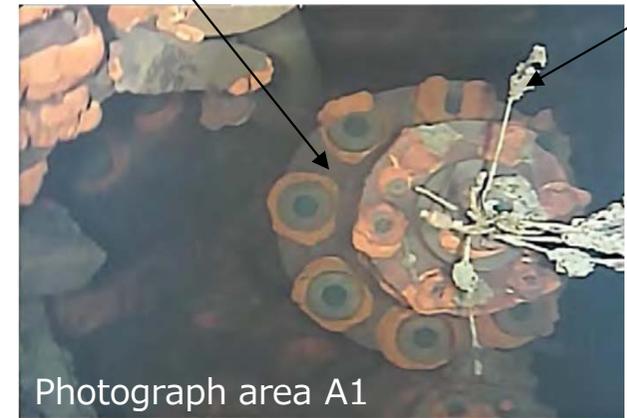
Different surface levels/pitches from adjacent CRD flanges

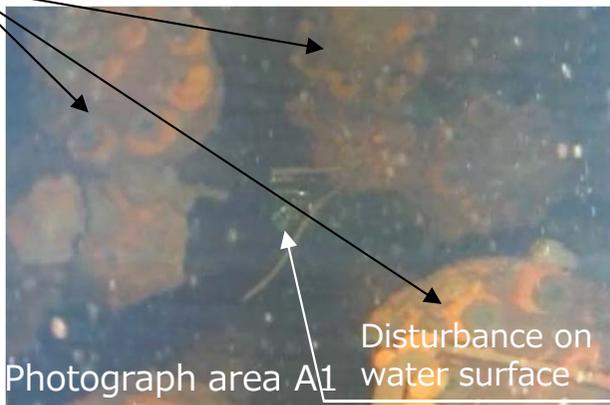
CRD housing bracket hangar rod

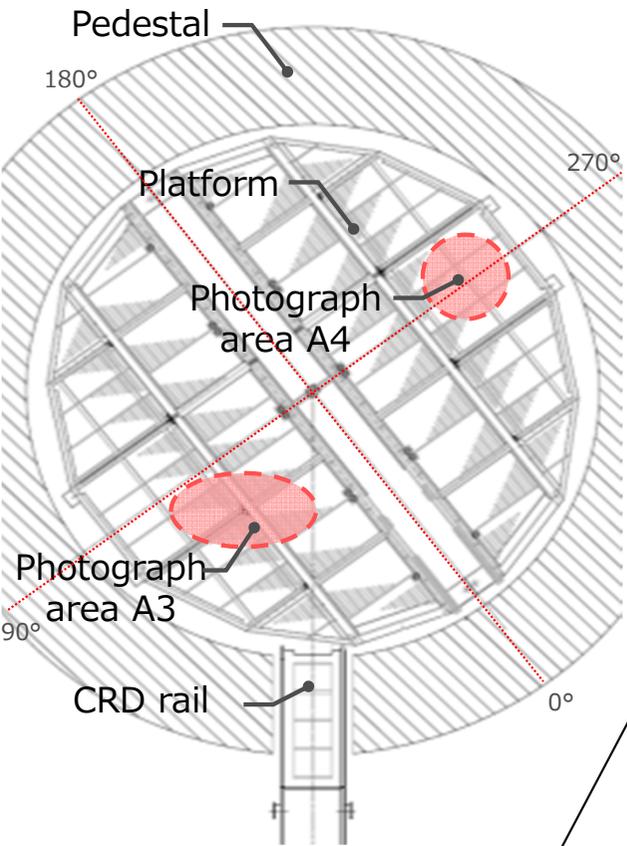
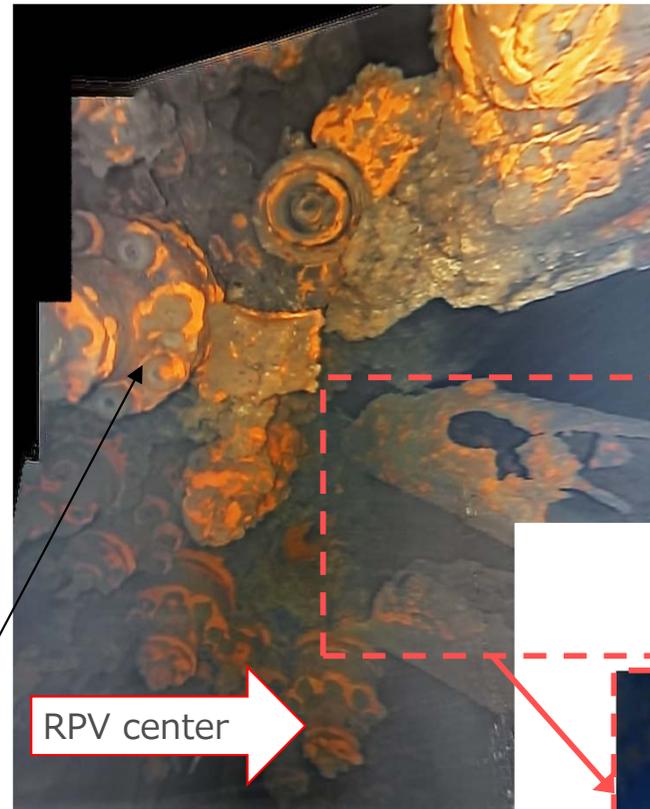
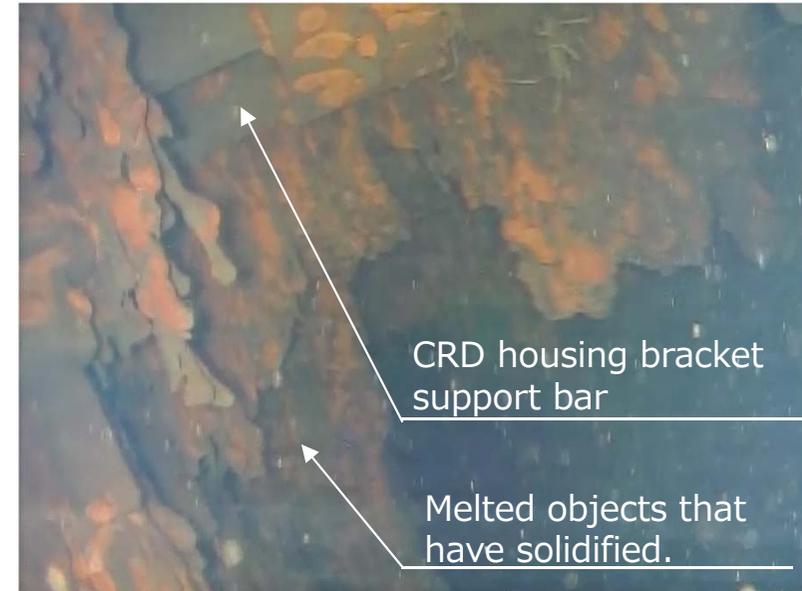
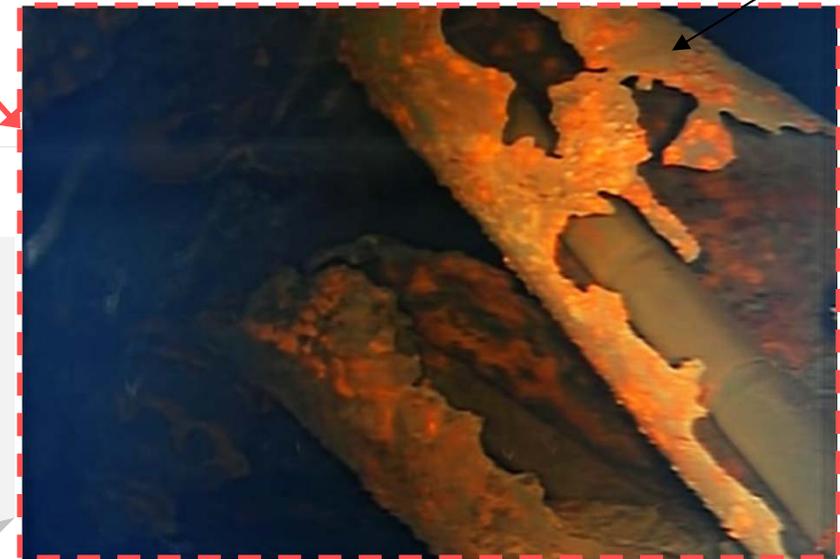
Photograph area A3 <Camera angle : Upward> Photograph area A4 <Camera angle : Horizontal>

Cylindrical structure (assumed to be CR guide tube)

- A structure that is assumed to be the CR guide tube was found near the CRD housing. (Refer to supplement 2 for the basis for this assumption.)
- Melted objects solidified and are attached to the CRD housing brackets.

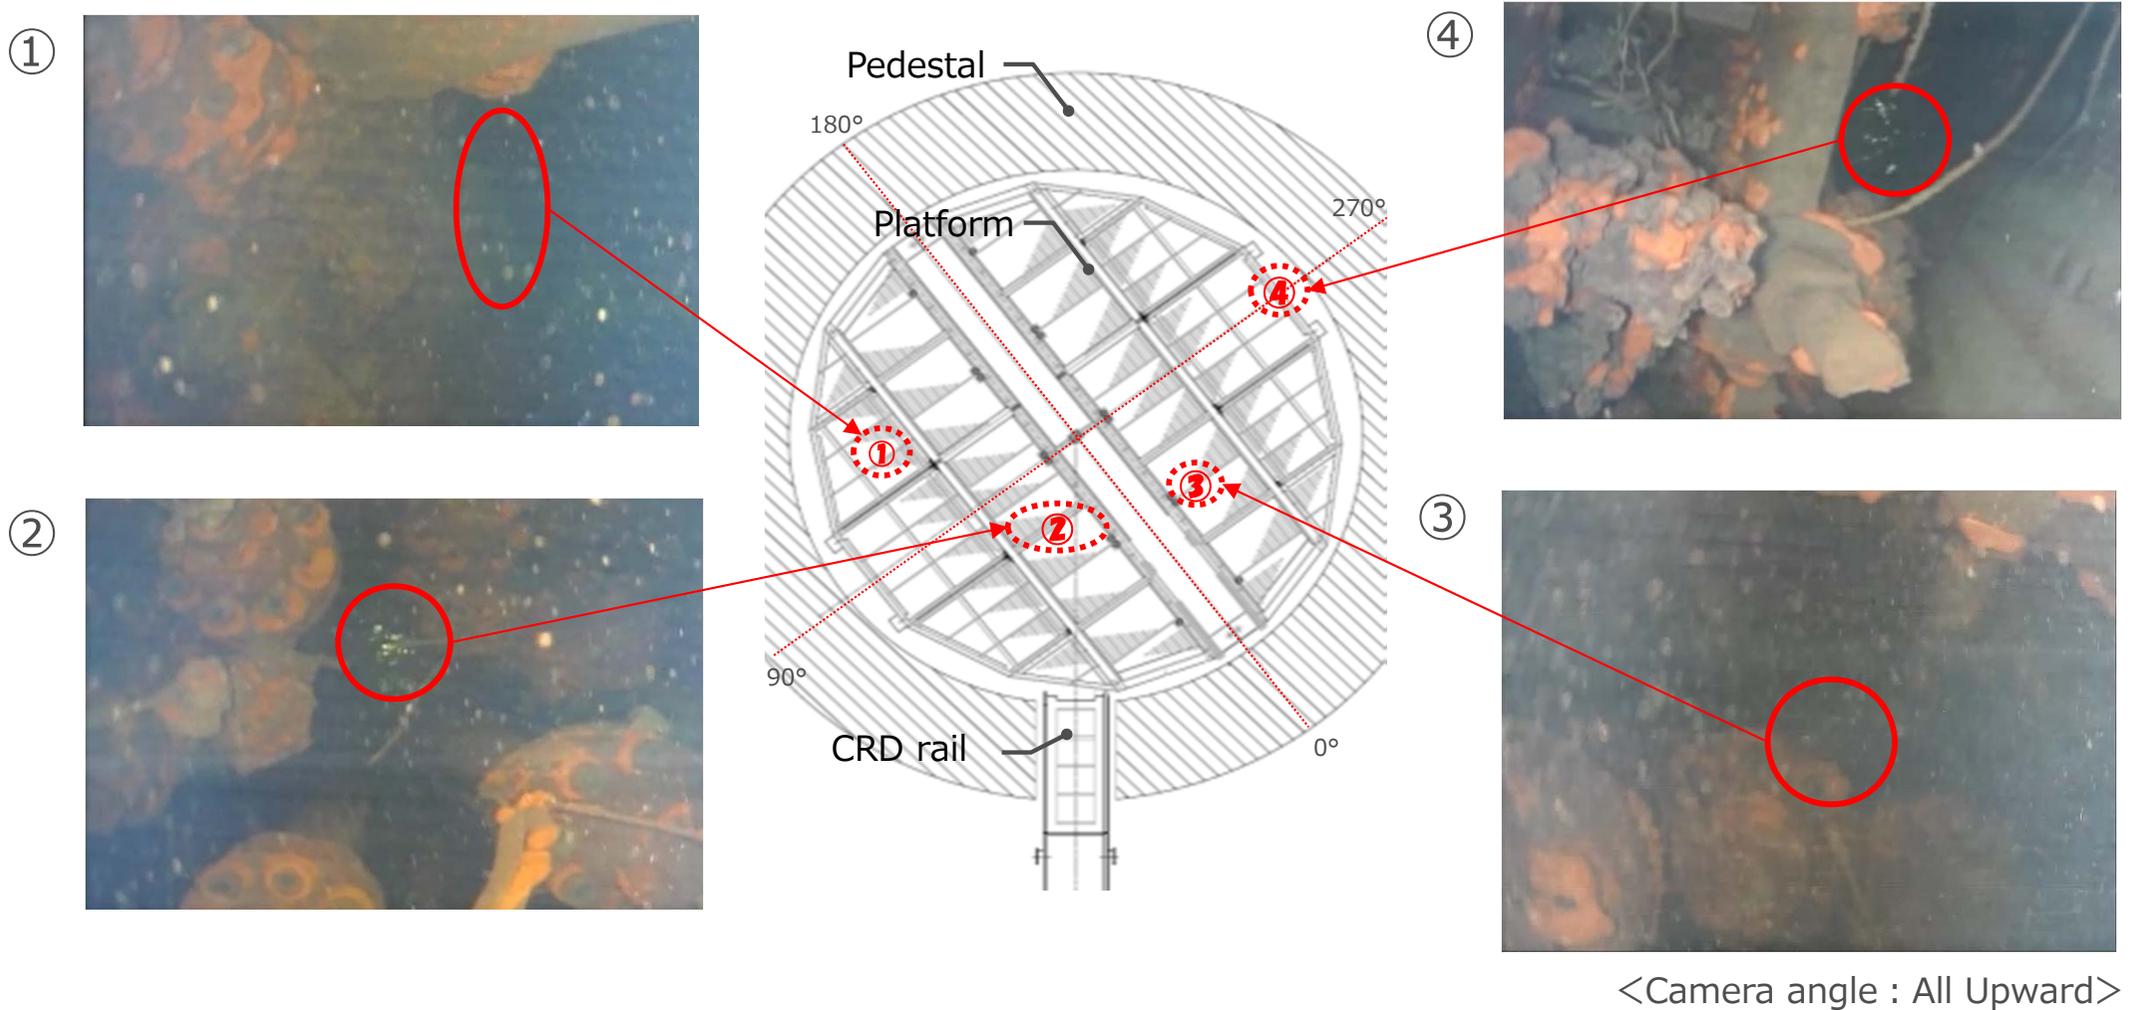
- Disturbances on the water surface at ①~④ suggest the possibility that there is damage on the periphery of the RPV as well as at the center of the bottom of the RPV.

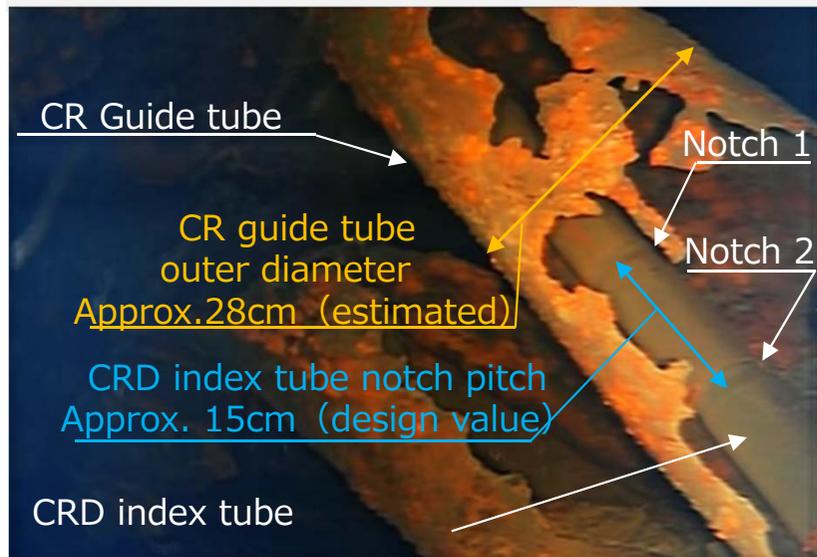
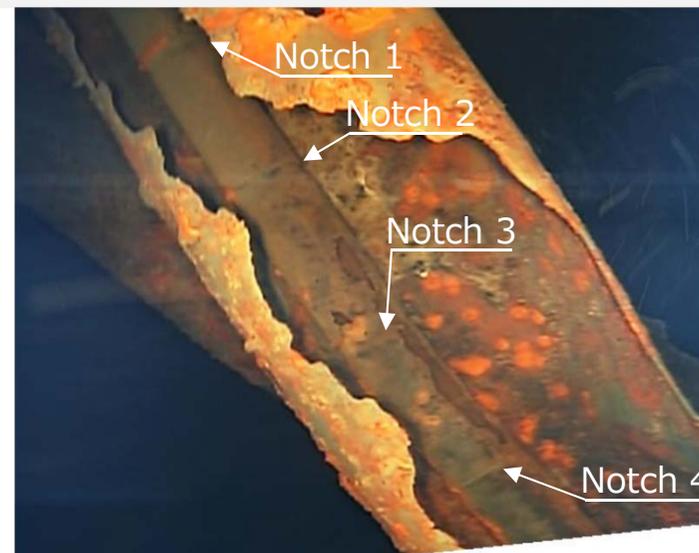
⇒ The CR was fully inserted and the CR index tube was stored in CRD guide tube at the time of the accident, so it is assumed that the cylindrical structure is CR guide tube and the rod-shaped structure is CRD index tube.

- The outer diameter of the cylindrical structure** is estimated to be **approx. 28cm** based on the photos since the interval between the notches on CRD index tube is approx. 15cm. **This estimate is almost the same as the design dimensions for the outer diameter of the CR guide tube (also approx. 28cm).**

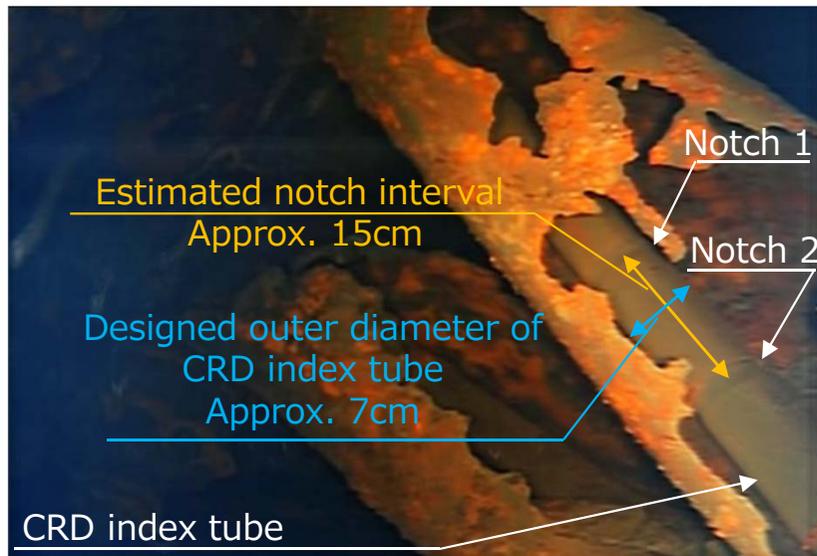
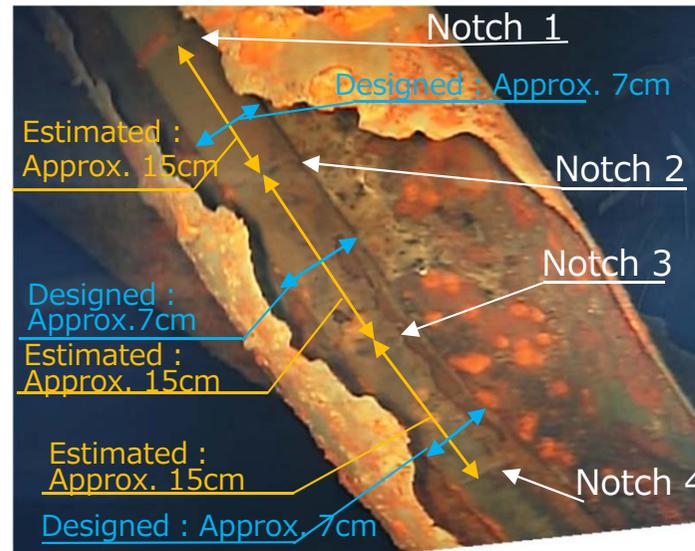
□ Each interval between the notches was estimated at approx. 15cm from photos 1 and 2 by referencing the design values for the outer diameter of the CRD index tube, which is approx. 7cm. **All estimated values are almost the same as the design dimensions (approx. 15cm).** Therefore, this structure is assumed to be the CRD index tube.

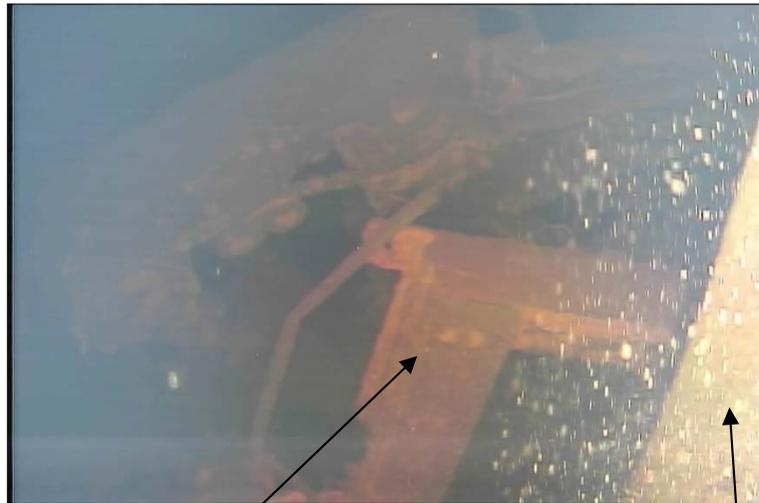
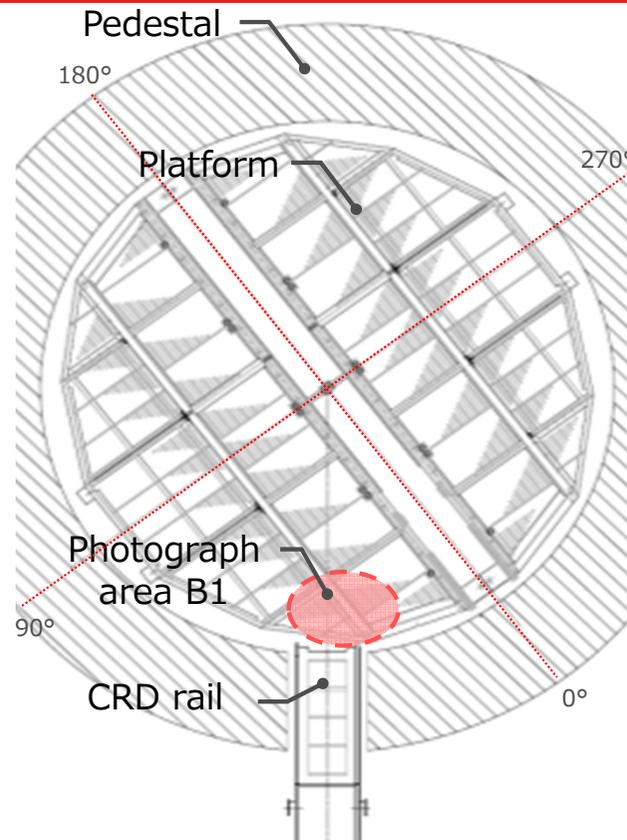
Photograph area B1 <Camera angle : Downward>

- Grating for the platform was not found.
- Pieces of the platform were found (the platform has fallen).

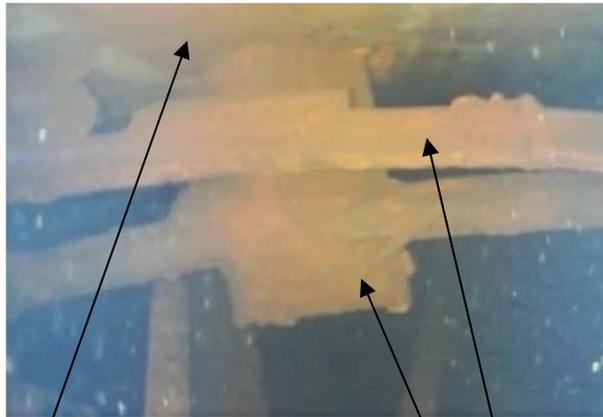
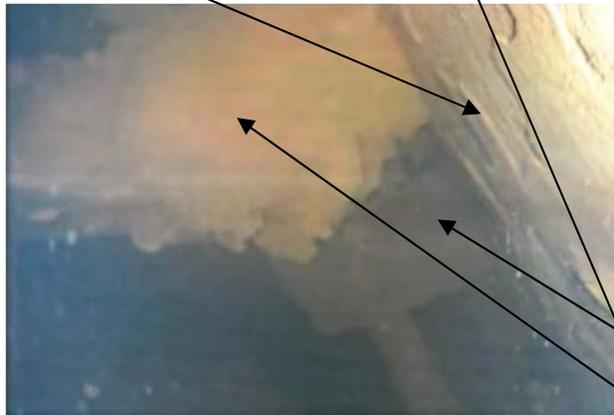
Photograph area B2 <Camera angle : Downward>

Deposit

- Platform circling rail and circling rail bracket remain.
- Deposit found on the circling rail bracket.

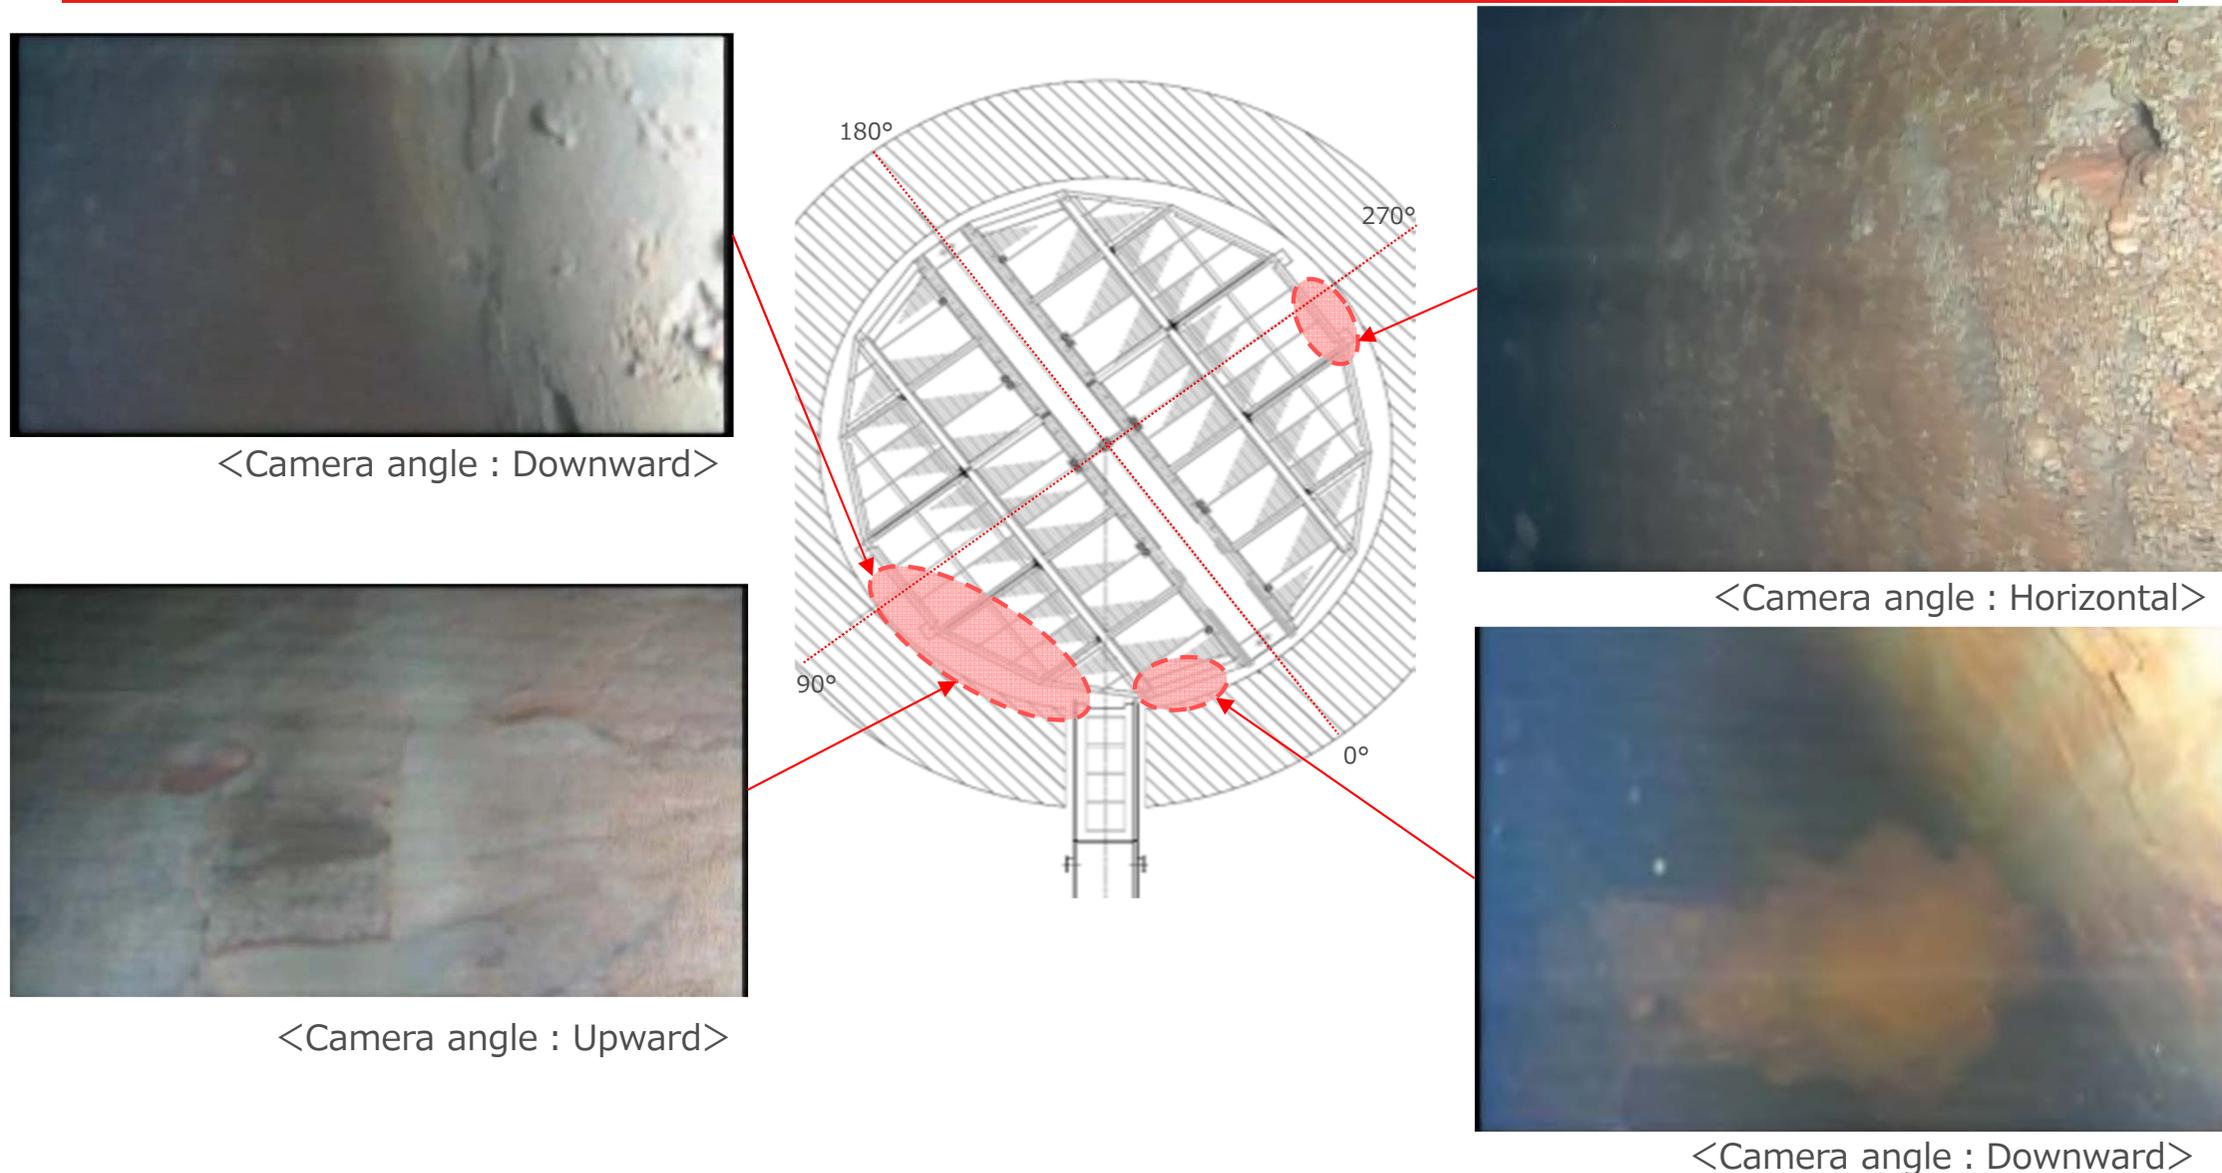
- While peeling of the epoxy paint and rough surfaces were seen on the pedestal internal wall, no major damage or deformation was found.

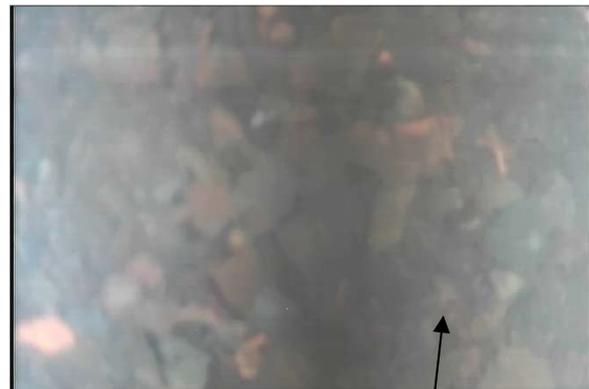
Photograph area C1  
<Camera angle : Downward>

Deposit (pebble form)

■ Deposits resembling sand, pebbles and clumps were found.

■ Access hatch was not visible. (Deposits were found nearby.)

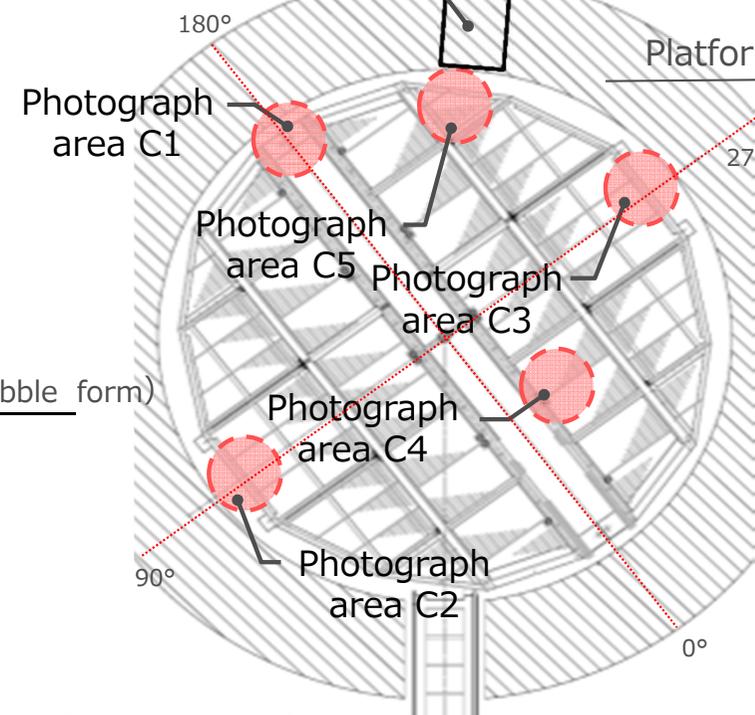
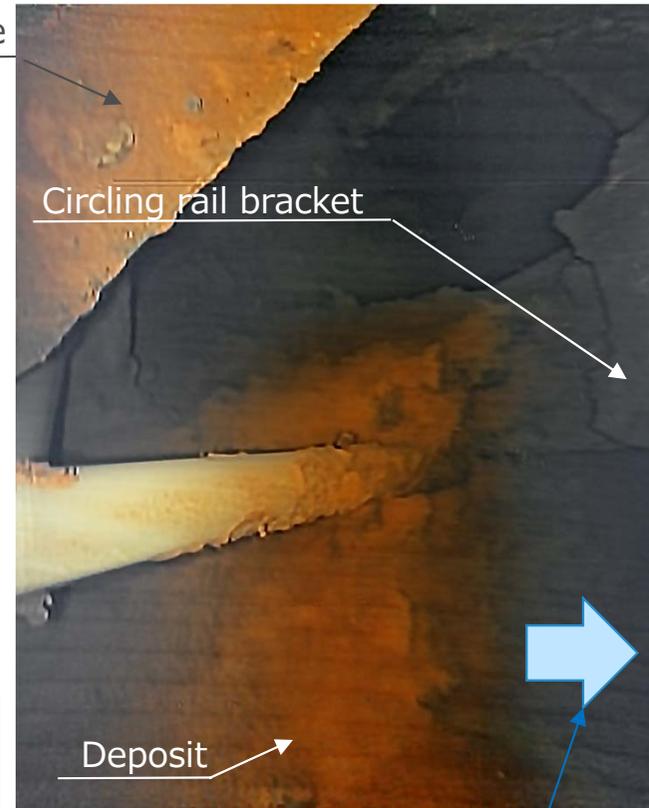
Photograph area C5 <Camera angle : Downward>

Deposit

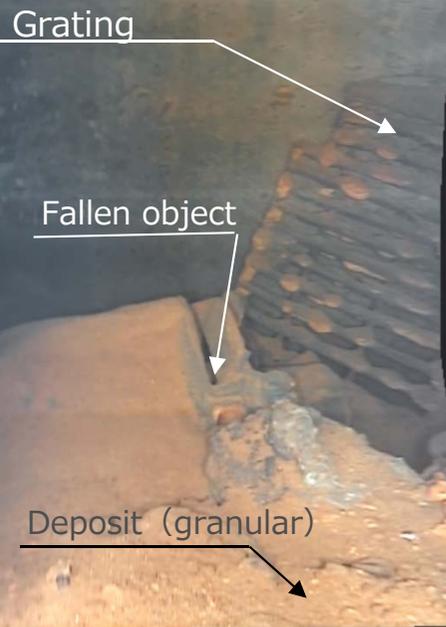
Photograph area C2  
<Camera angle : Horizontal>

Fallen object

Deposit (granular)

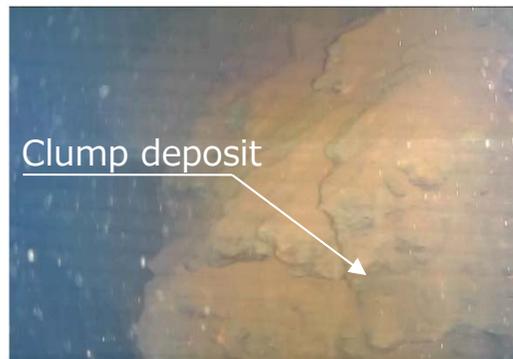
Photograph area C3  
<Camera angle : Upward>

Clump deposit

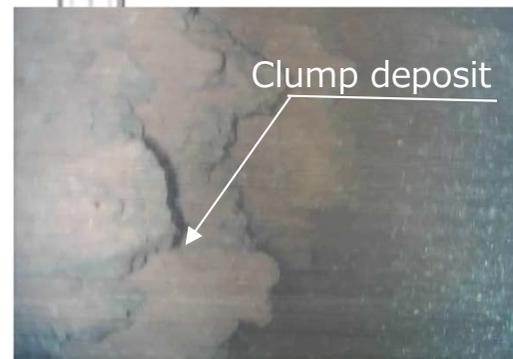
Photograph area C4  
<Camera angle : Downward>

Clump deposit

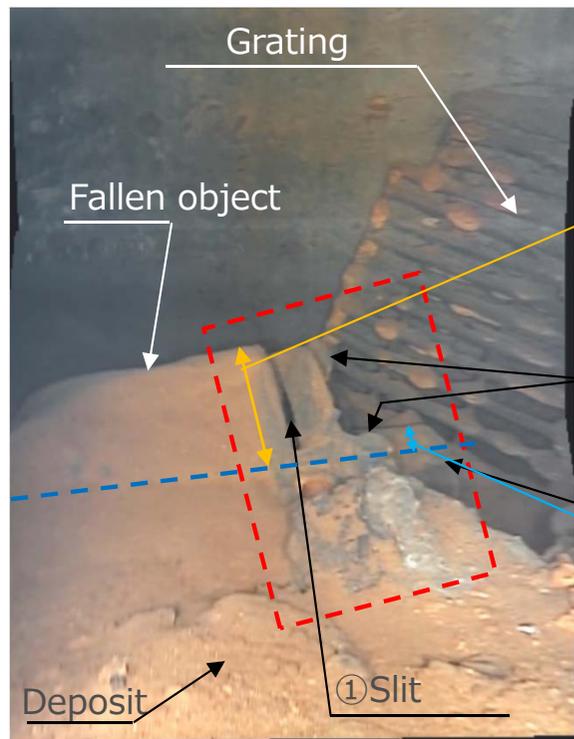
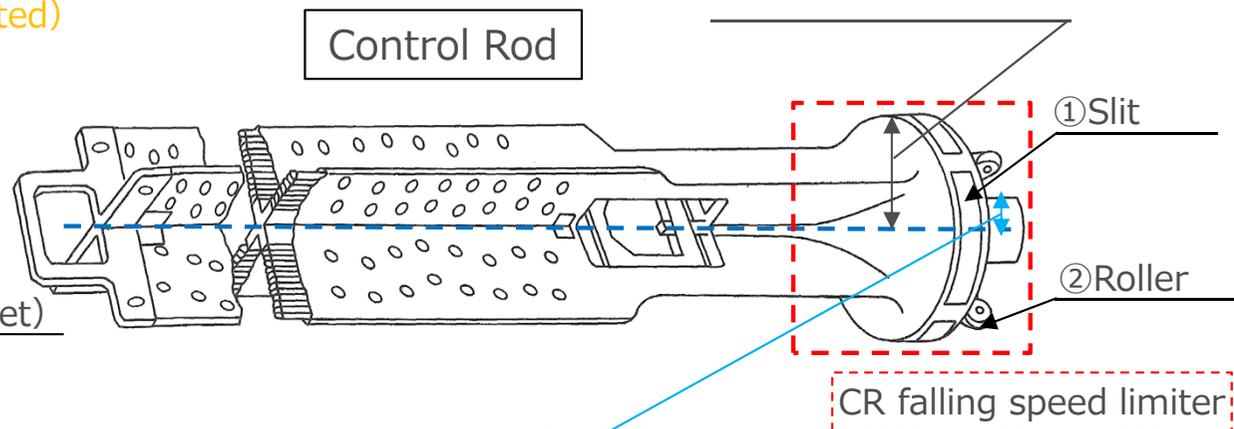
- At the right edge of the fallen object (within the red box) ①a slit and ②two roller-shapes could be seen suggesting that this might be the CR falling speed limiter. However, the unique umbrella-shaped part of the CR falling speed limiter could not be seen because it is buried underneath deposits.

- The radius of the structure assumed to be the falling speed limiter was estimated as approx. 13cm based upon the design values for the socket radius (approx. 3cm). That is almost the same as the design dimensions (approx. 12cm).

- This object could not be identified for certain since the unique umbrella-shaped part of the structure could not be found.

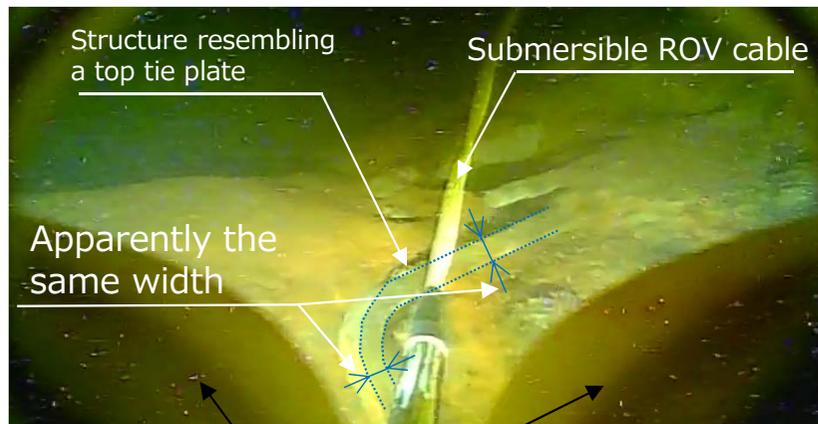
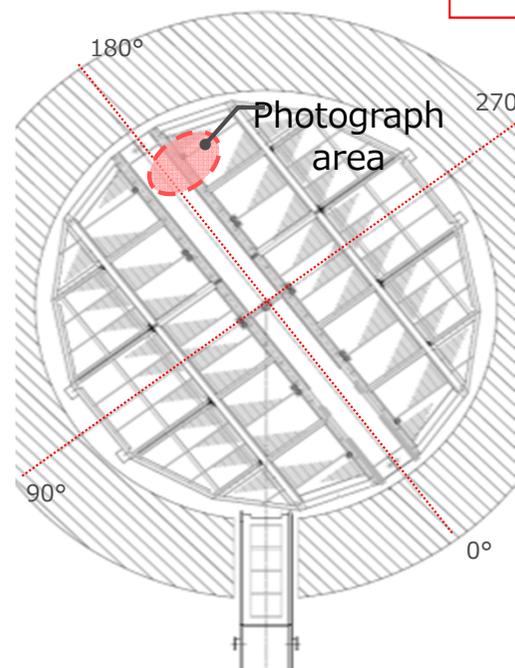
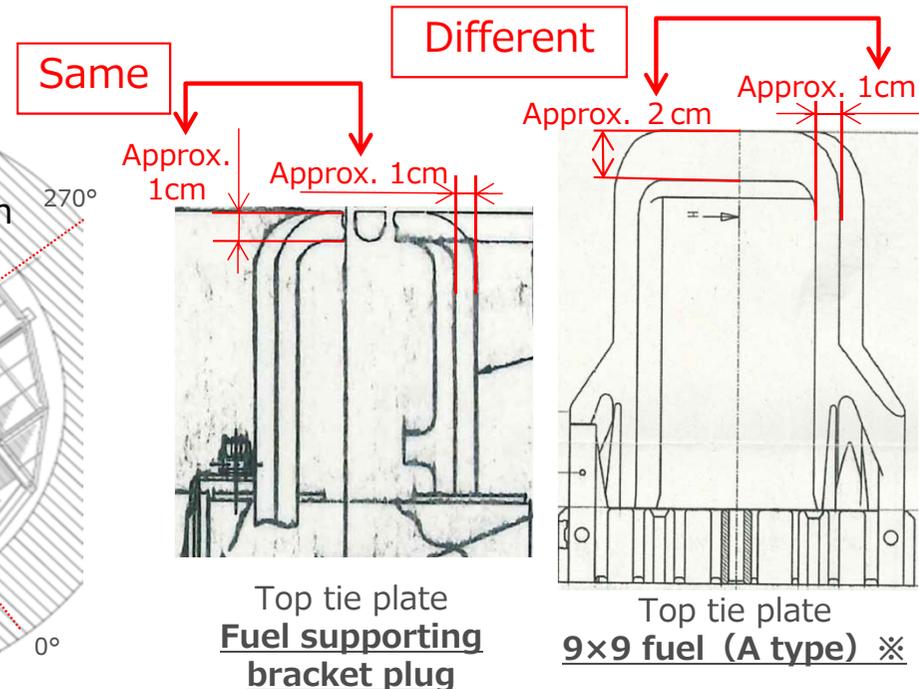
- A structure resembling the top tie plate※ was found at the bottom of the pedestal.
- The size of the handle of this top tie plate looks to be almost the same as the width of the vertical part based on the photo, however, this could not be confirmed since photos were only taken from one angle.

- This structure might be a fuel supporting bracket plug if the handle and the vertical part of the top tie plate are the same width. However, the widths could not be confirmed since the photos were only taken from one angle.

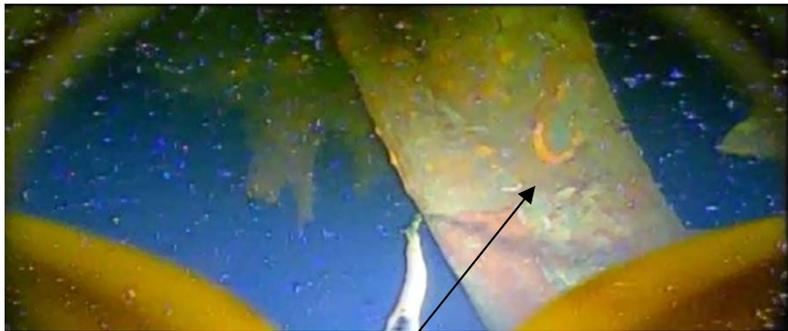
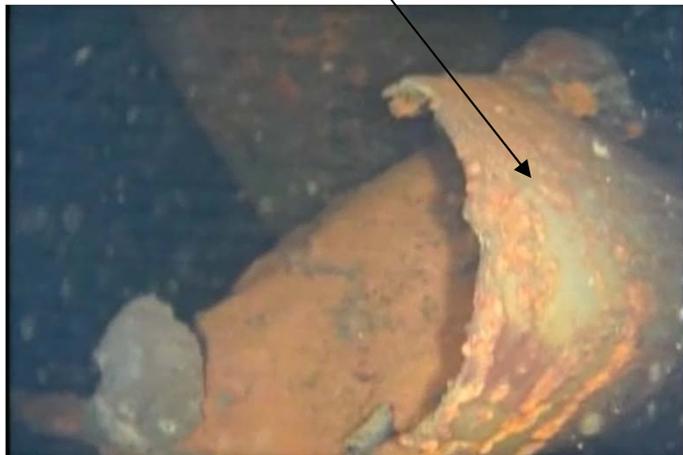
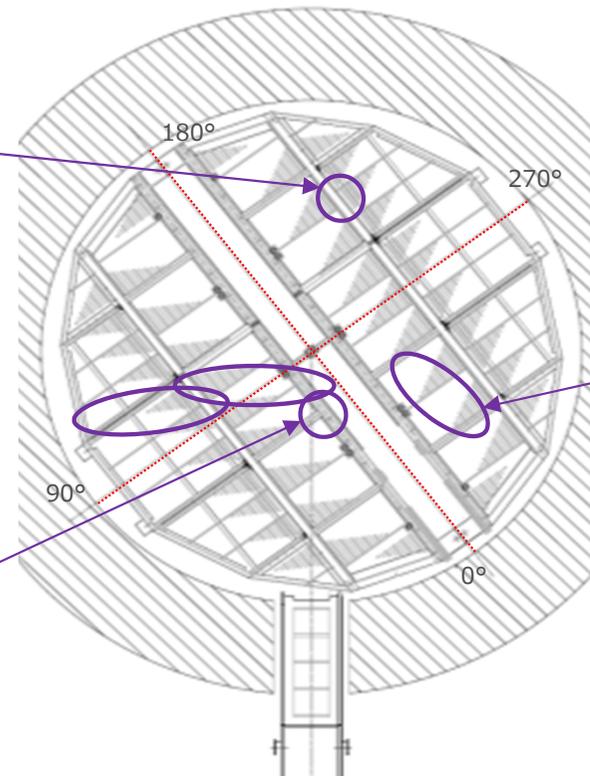
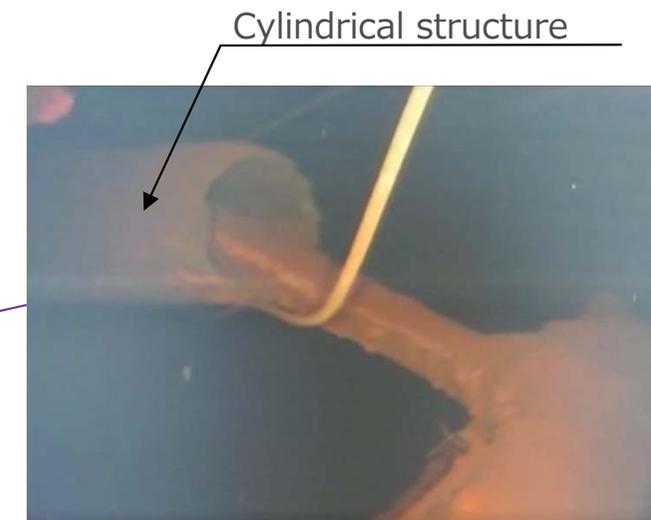
- Characteristics of appearance
  - Cylindrical structures similar to the CR guide tube were found at multiple places in the pedestal.
- Dimension estimate
  - Dimensions could not be estimated because there were no structures to be used as reference.
- Results
  - Based on their appearance it is assumed that these structures are the CR guide tubes but a positive identification was not possible because the dimensions could not be estimated.

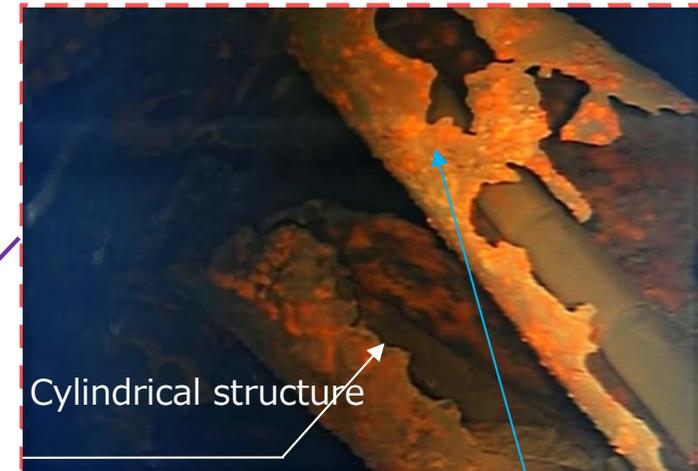
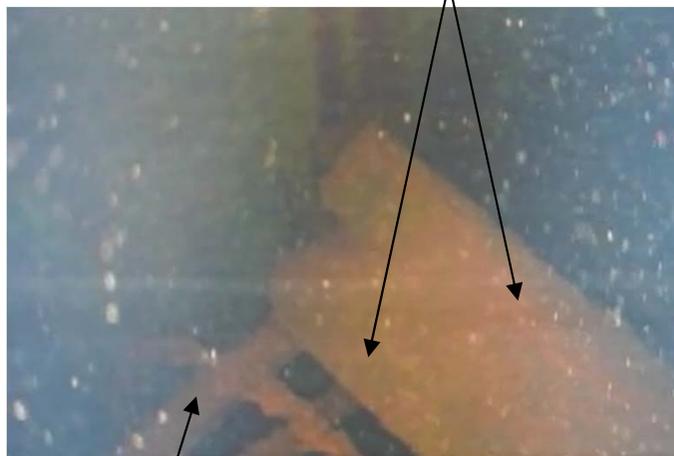
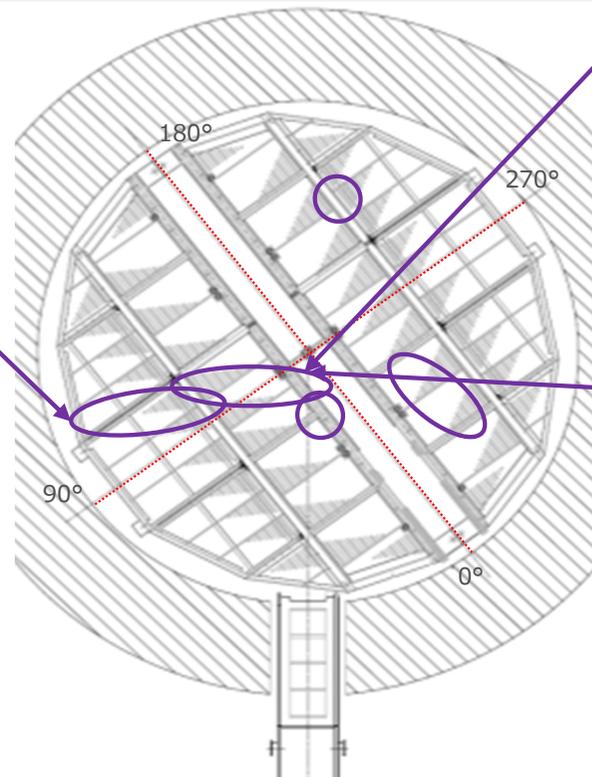
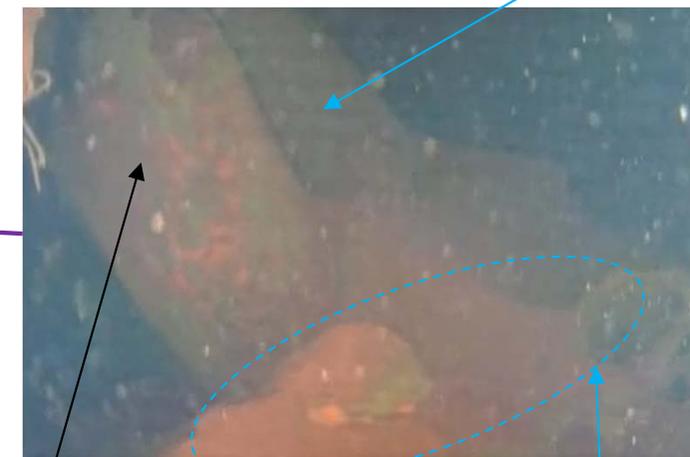
- Characteristics of appearance
  - Cylindrical structures similar to CR guide tubes were found at multiple places in the pedestal.
- Dimension estimate
  - Dimensions could not be estimated because there were no structures to be used as reference.
- Results
  - Based on their appearance it is assumed that these structures are the CR guide tubes but a positive identification was not possible because the dimensions could not be estimated.

Cylindrical structure buried in deposits

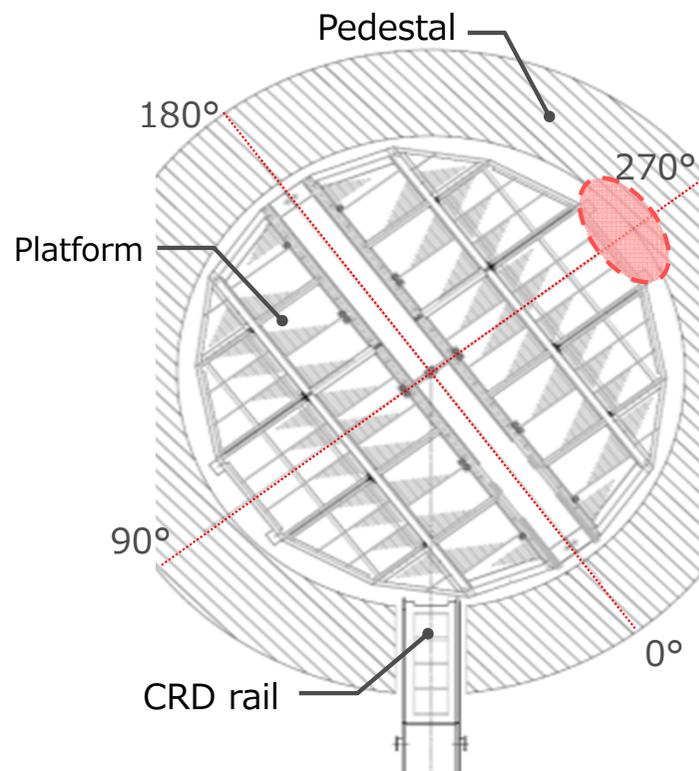
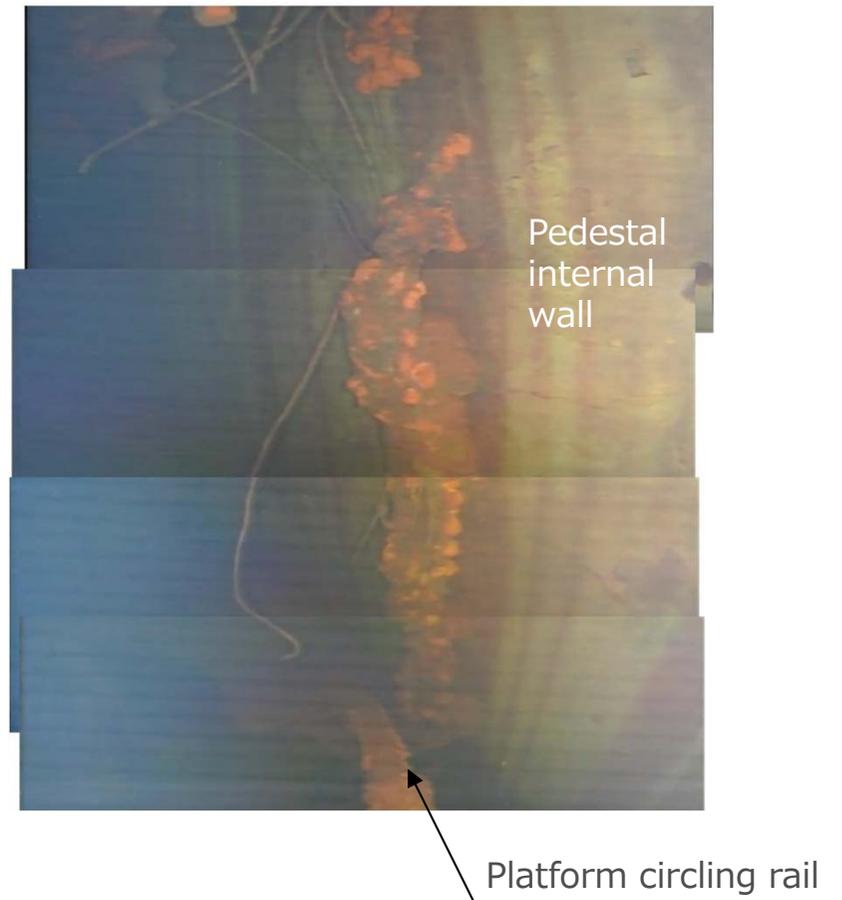
- Damaged cables were found along the pedestal internal wall near 270°.
- It is assumed that high-temperature molten material fell into the pedestal, attached to the cables and caused the damage.
