Outline drawing of water removal work on Cesium adsorption tower (vessel) for water treatment facility

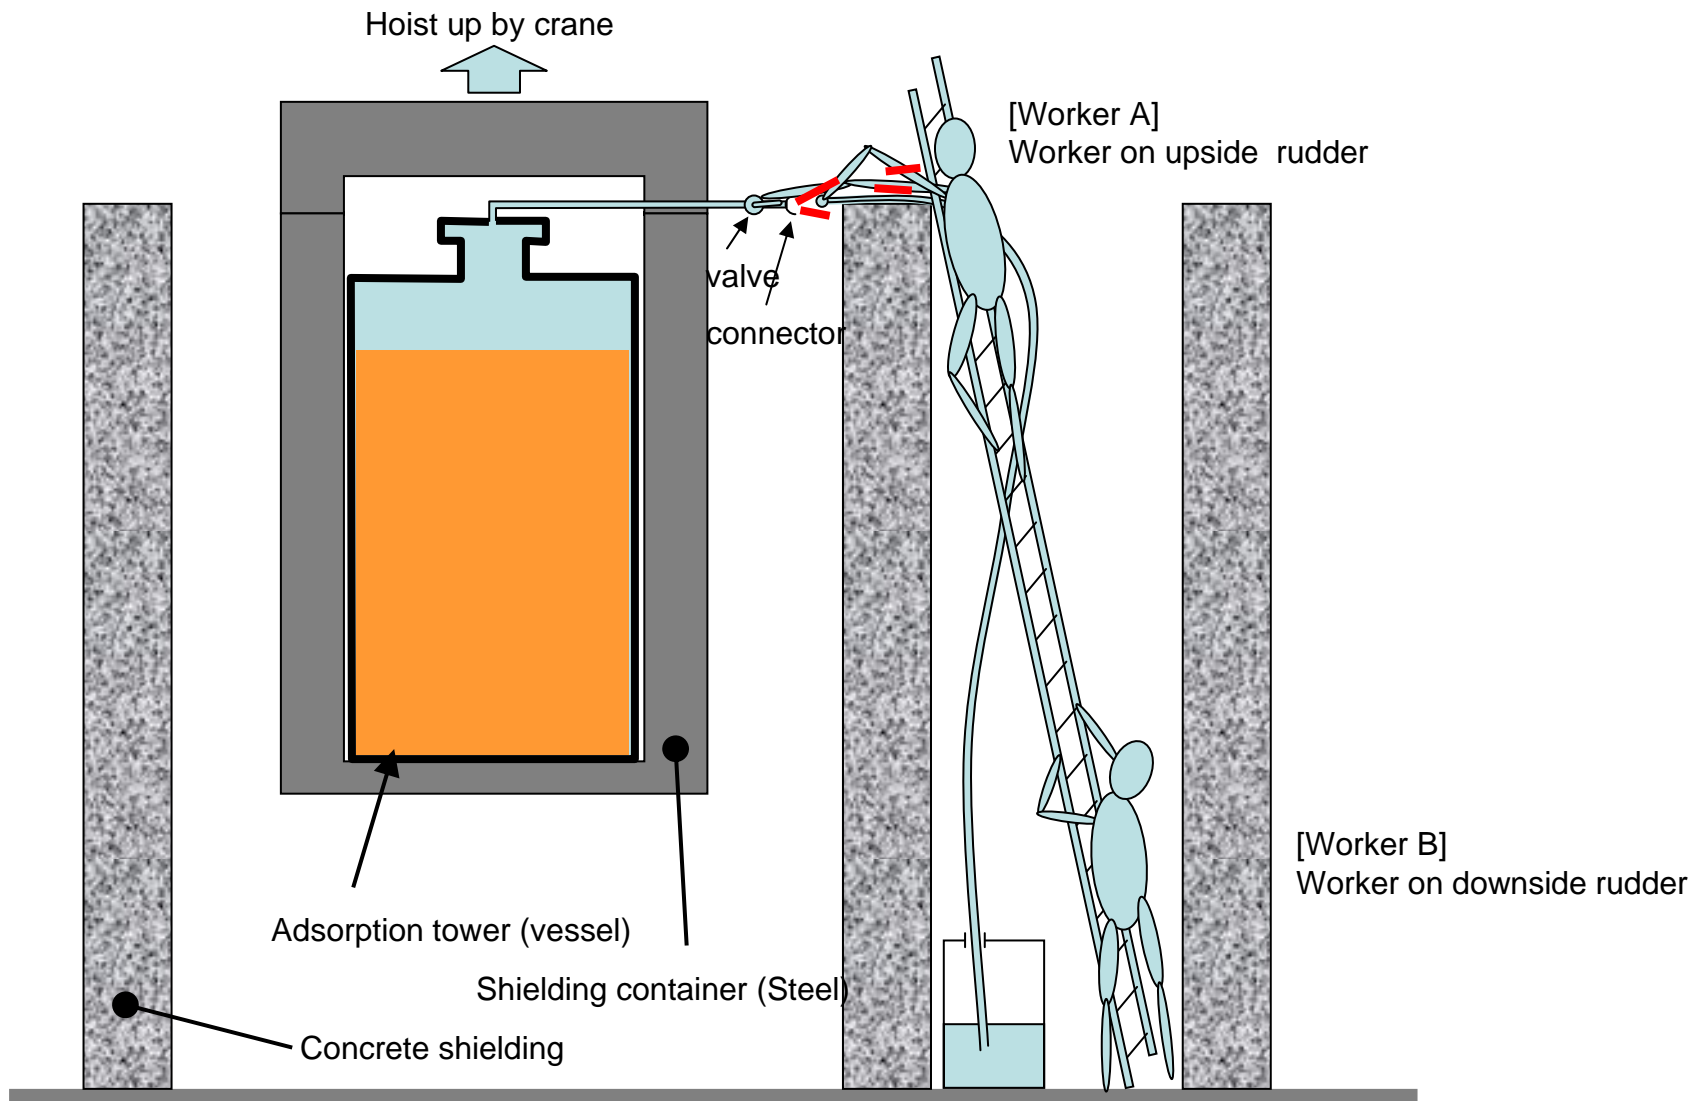
It should have been removed at "valve-close" though the hose had been removed at "valve-open", that caused water spewing out from connecting part and got the worker wet.
