Investigation of water leaking
from flexible hose
at alternative circulating cooling
system
Spent Fuel Pool at Unit 4

September 1, 2011
Tokyo Electric Power Company

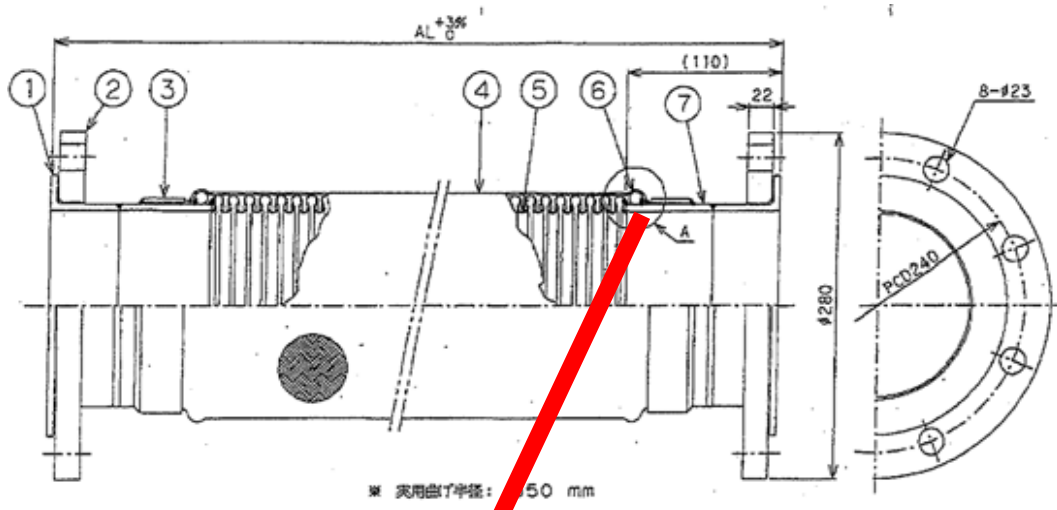
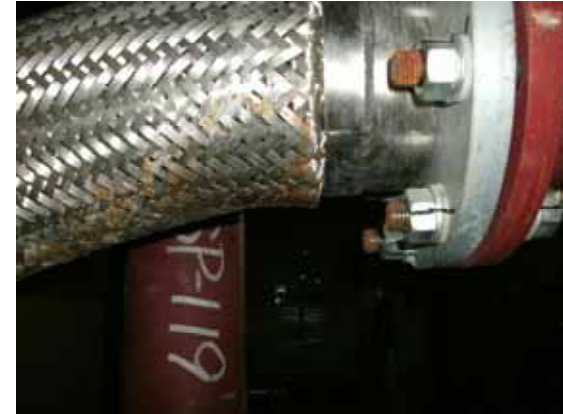
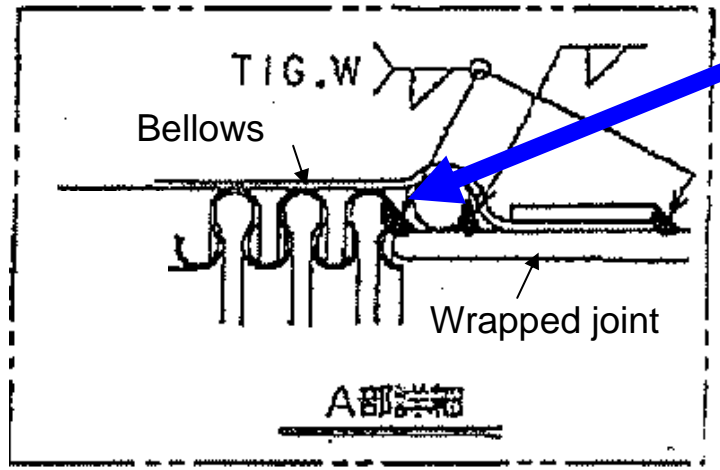
1. Leaking part of flexible hose

Found corrosion at the bellows and welding of wrapped joint

- Bellows
- Materials: Stainless steel(SUS316L)
- Wrapped joint (at short pipe)
- Materials: Stainless steel(SUS316L)
- Welding materials 316L(TIG weld)
- Leak occurred at welding part and the corrosion is not found on the bellows itself.

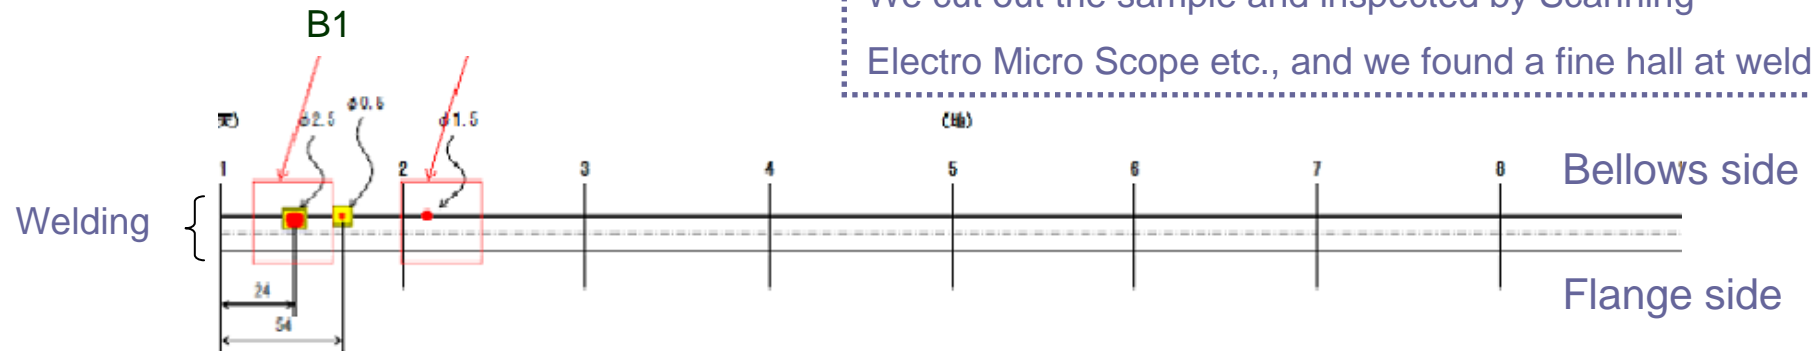
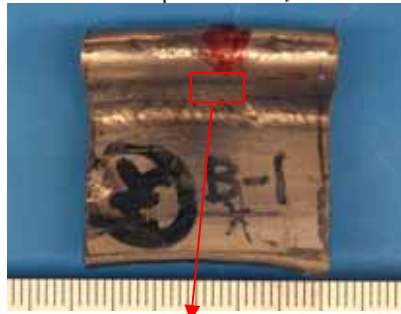
2.Result of inspection about Leak point on flexible hose

PT indicating pattern

Sampling point

■ The point where the leak was found by leak test

As we conducted Penetrant Test (PT) about the bellows that leak was found, indicating pattern is found from it.
We cut out the sample and inspected by Scanning Electro Micro Scope etc., and we found a fine hole at welding.

The cause of leak by corrosion is estimated that chloride concentration of water passing in the hose was high, and the temperature of water at start of operation of alternative cooling system for spent fuel pool at Unit 4 was high. (under continuous investigation)

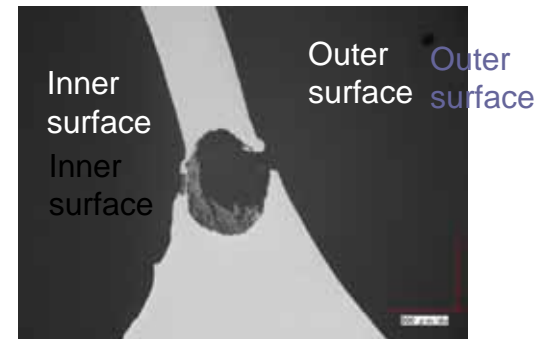
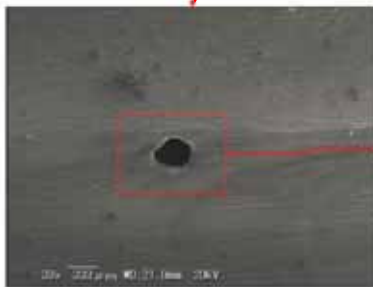
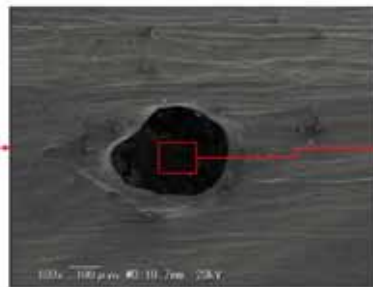
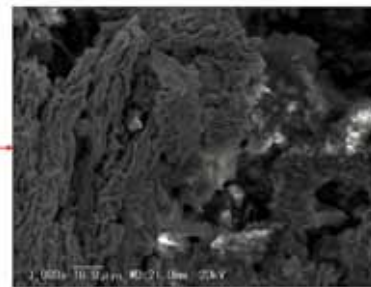
Surface of sample B1

Cross-section of sample B1

Bellows

Welding metal
