## Site Photographs of Fukushima Daini Nuclear Power Station

Since the occurrence of Tohoku-Chihou-Taiheiyou-0ki Earthquake we have disclosed site photographs mainly of Fukushima Daiichi Nuclear Power Station. These are photographs of Fukushima Daini Nuclear Power Station as the reference material of "The impact of Tohoku-Chihou Taiheiyo-0ki Earthquake to Nuclear Reactor Facilities at Fukushima Daini Nuclear Power Station" released on August 12.

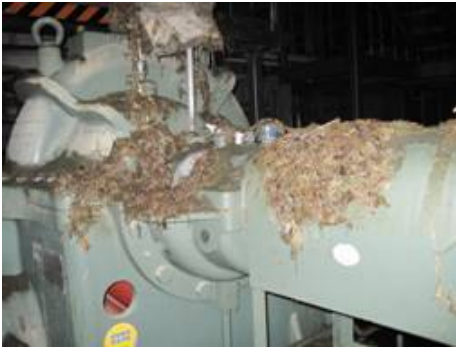
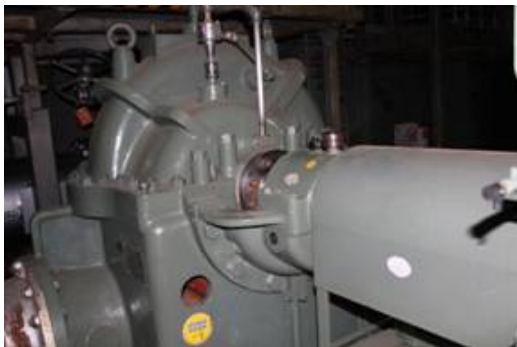
<p>Date 2011/3/23            Location R C W 2 pump (B) at B1 of Heat Exchanger Building, Unit 4            Photo by TEPCO Staff</p>	<p>Date 2011/8/26            Location R C W 2 pump (B) at B1 of Heat Exchanger Building, Unit 4            Photo by TEPCO Staff            Facility Status Restoration completed</p>

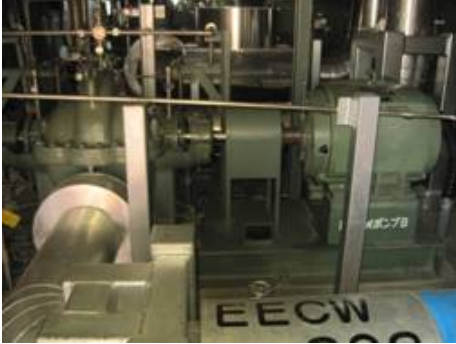
Date 2011/3/19 Location E E C W pump ( B ) of 1st floor of Heat Exchanger Building, Unit 3 Photo by TEPCO Staff Facility Status In operation	
<u>5 . [Inundated] P / C Power Panel</u>

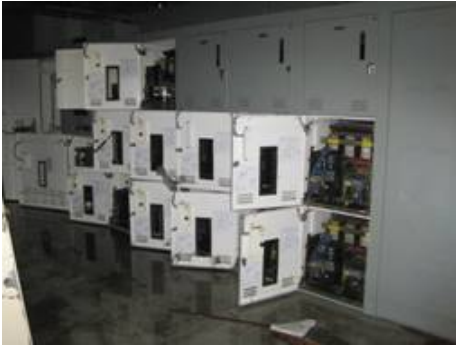
Date 2011/3/13 Location P / C Power Panel at 1st floor of Heat Exchanger Building, Unit 1 Photo by TEPCO Staff	
<u>6 . [Not Inundated] P / C Power Panel</u>

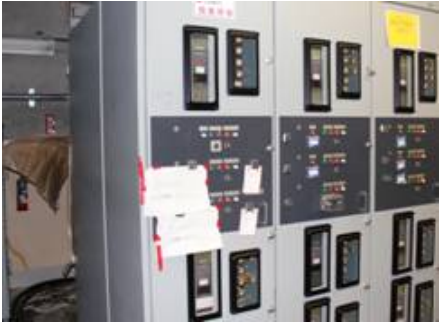
Date 2011/4/2 Location P / C Power Panel at 1st floor of Heat Exchanger Building, Unit 3 Photo by TEPCO Staff Facility Status In operation

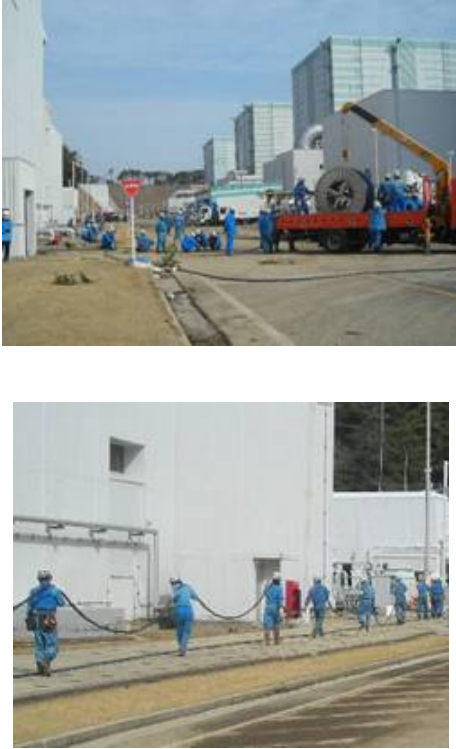
<p>Date            2011/3/13  Location        East Side of Waste Treatment Facility  Photo by        TEPCO Staff</p>	<p>Date            2011/8/26  Location        East Side of Waste Treatment Facility  Photo by        TEPCO Staff</p>
<u>8 . Powered by High Voltage Power-Supply Car</u>

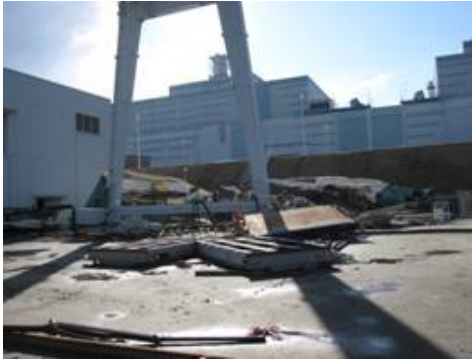
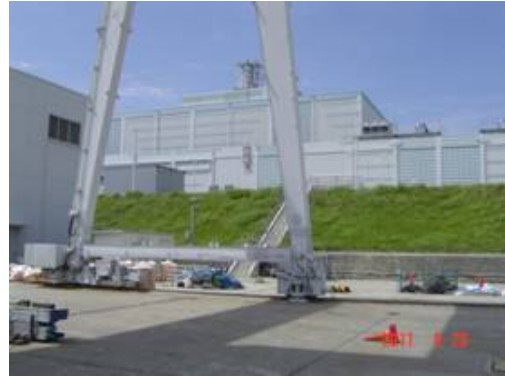
9 . Debris scattered by Tsunami

Date 2011/3/16  
Location Between Heat Exchanger Buildings,  
Unit 3 and 4  
Photo by TEPCO Staff

Date 2011/8/29  
Location Between Heat Exchanger Buildings,  
Unit 3 and 4  
Photo by TEPCO Staff  
Facility Status Debris removed

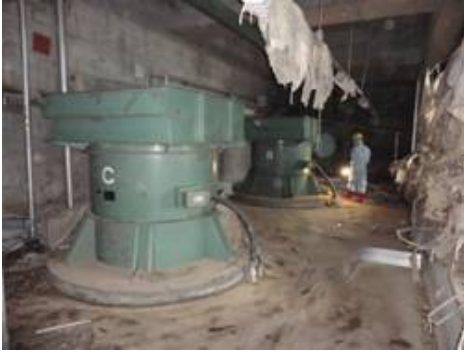
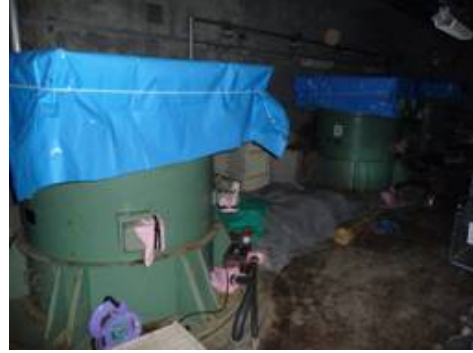
12. [Inundated] Emergency air blower for Emergency DG

Date 2011/3/20  
 Location Emergency air blower for Emergency DG, Unit 1  
 Photo by TEPCO Staff

Date 2011/8/26  
 Location Emergency air blower for Emergency DG, Unit 1  
 Photo by TEPCO Staff  
 Status Under restoration

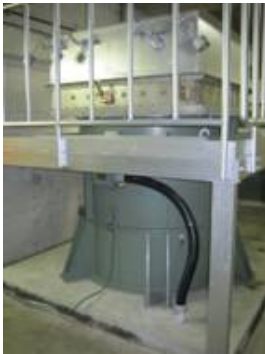
13. [Not Inundated] Emergency air blower for Emergency DG

Date 2011/3/20  
 Location Emergency air blower for Emergency DG, Unit 3  
 Photo by TEPCO Staff

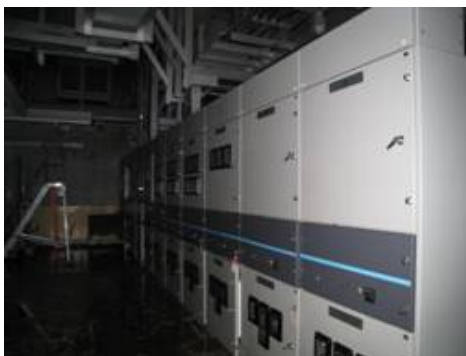
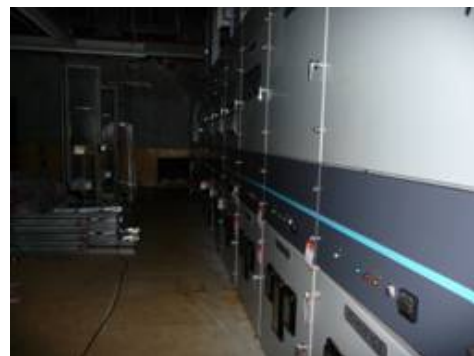
14. [Inundated] M/C power panel (Unit 1)

Date 2011/4/2  
 Location M/C power panel, Unit 1  
 Photo by TEPCO Staff

Date 2011/8/26  
 Location M/C power panel, Unit 1  
 Photo by TEPCO Staff  
 Status Under restoration

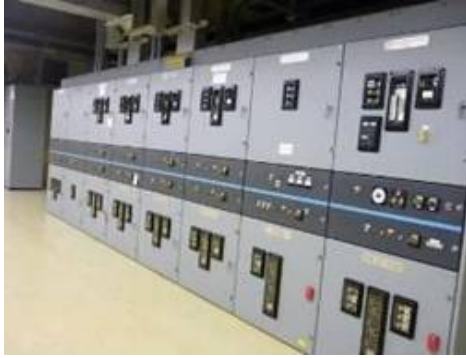
15 . [Not Inundated] M/C power pane

Date 2011/3/27  
 Location M/C power panel, Unit 3  
 Photo by TEPCO Staff

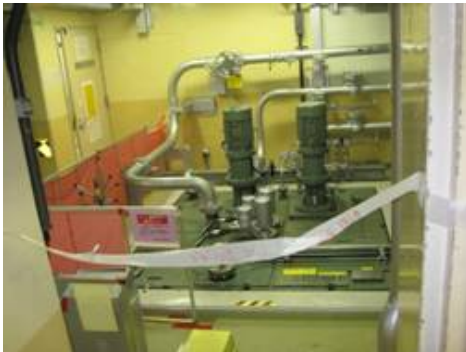
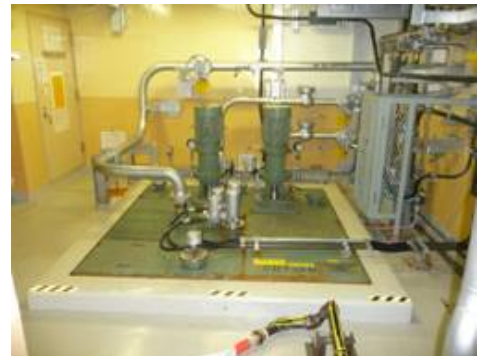
16 . [Inundated] Second basement of Reactor Building

Date 2011/3/21  
 Location Storm drain sump, Unit 1  
 Photo by TEPCO Staff

Date 2011/8/26  
 Location Storm drain sump, Unit 1  
 Photo by TEPCO Staff  
 Status Under restoration

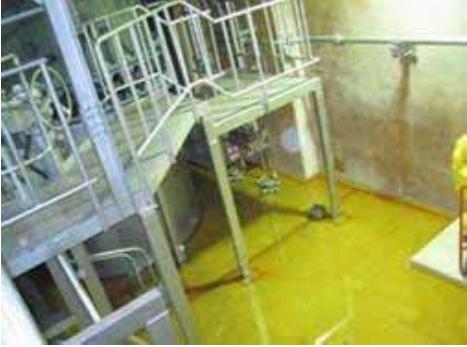
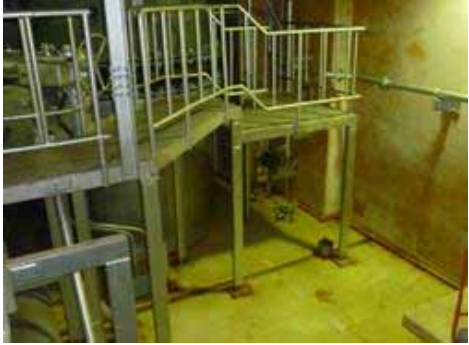
Situation after the disaster	Current situation
<u>17 . [Inundated] Turbine building</u>

<p>Date 2011/3/20            Location Condenser room on the first basement, Unit 1 *            Photo by TEPCO Staff</p>	<p>Date 2011/8/26            Location Condenser room on the first basement, Unit 1 *            Photo by TEPCO Staff            Status Drainage completed, To be overhauled</p>
<u>18 . [Inundated] Turbine Building</u>

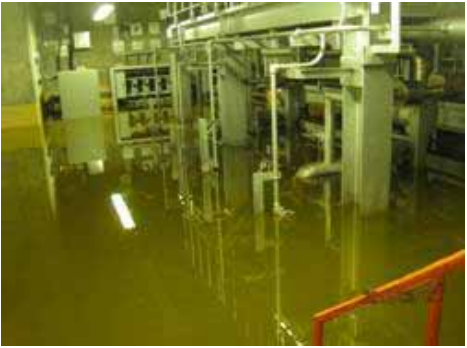
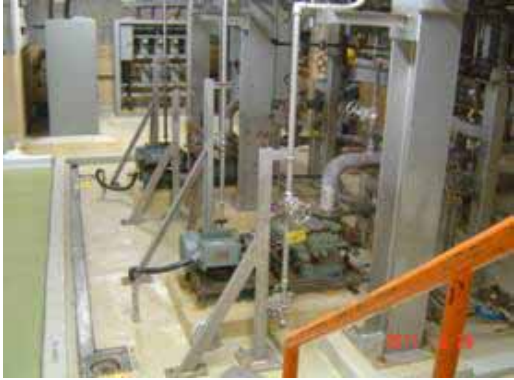
<p>Date 2011/3/19            Location HSCR condensate water transfer pump on the second basement, Unit 3            Photo by TEPCO Staff</p>	<p>Date 2011/8/29            Location HSCR condensate water transfer pump on the second basement, Unit 3            Photo by TEPCO Staff            Status Drainage completed, To be overhauled</p>

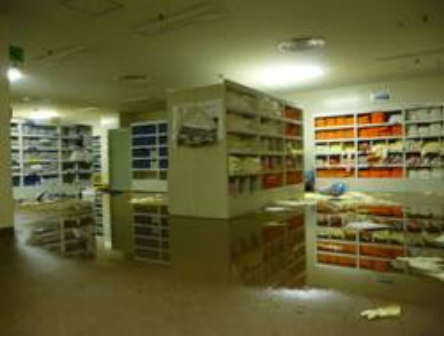
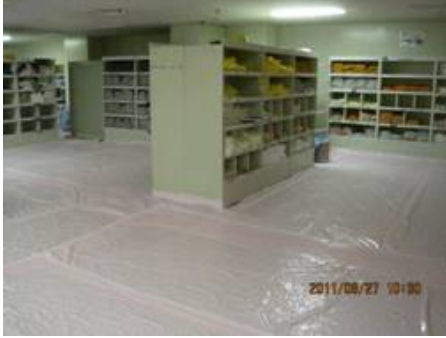
Situation after the disaster	Current situation
<p>20 . [inundated] Waste Treatment Building</p>

<p>Date 2011/3/16            Location Locker room on the 1st floor of Waste Treatment Building            Photo by TEPCO Staff</p>	<p>Date 2011/8/27            Location Locker room on the 1st floor of Waste Treatment Building.            Photo by TEPCO Staff            Facility Status Restoration Completed.</p>
<p>21 . The situation of Monitoring Post No. 7 which was partly lost by water current</p>

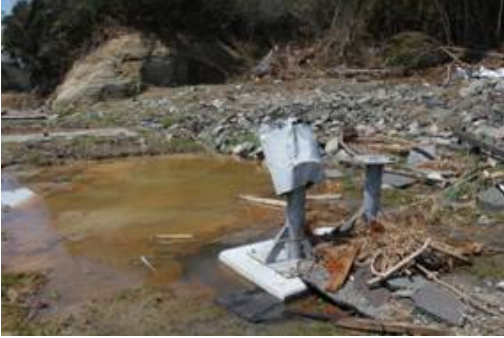
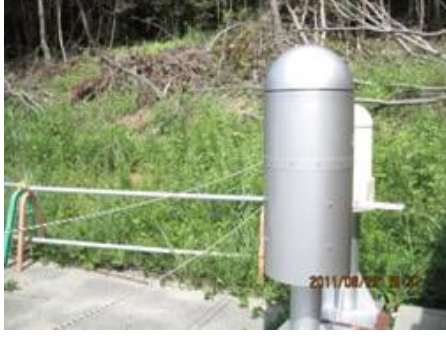
<p>Date 2011/4/24            Location Monitoring Post No. 7            Photo by TEPCO Staff</p>	<p>Date 2011/8/29            Location Monitoring Post No. 7            Photo by TEPCO Staff            Facility Status Completed the replacement of the temporary post with the permanent one.</p>
<p>22 . The situation of the damaged Tower Crane</p>

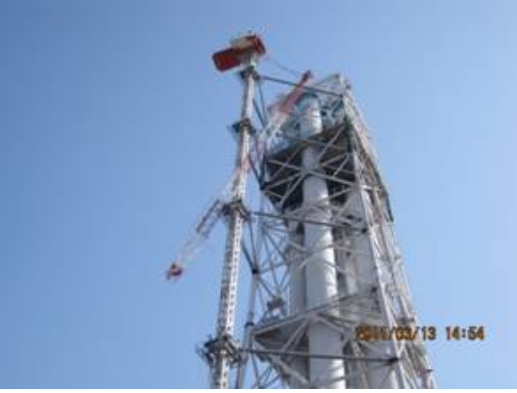
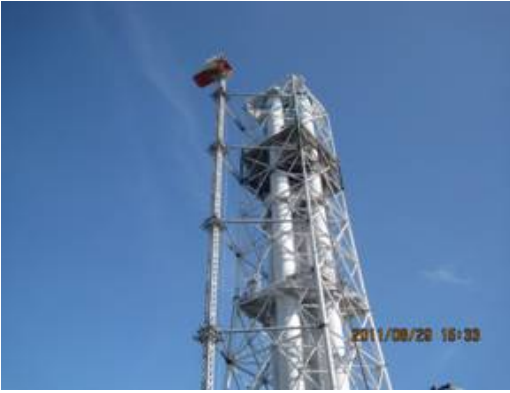
<p>Date 2011/3/13            Location exhaust stack            Photo by TEPCO Staff</p>	<p>Date 2011/8/29            Location exhaust stack            Photo by TEPCO Staff            Facility Status Completed removal of arm</p>

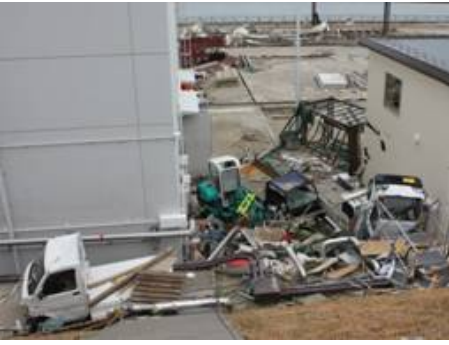
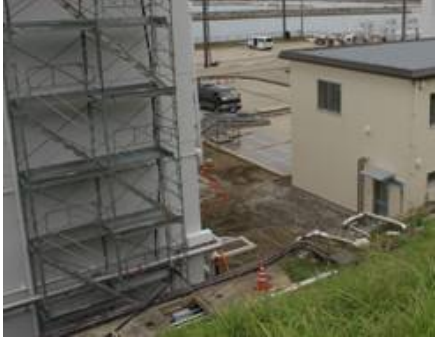
Situation after the disaster	Current situation
26. The situation of facilities which symbolizes the damage by tsunami (Around the Seawater Heat Exchanger Building of Unit 3)

<p>Date 2011/4/2  Location Around the Seawater Heat Exchanger Building of Unit 3  Photo by TEPCO Staff</p>	<p>Date 2011/8/26  Location Around the Seawater Heat Exchanger Building of Unit 3  Photo by TEPCO Staff  Facility Status Completed removal of vehicles. Laying cables for Heat Exchanger Buildign are install is underway.</p>

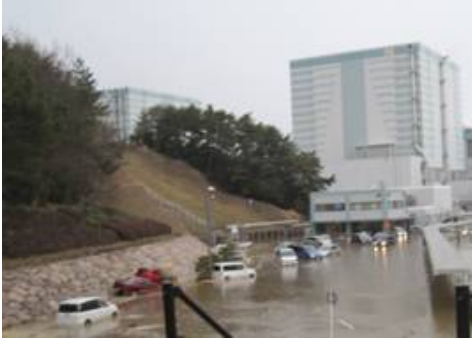
27. The situation of facilities which symbolizes the damage by tsunami (North side of Main Anti-Earthquake Building)

<p>Date 2011/3/11  Location North side of Main Anti-Earthquake Building  Photo by TEPCO Staff</p>	<p>Date 2011/8/29  Location North side of Main Anti-Earthquake Building  Photo by TEPCO Staff  Facility Status Completed Removal of vehicles</p>

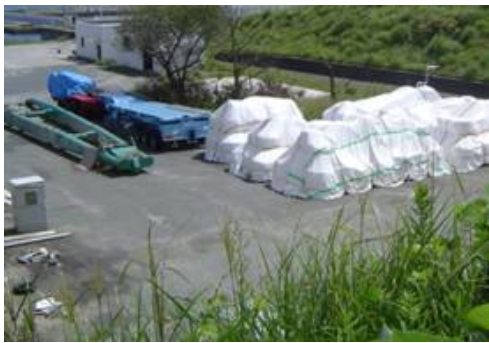
28. The situation of facilities which symbolizes the damage by tsunami (Shallow Draft Quay)

<p>Date 2011/03/16  Location Shallow Draft Quay  Photo by TEPCO Staff</p>	<p>Date 2011/08/31  Location Shallow Draft Quay  Photo by Employess  Facility Status Completed rubble removal</p>
