Survey result of damages to air-conditioning ducts etc. in the Reactor Building, Unit 4, Fukushima Daiichi Nuclear Power Station

The status of the 5th floor, R/B, Unit 4

The status of the 4th floor, R/B, Unit 4

The status of the 3rd floor, R/B, Unit 4

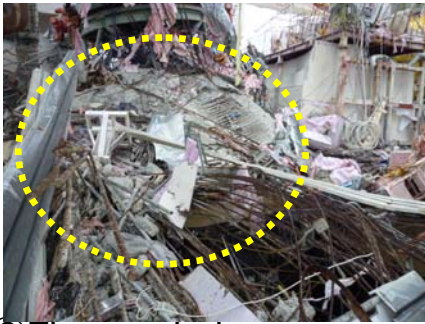
① Rebar deformed upward

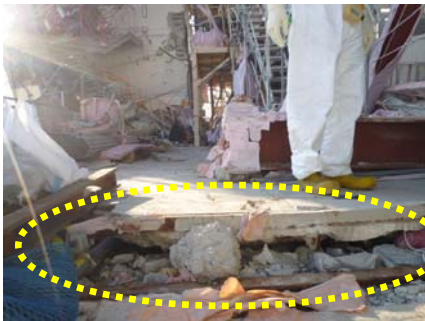
② Floor curled up

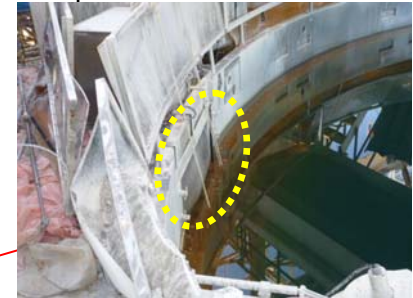
④ Wire mesh, inlet of the air-conditioning at Reactor Well was bent to the reverse direction

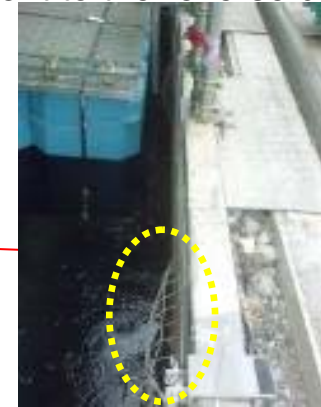
⑤ Wire mesh, inlet of the air-conditioning at Spent Fuel Pool was bent to the reverse direction

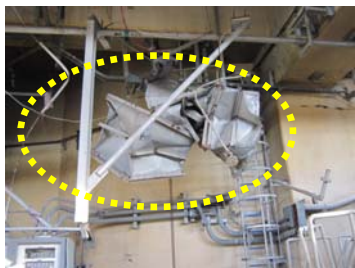
⑥ Rubbles from air-conditioning ducts

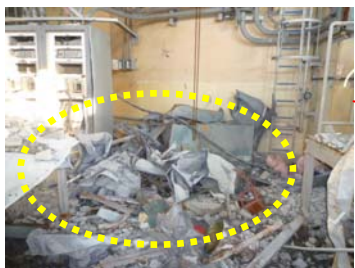
⑦ Rubbles from air-conditioning ducts

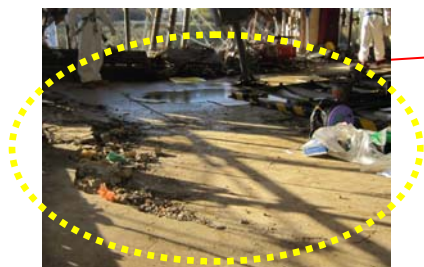
⑧ Floor pushed down

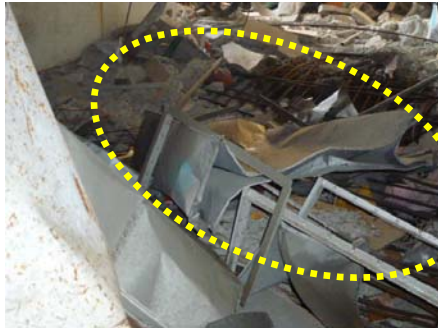
⑬ Damages to the floor

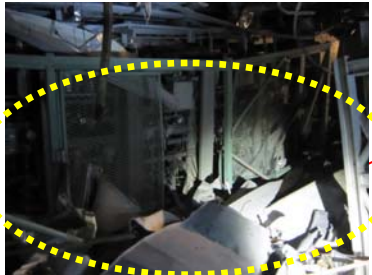
⑭ Floor pushed down
(in front is rubbles from air-conditioning ducts)

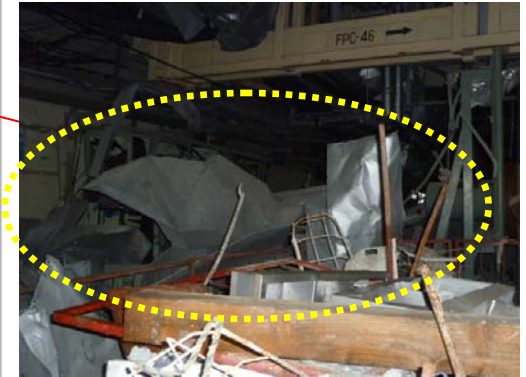
⑯ Rubbles from air-conditioning ducts

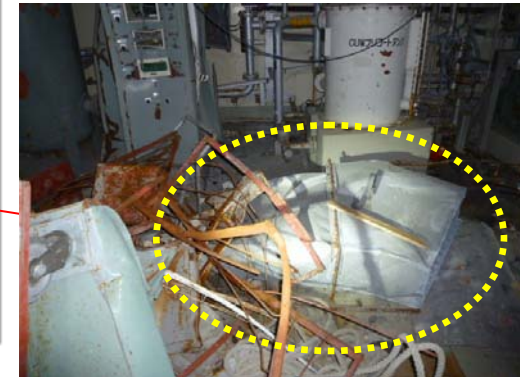
⑰ Rubbles from air-conditioning ducts
