Situation of investigation on water leakage from around the welded part of filter valve of 2nd Cesium adsorption apparatus (Sarry) B system (Continued report)

Investigation result of cross section of the leakage part

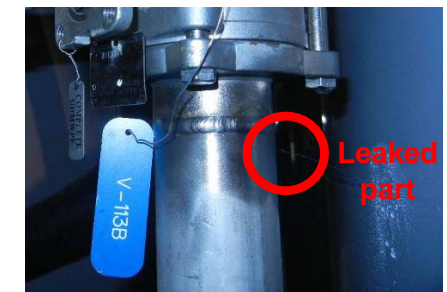
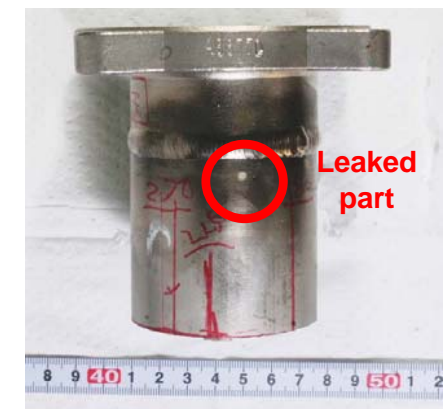
Leaked part

■ At around 8:30 am on February 25, water leakage was found at around the welded part of filter valve inlet of 2nd Cesium adsorption apparatus (Sarry) B system. On February 26, the filter was replaced and operation was restarted. Its operation was continued without any problem until its operation stop (scheduled stop) on March 2.

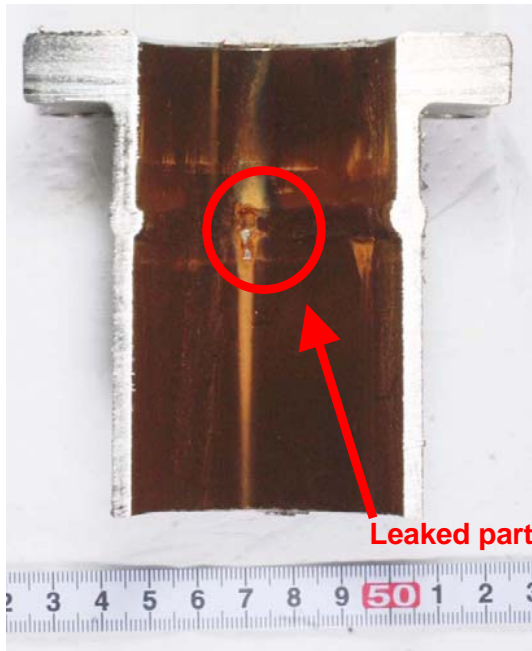
Leaked part: Before the clad (water stain) removed

- i) Due to the passing of accumulated water containing clad and so on, clad (water stain) and other materials are accumulated, which causes the environment that the corrosion is likely to occur.
- ii) Starting from the accumulated part of clad and other materials (base material around the welded part), partial corrosion (corrosion hole by the crack corrosion) was generated and developed by the chloride ion containing in the accumulated water, and as the result of penetration for the direction of pipe thickness, leakage was occurred from the pipe surface
※ In order to prevent the microbially caused clog of the filter, sodium hypochlorite was injected into the system, which might have facilitated the corrosion.

- i) Replacement of (1A), (2A), (2B), the same shape of filters as the leaked filter
- ii) Temporary suspension of sodium hypochlorite injection

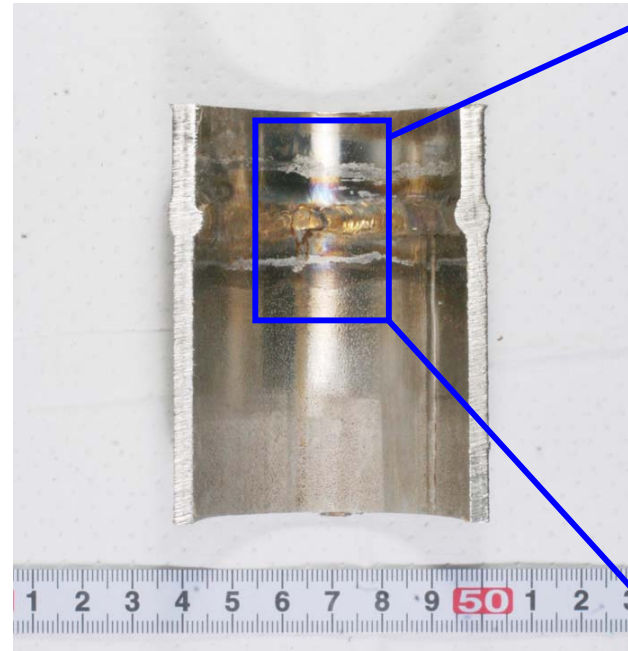
Leaked part: After the clad (water stain) removed

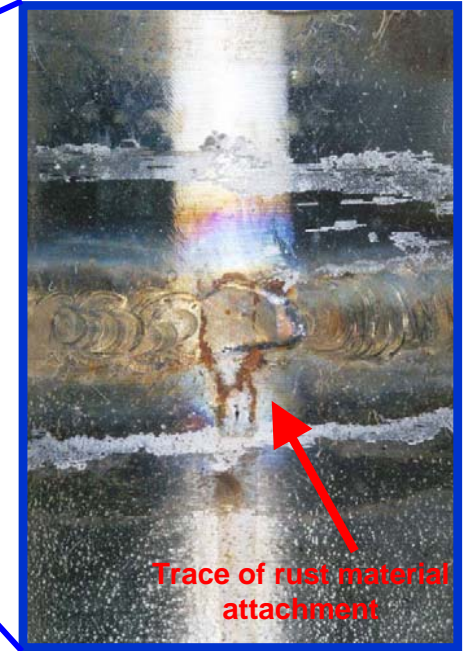
Close-up picture

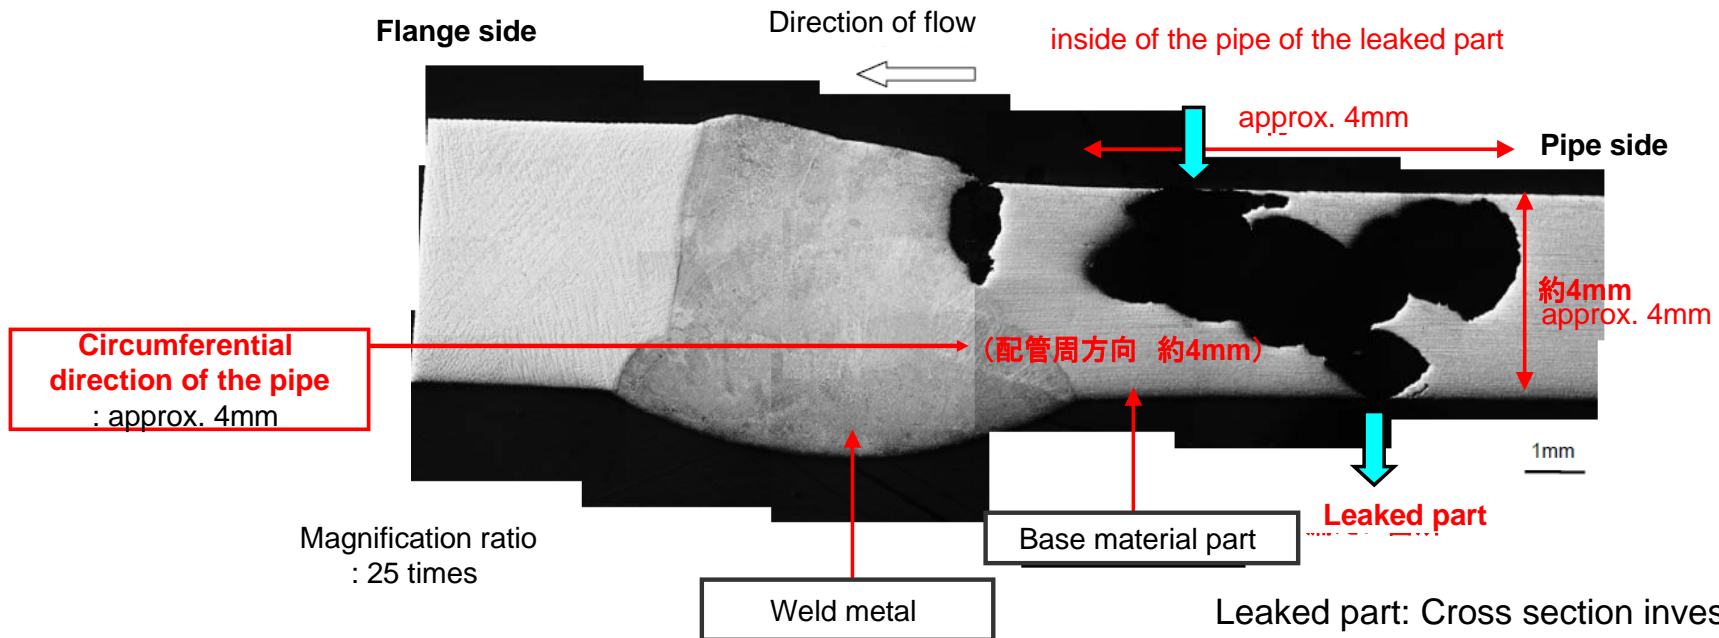
Leaked part: Cross section investigation

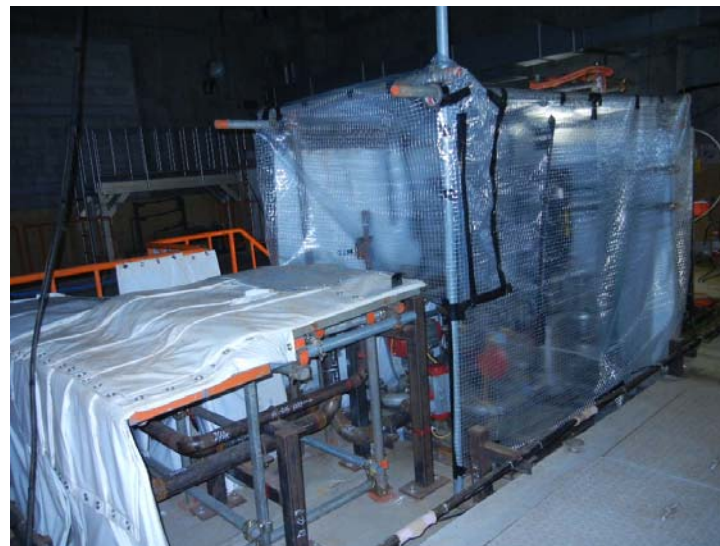
Situation of sheet curing

- i) Development of investigation method for the purpose of valuating soundness of pipe parts and so on
- ii) To prepare for the leakage, sheet was covered for curing around pipe parts of valve rack and booster pump skid to prevent the leakage from outspreading.
