Tokyo Electric Power Company

Result of Investigation on Unit 1 Operating Floor at Fukushima Daiichi Nuclear Power Station

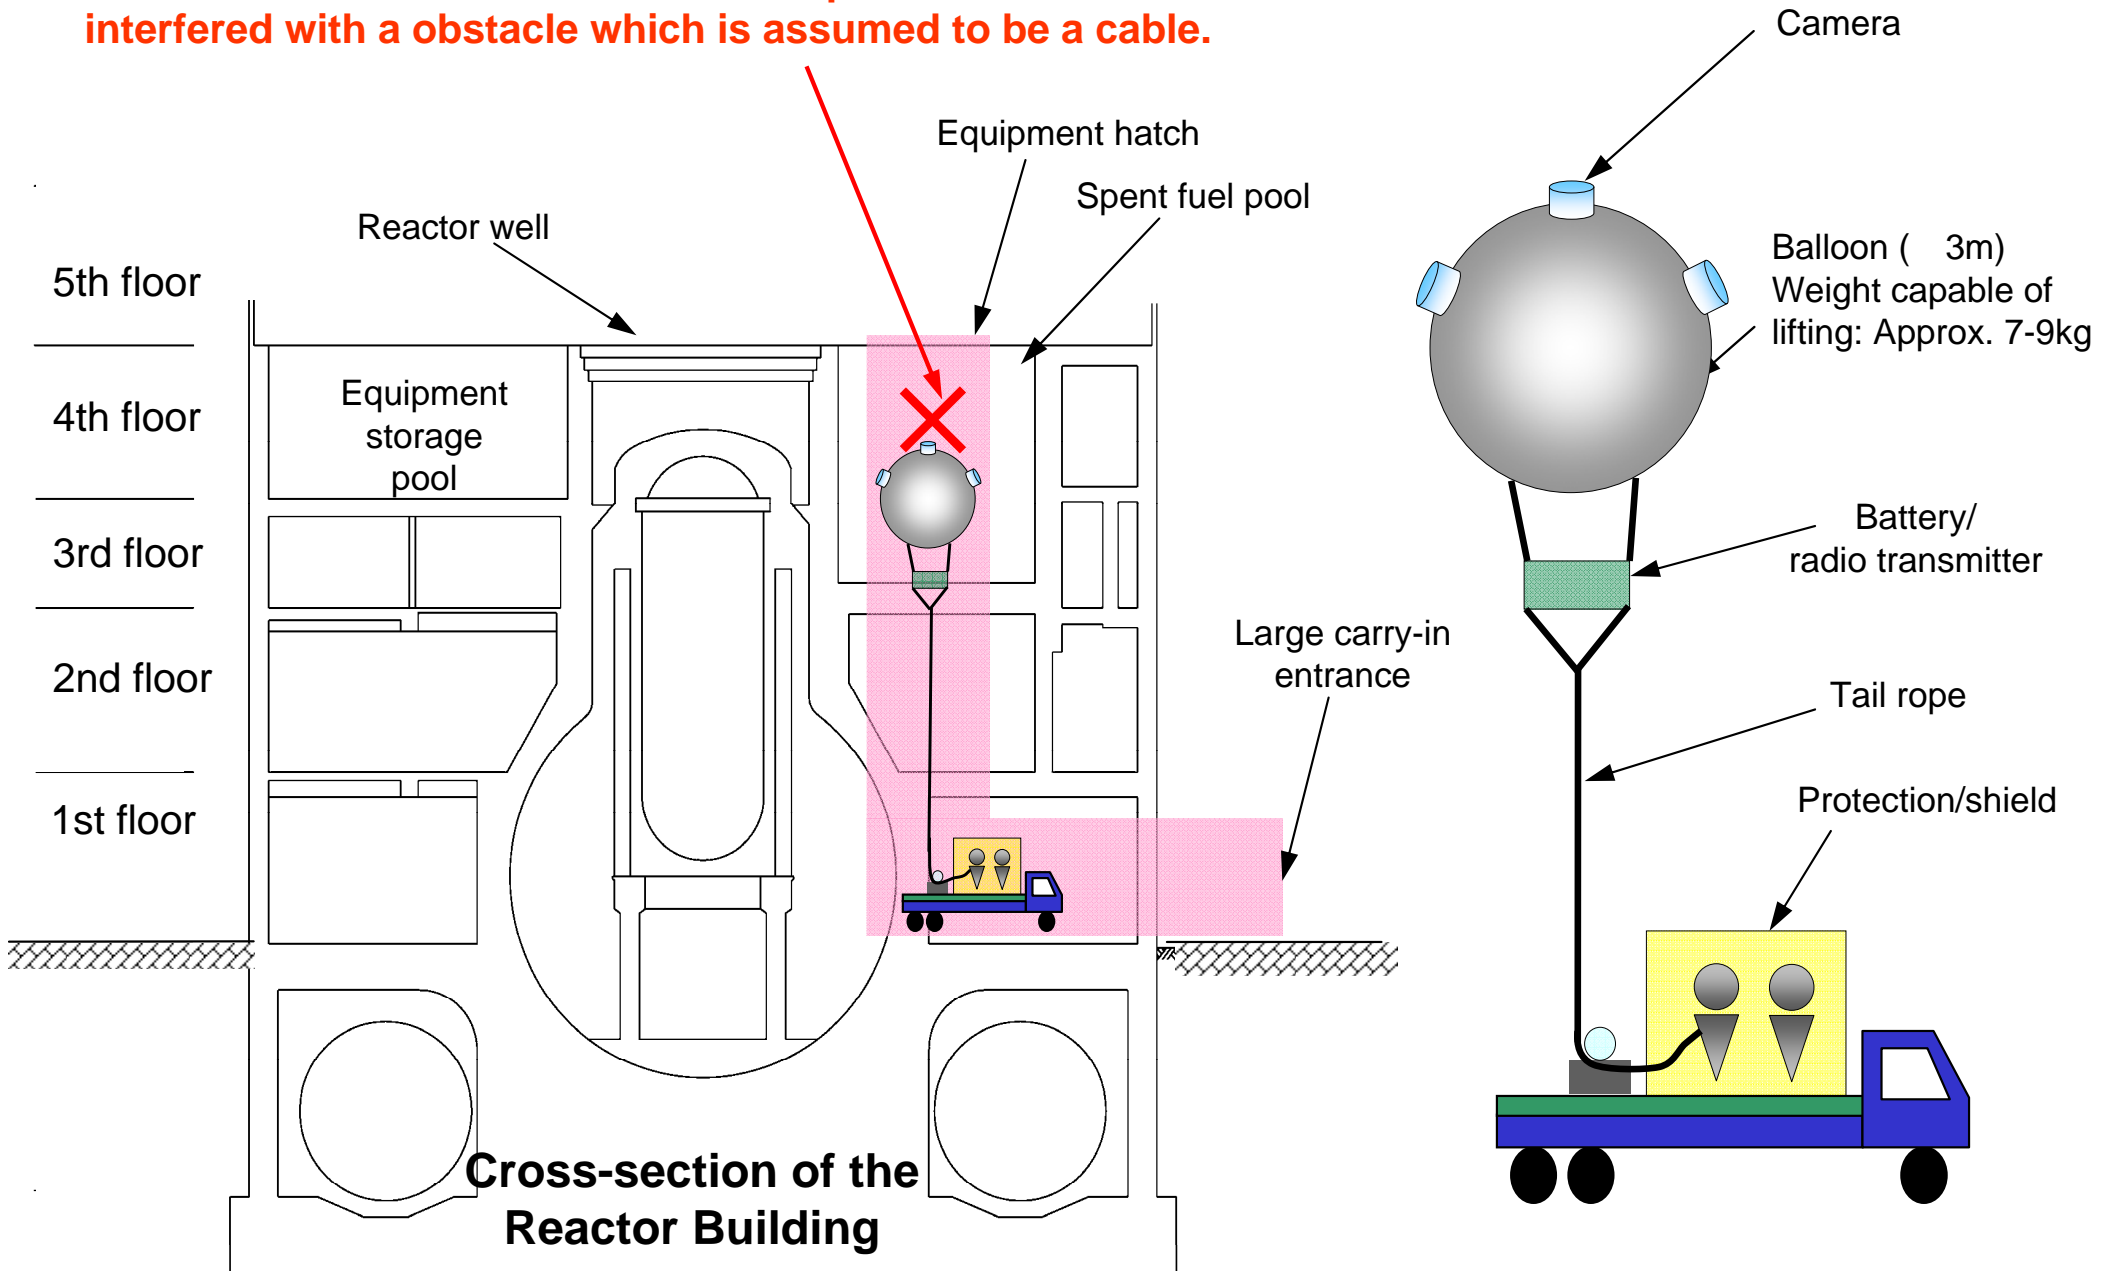
The balloon was unable to reach the operation floor as it interfered with an obstacle which is assumed to be a cable.

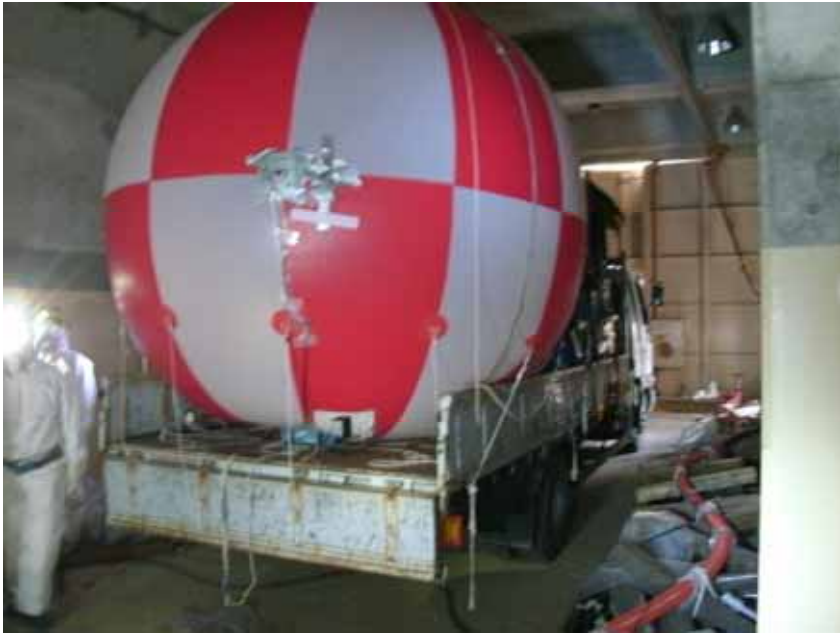
Balloon loaded on the truck

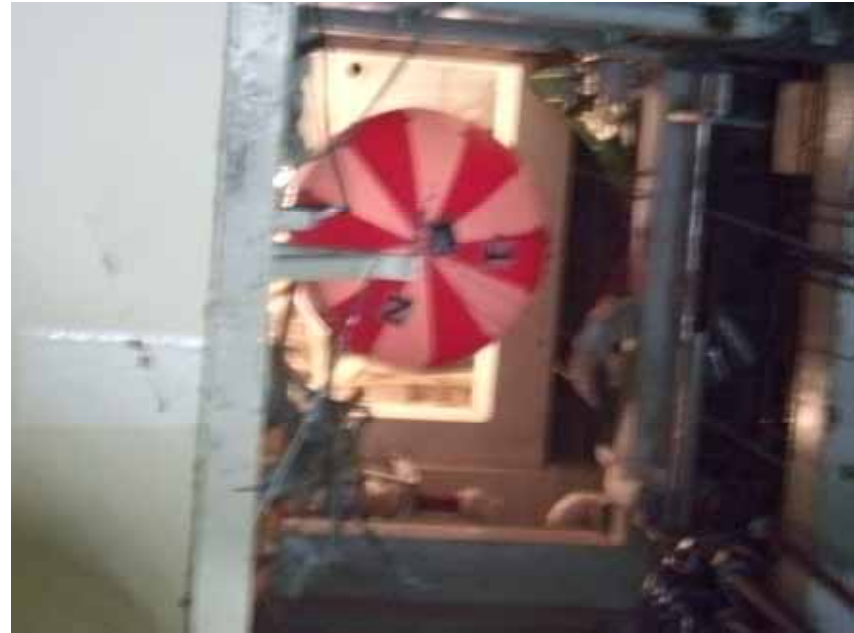
Balloon floating inside the hatch shaft
(Photo taken from straight below the
balloon)

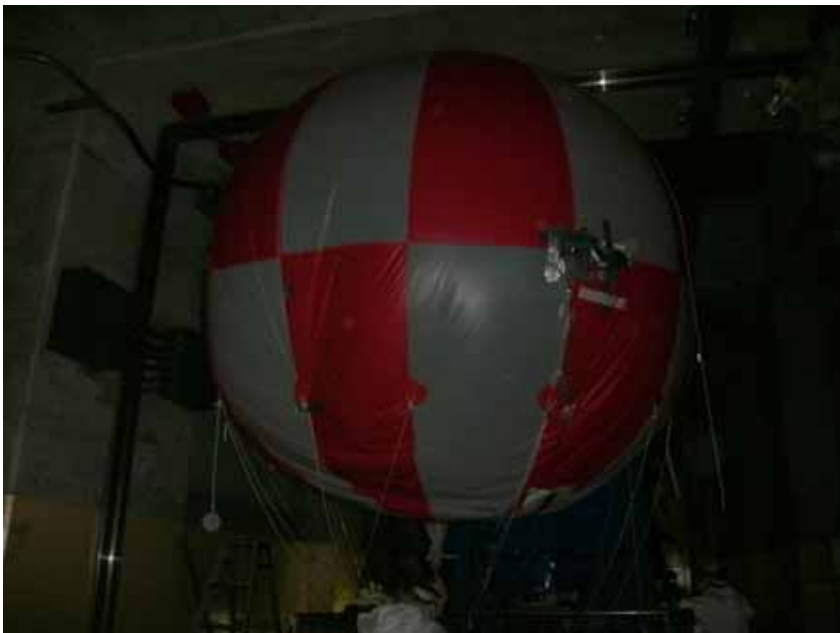
Appearance of the balloon
