Results of the Second Soundness Inspection of Unit 4 Reactor Building at Fukushima Daiichi Nuclear Power Station

August 30, 2012

Tokyo Electric Power Company

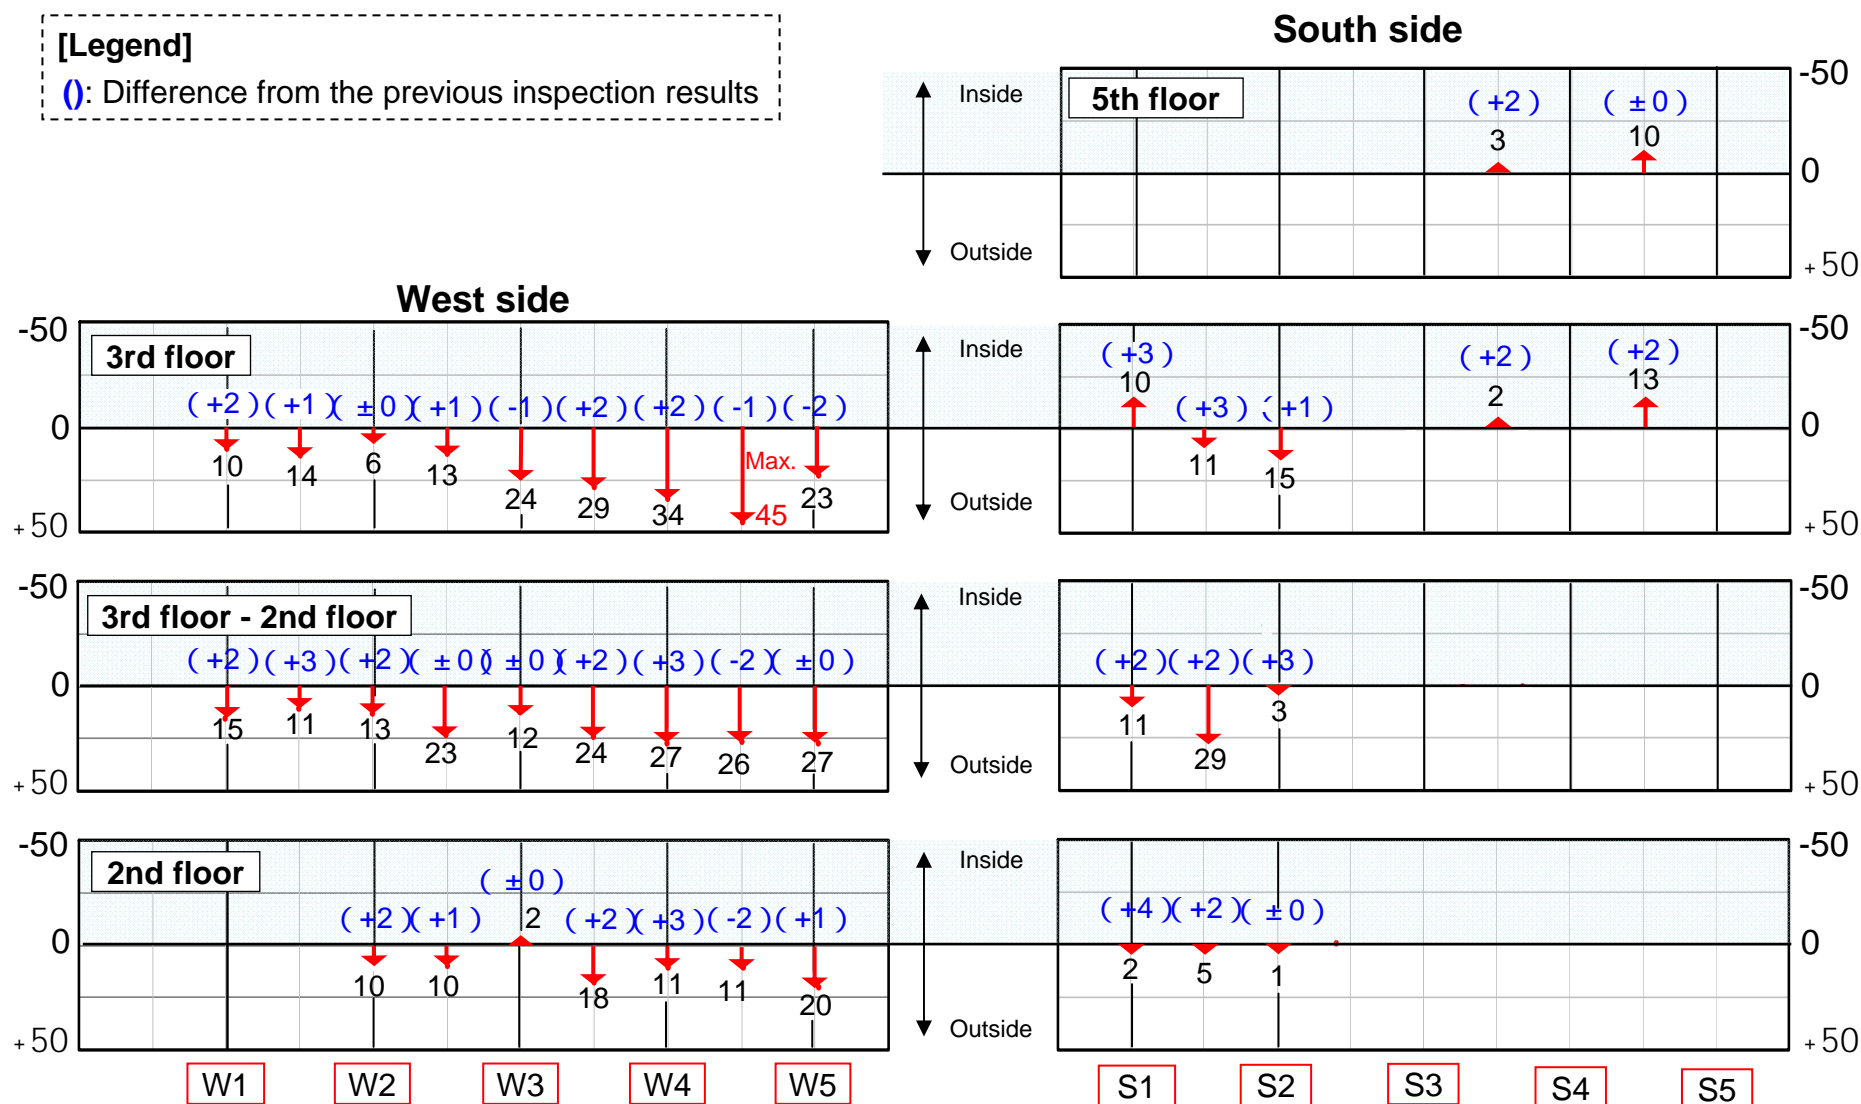
Horizontal difference*1 calculation results

- The horizontal differences measured this time were about the same as those in the first inspection (May 2012) and the detailed inspection of exterior walls (June 2012), and the deformation characteristics on the measurement points were also similar.

- The small difference from the previous measurement results may be due to factors such as error of the optical equipment (Measurement error of $\pm 2\text{mm}$ may cause approx. 4mm (Max.) error in horizontal difference) and thermal expansion of concrete (thermal expansion coefficient: Approx. $7-13 \times 10^{-6}/$) which may cause approx. 2-4mm error because of the difference of average monthly temperatures of May and July.

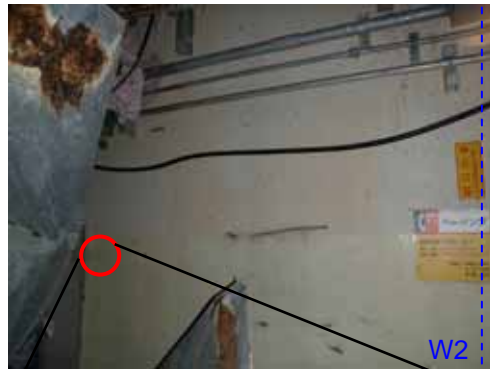
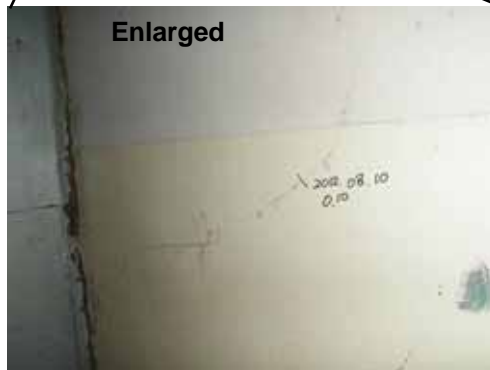
Though cracks of the maximum of 0.3mm wide were found on the second floor west exterior wall where partial bulge was found, the small cracks found this time should have no significant impact on the durability and strength of the building.

1. Inner surface of the second floor west exterior wall between W2 and W3 (Crack width: 0.1mm)

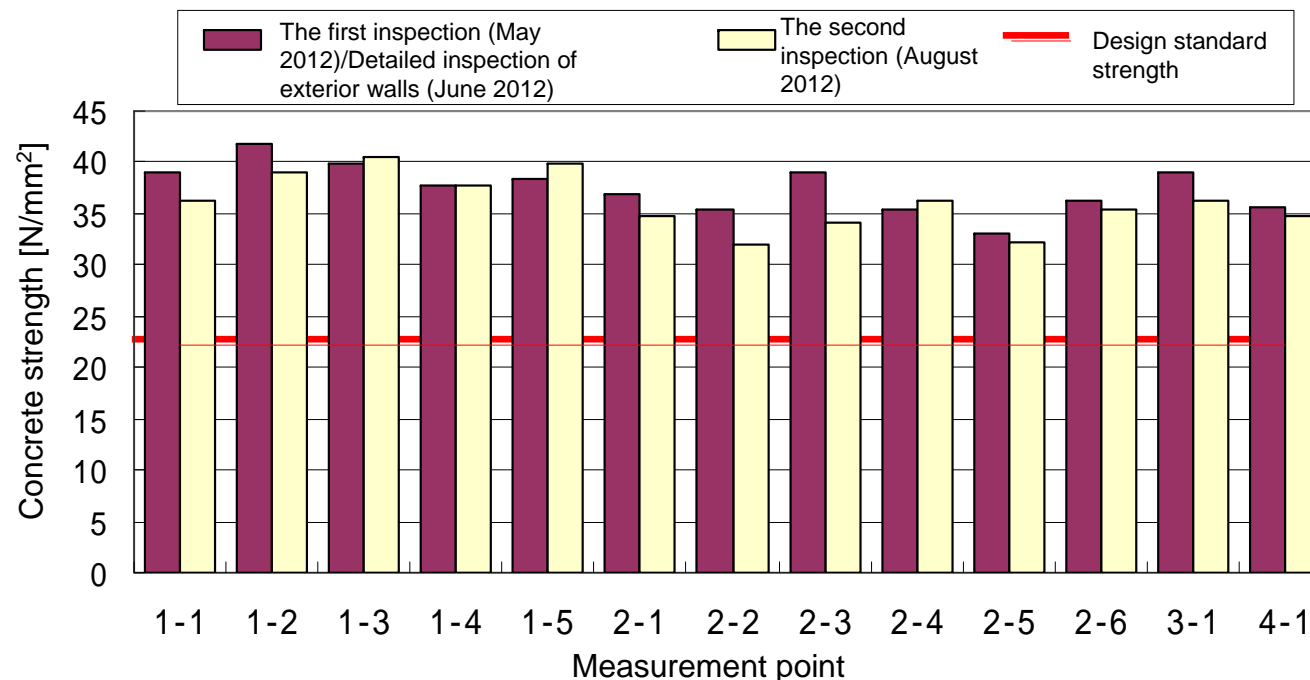
Concrete strength evaluation results

As a result of measurement, the concrete strengths on all the measurement points were above the design standard (22.1N/mm²) similarly to the past results. The results obtained this time are considered to be about the same as the previous results taking into consideration the error of Schmidt Hammer*¹ and that the measurement points were set at different locations from the previous ones. (The concrete strength fulfilled the design standard in the first inspection (May 2012) and the detailed inspection of the exterior walls (June 2012).)
