Water Leakage from Unit 6 Purification Equipment Pipe at Fukushima Daiichi Nuclear Power Station

Date and Time: October 4, 2012 at around 4:30 PM

Location: F tank area in the north of Unit 5-6

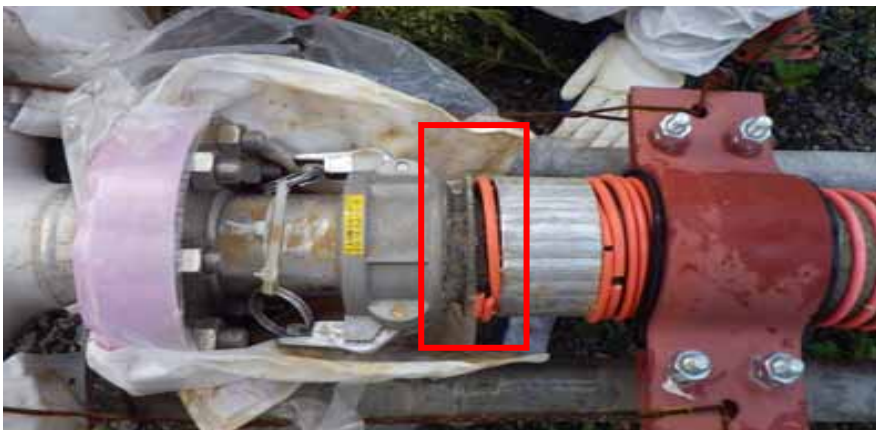
Location of water leakage

2. It was confirmed that the leakage stopped at around 4:35 PM after the pump was stopped.
3. Upon investigation, the leakage location was identified to be the hole on the joint of the pipe where the water treated in the chelate resin/zeolite absorption tower goes through.

- Hole size: Approx. 3mm x 1mm
 - Leaked water: Treated water which came from the radioactive material removal equipment (Approx. 12L)
 - Nuclide analysis results of the leaked water
I-131: Below the detection limit (1.6×10^{-2} Bq/cm³), Cs-134 : 1.5×10^{-1} (Bq/cm³),
Cs-137 : 2.4×10^{-1} (Bq/cm³)
