An Issue Found with the Minimum Flow Rate Bypass Valve of Unit 5 Reactor Core Spray System (B) at Fukushima Daiichi Nuclear Power Station

Date and Time: October 10, 2012 at around 10:37 AM

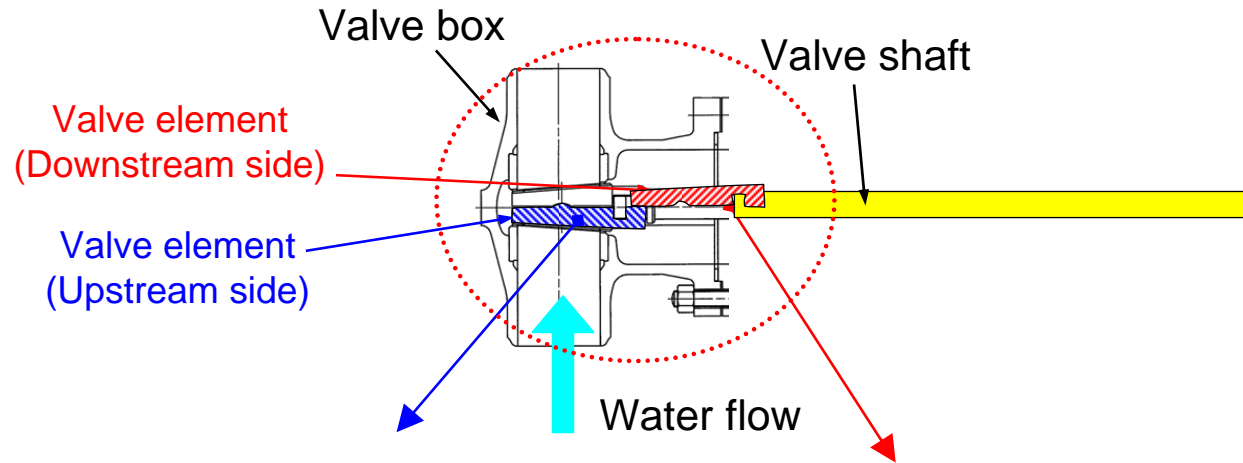
Condition of the valve at the time of the inspection

At a regular inspection of the reactor core spray system (B), the minimum flow rate bypass valve did not close all the way when it should have. However, the system flow rate fulfilled the requirement stipulated by the technical specification.

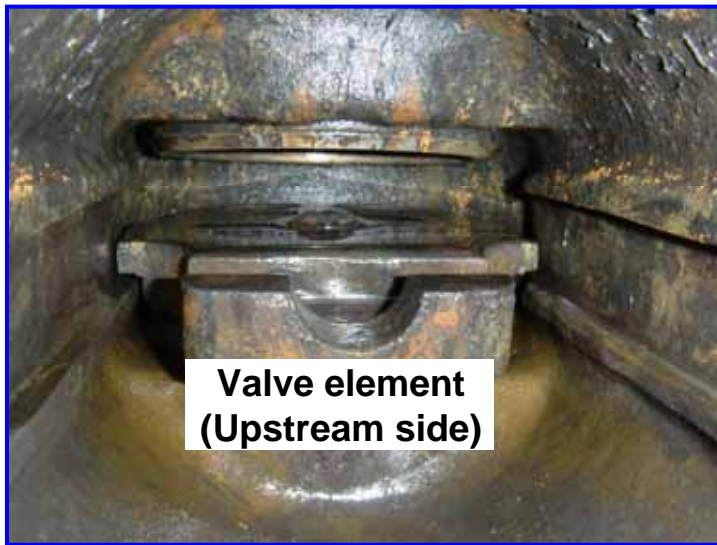
One of the two valving elements (on the inlet side) of the minimum flow rate bypass valve was found to be removed.

Valve element in the valve box which came off of the valve shaft (Upstream side)

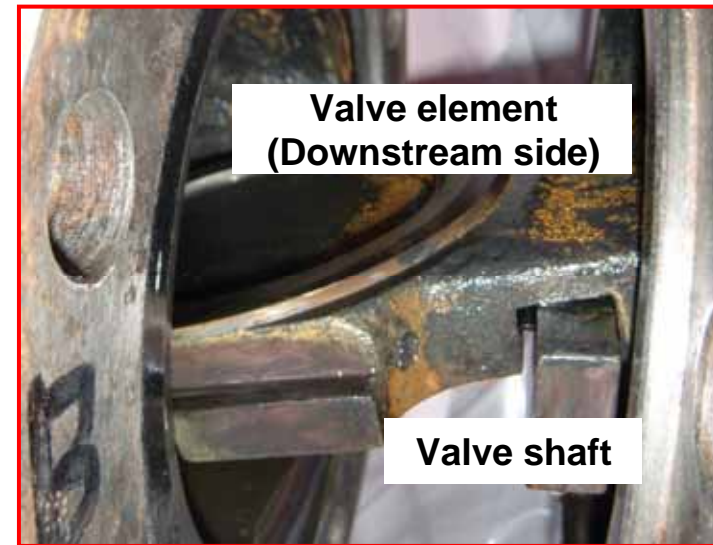
Connection between the valve element (downstream side) and the valve shaft when the valve was disassembled
