The Water Leakage at the Accumulated Water Transferring Pipe in Unit 3 Turbine Building at Fukushima Daiichi Nuclear Power Station

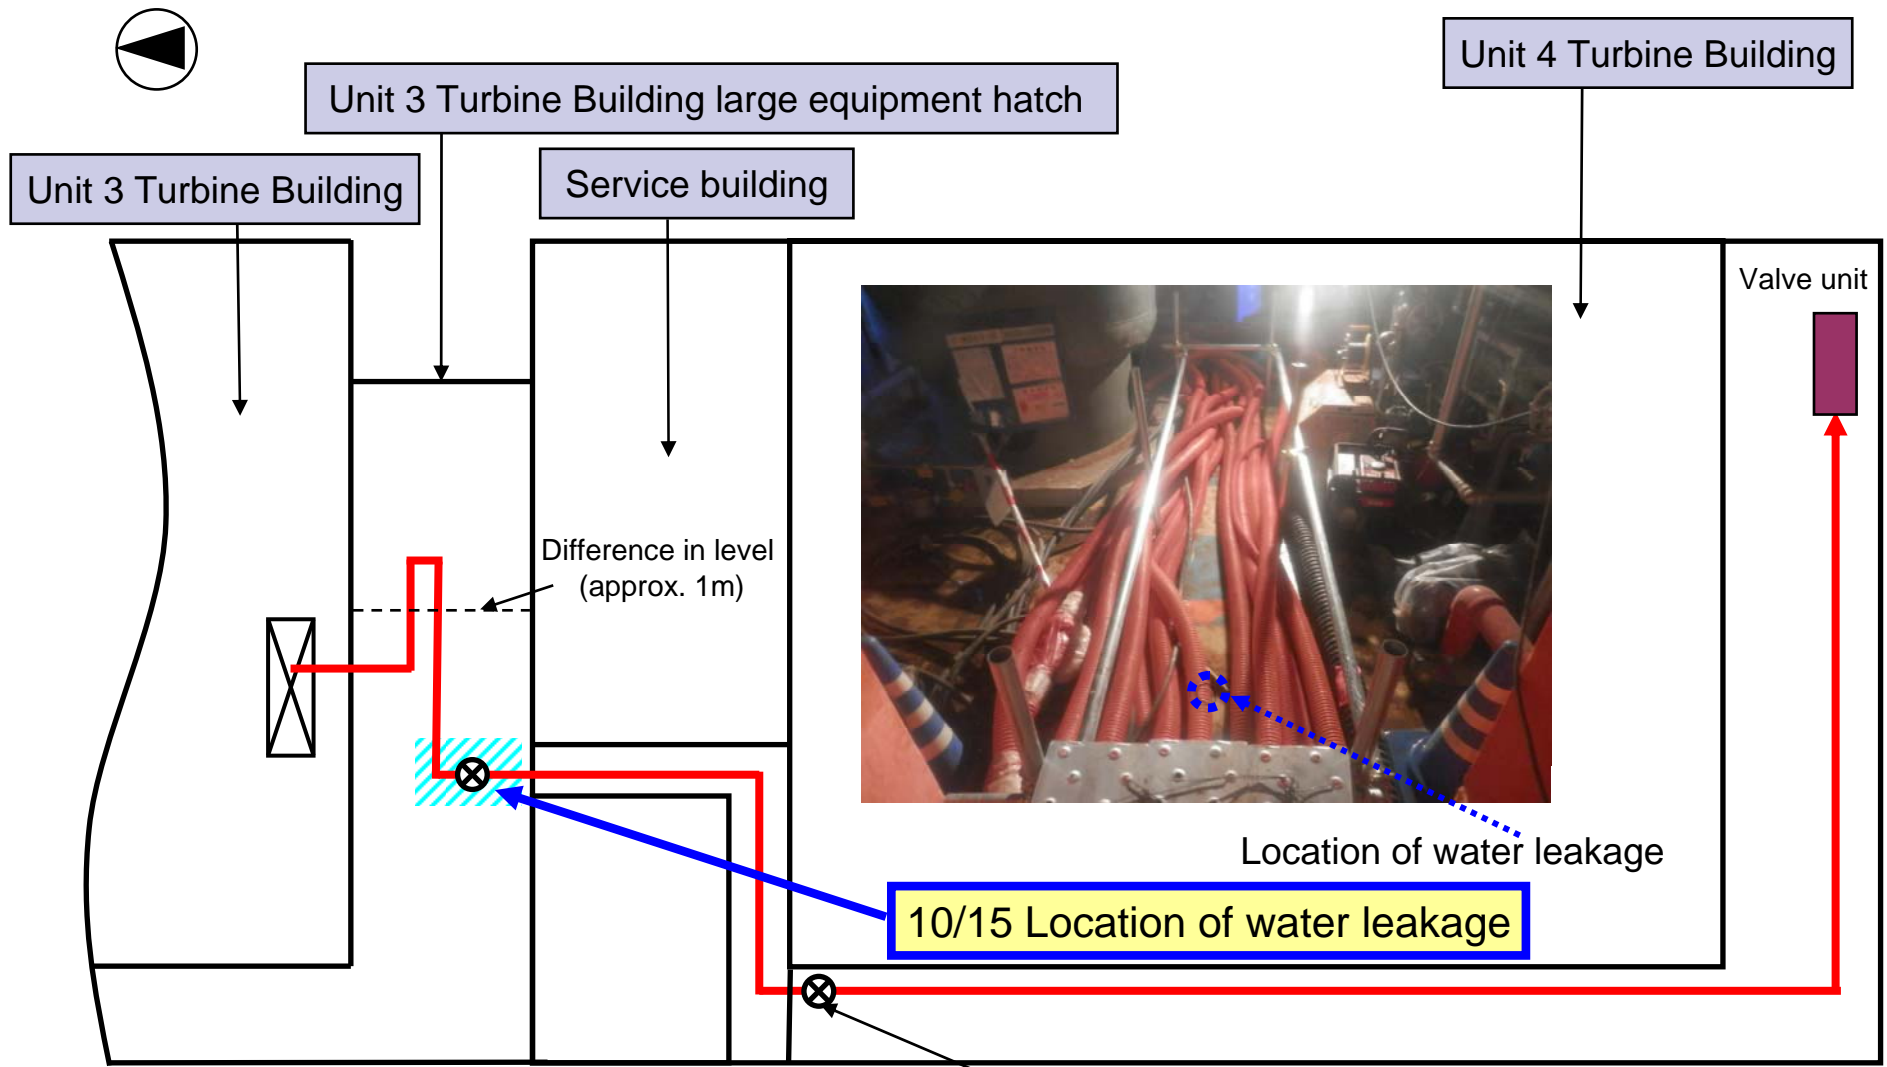
Location of water leakage

Area affected by the water leakage
3m x 6m x 5mm

Amount of the leaked water
90 litre

Results of the leaked water nuclide analysis
I-131: ND
Cs-134 : 1.0×10^4 Bq/cm³
Cs-137 : 1.8×10^4 Bq/cm³
