Results of Investigation on the Lower Part of Unit 2 Vent Pipe at Fukushima Daiichi Nuclear Power Station

December 11, 2012

Tokyo Electric Power Company

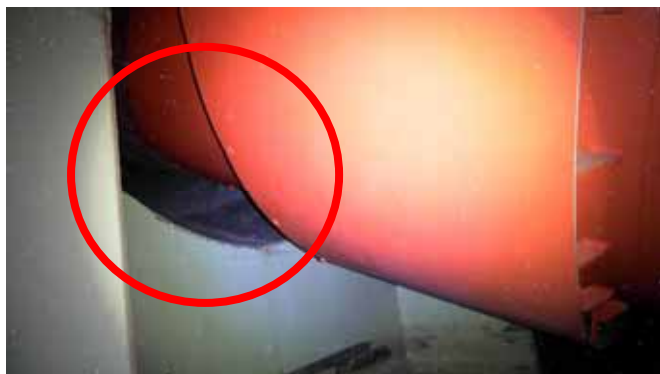
Edge of vent pipe sleeve

No water leakage was found on the edge of the vent pipe.

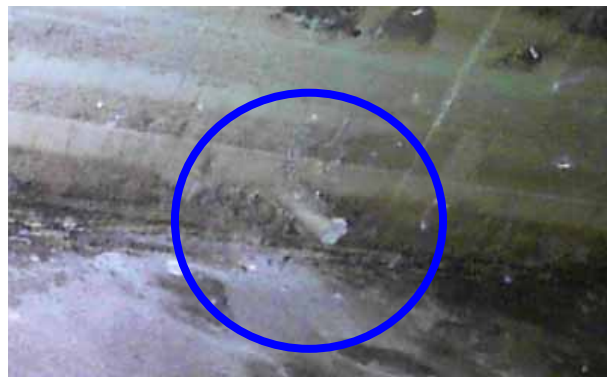
Edge of sand cushion drain pipe

No water leakage was found on the edge of the sand cushion drain pipe.

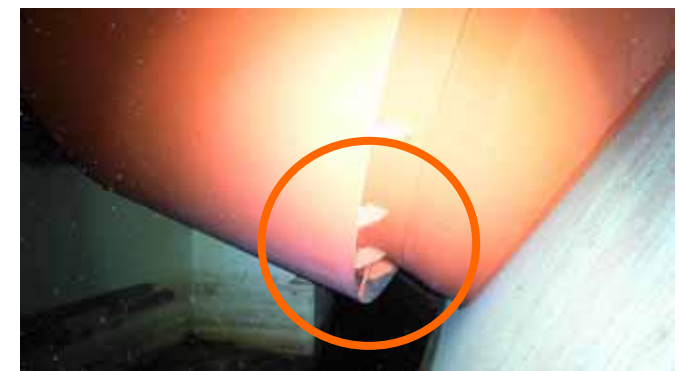
Lower part of vent pipe bellows cover

No water leakage was found in the lower part of the vent pipe bellows cover.
