Puddle Found on the First Floor of Unit 4 Waste Treatment Building at Fukushima Daiichi Nuclear Power Station

< Reference >
December 14, 2012

Tokyo Electric Power Company

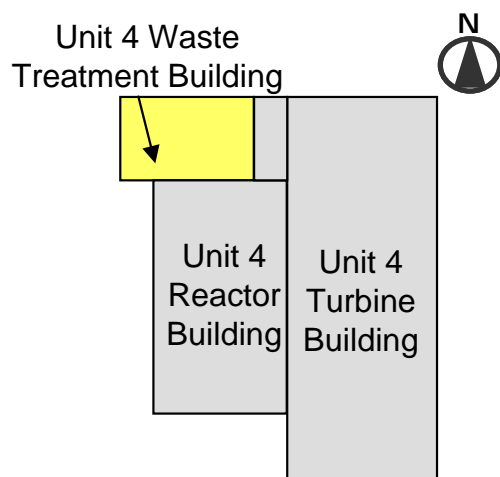
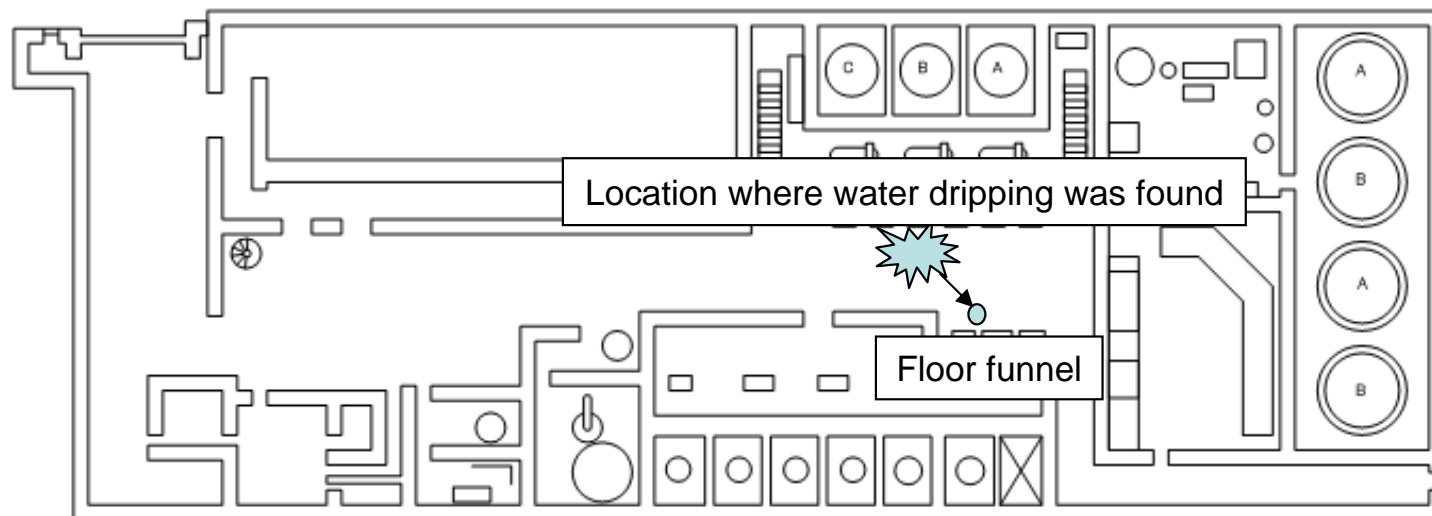
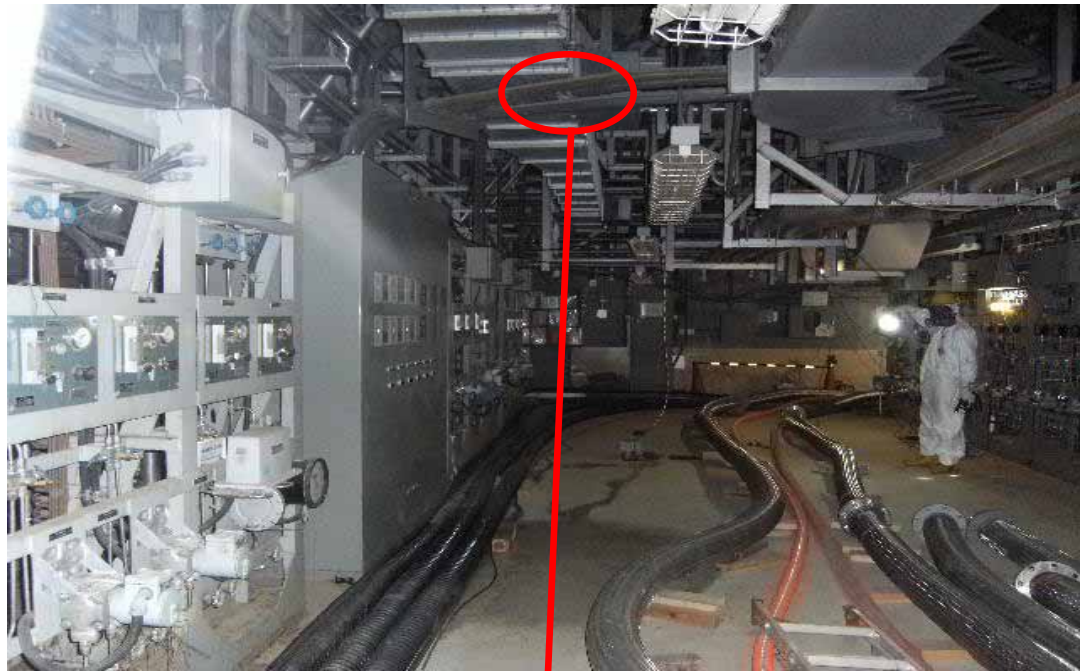
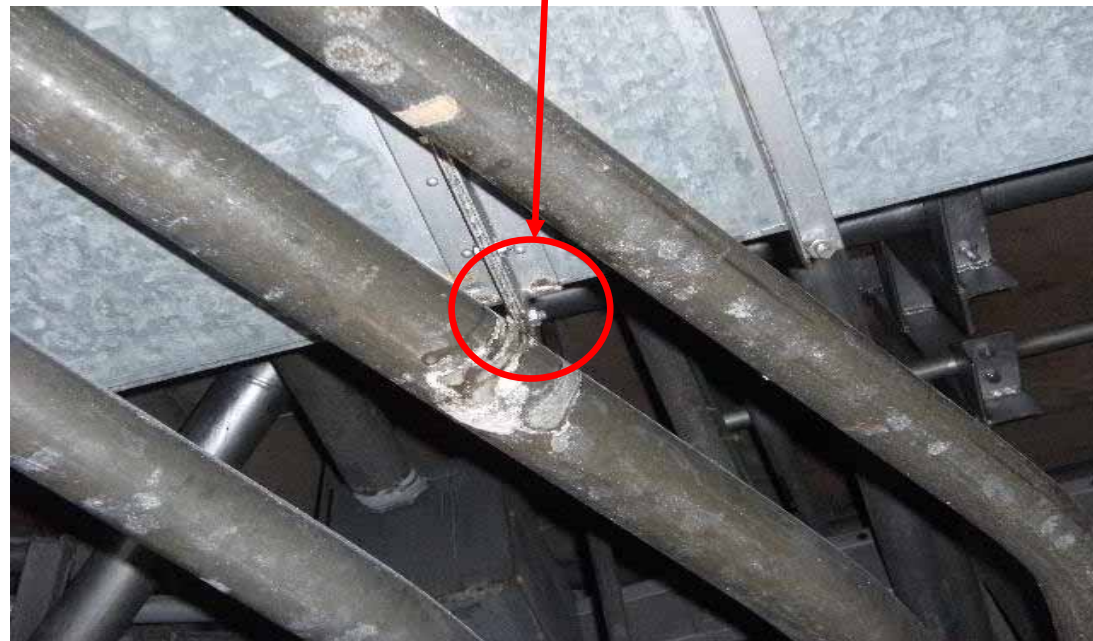
A TEPCO employee found water dripping (about 2 drops per second) from the air conditioning duct installed on the upper part of aisle on the first floor of Unit 4 Waste Treatment Building. The water has not flowed to the outside of the building since the water flowed into the floor funnel (pipe connected to the basement) nearby and the structure of the first floor surface is similar to a dam.

Area affected by the water dripping (Floor surface): Approx. 2m x 1m x 1mm (depth) (Approx. 2L)

Radioactivity density analysis results of the dripped water

Cesium 134: Approx. $4.2 \times 10^1 \text{Bq/cm}^3$, Cesium 137: Approx. $7.2 \times 10^1 \text{Bq/cm}^3$

Assumed cause: Rainwater flowed in from the damaged part of the outdoor duct dripping from the duct joint

Countermeasure: Measures to prevent rainwater from flowing in are under consideration (The duct is currently not in use).
