We affirm that the Reactor Building and Spent Fuel Pool of Unit 4 will not collapse in the event of an earthquake

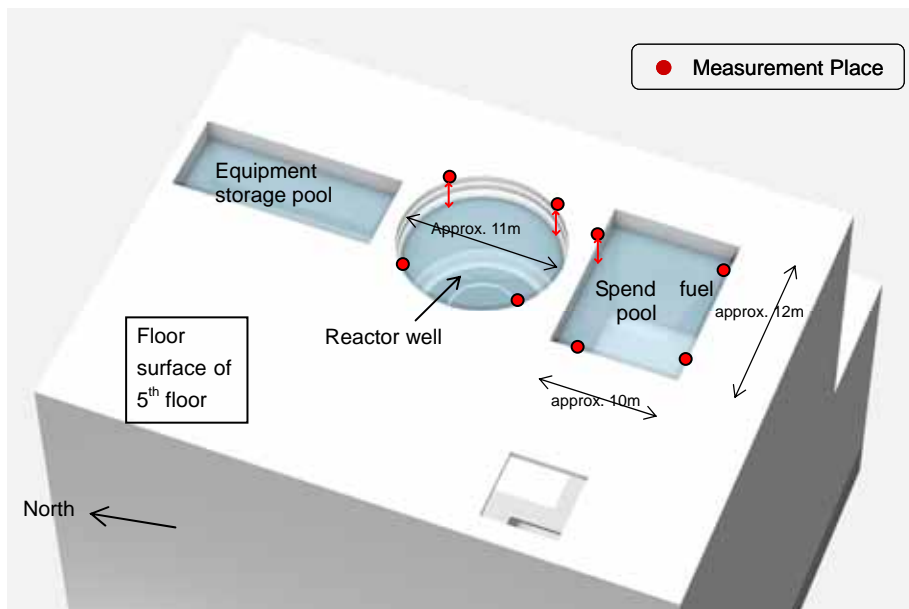
Figure 1 Measurement points

1) We measured the distance between the water surface of the spent fuel pool and the floor surface of the building, and confirmed that the building has not tilted.

We have measured the distance at 4 corners of the 5th floor of the reactor building between the water surfaces of the spent fuel pool, the reactor well and the floor surface of 5th floor. We conducted the measurements twice on February 7 and April 12, 2012 and the measured data at the 4 corners were mostly the same. Thus, we confirmed that the floor surface of the 5th floor, water surfaces of the spent fuel pool and the reactor well were parallel.

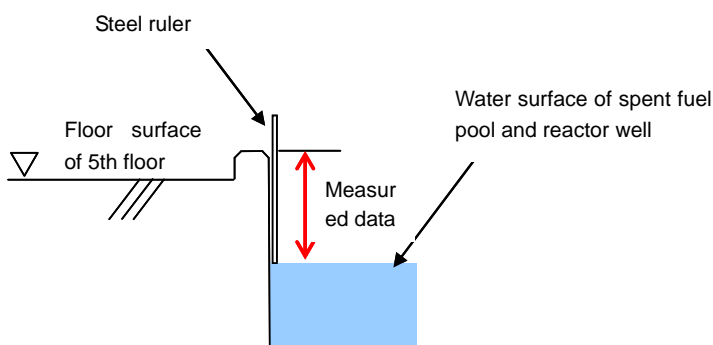
Figure 2 Measurement Method

Water level changes depending on the operation of cooling system.

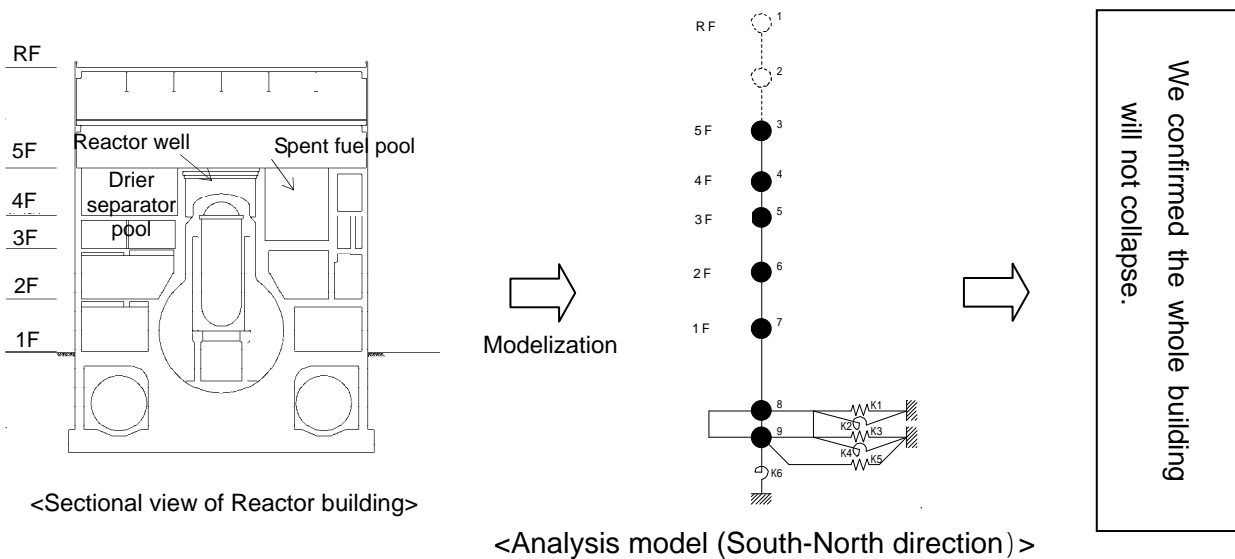
Figure 3 Analysis model

Using an analysis model reflecting the damage of the reactor building per the hydrogen explosion as shown in figure 3, we conducted an evaluation of the reactor building against the seismic movement (600 gal) used for the seismic back-check equivalent to the Tohoku-Pacific Ocean Earthquake and confirmed that the reactor building has a sufficient margin of seismic safety.

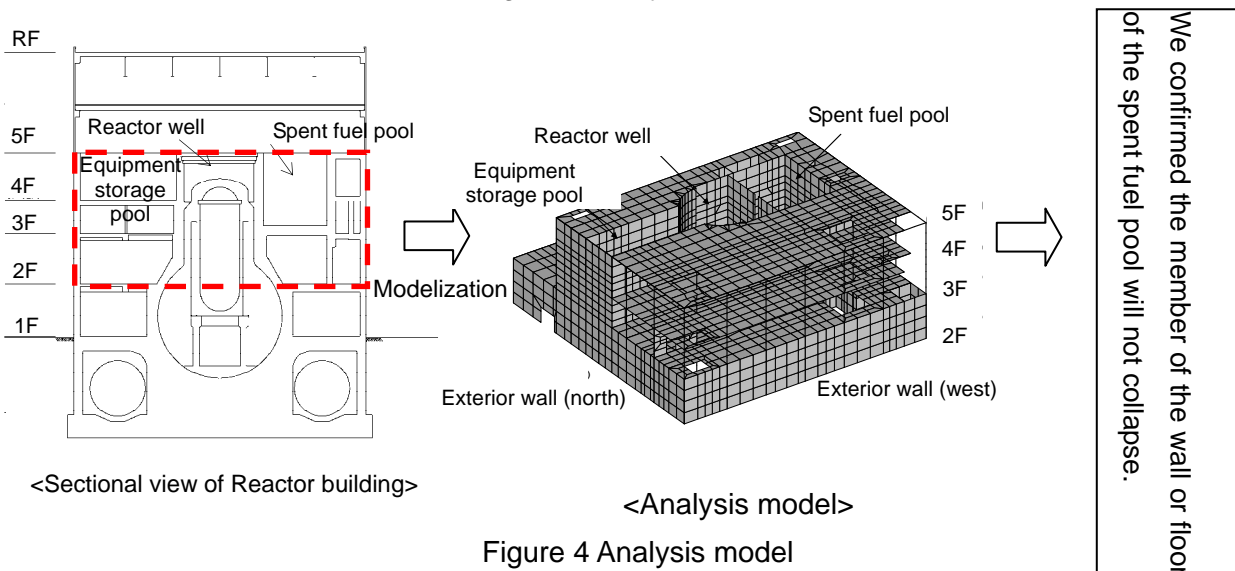
Figure 4 Analysis model

Additionally, we conducted a partial evaluation with an analysis model considering the building damage or conditions of the pool water at high temperatures in figure 4 and confirmed that the spent fuel pool has a sufficient margin of seismic safety.

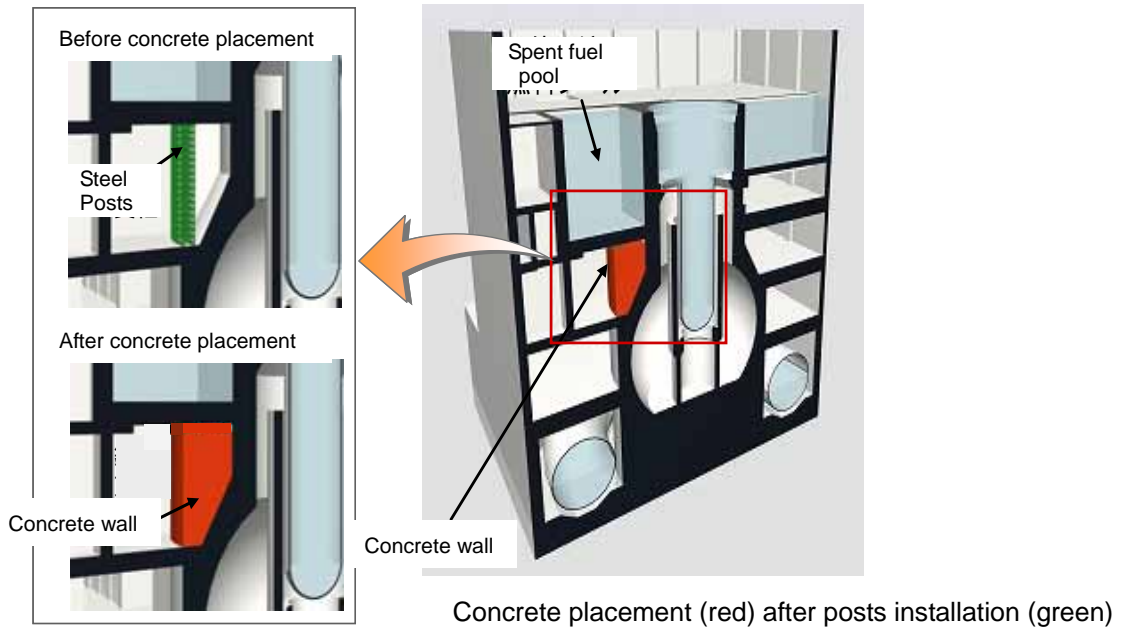
Figure 5 Reinforcement image at the bottom of the spent fuel pool

Table 2 shows the enhanced seismic safety effect resulting from these reinforcements. It shows that the seismic safety margin against the load of the spent fuel pool improved by 20%.

We enhanced the support function against the load of the spent fuel pool by installing steel posts at the bottom of the spent fuel pool. In addition, we encased the posts in concrete to increase its strength. (Completed on July 30, 2011)

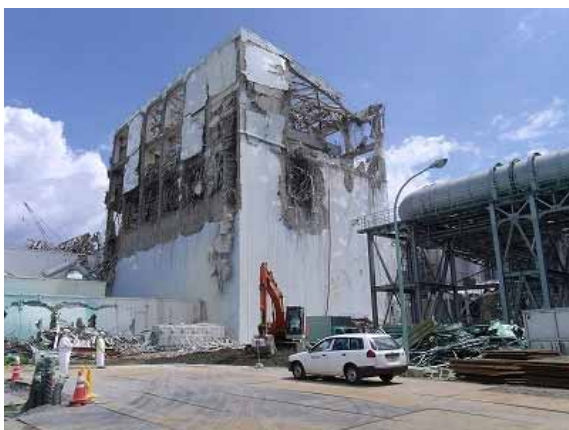
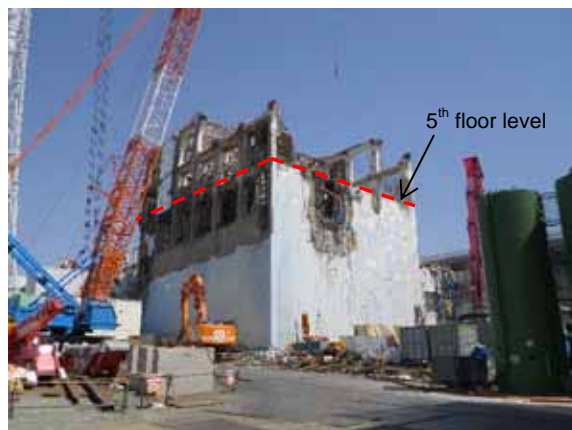
Figure 7 Situation of the Reactor Building of Unit 4

Table 7 shows the removal situation of the damaged building frame above the 5th floor. The removal above the 5th floor will be completed by the middle of this fiscal year.
