# Progress Status and Future Challenges of Mid-and-Long-Term Roadmap toward the Decommissioning of TEPCO's Fukushima Daiichi Nuclear Power Station Units 1 – 4 (Outline)

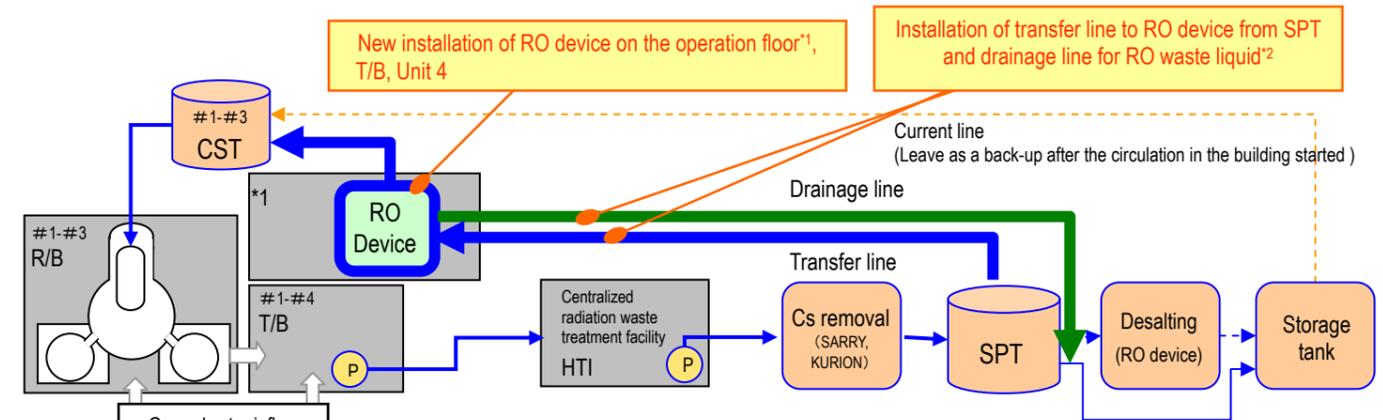
Figure 1: Circulation loop image in building

- **Study status on the shortening of circulation loop**
  - To improve the reliability of circulated water injection line and reduce the risk of contaminated water leakage to outside the building, the shortening of circulation loop in size is under study. It is planned to install RO device inside the building by the end of 2014 to shorten the reactor water injection loop (circulation loop) from about 3 km to 0.8 km\* by stopping water running through the RO device installed on the hill (see Figure 1).

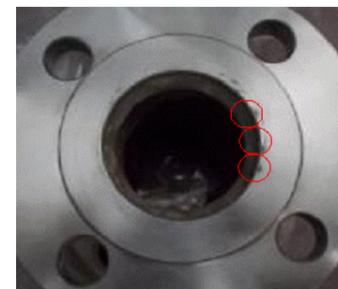
Plumbing flange at the exist of Supply pump 1

- As for System C, preventive actions were taken with priority, and hot testing was started (from Sep. 27). Later, the operation was suspended as planned (Nov. 3 through 18) to verify the effectiveness of the actions taken. As the result, it was found that, although one flange had three tiny crevice corrosions, these were not the ones that affect the quality of sealing itself, and the occurrence of corrosion has been largely suppressed. Consequently, the actions taken were verified as effective (see Figure 2).

Tiny crevice corrosion identified at 3 spots

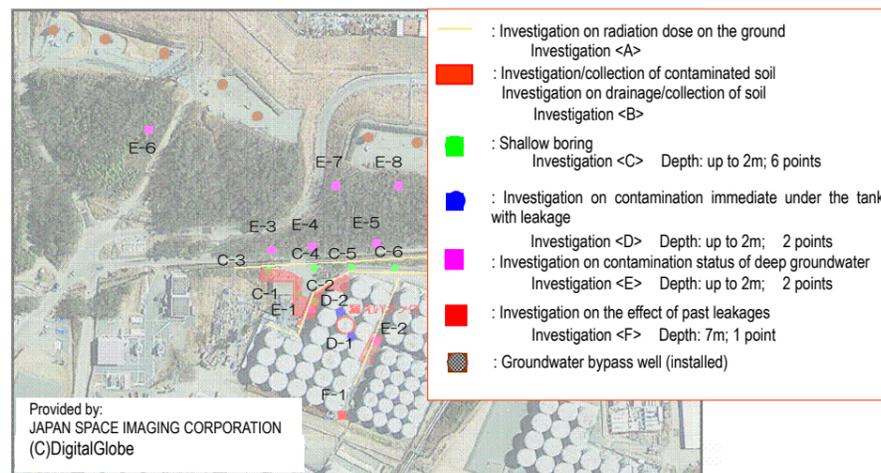
Figure 3: Investigation points around the tank

- Puddles were detected inside the dike in the H4 tank area that stores contaminated water and outside the drain valve of the channel (Aug. 19). As water had spread around the bolt fixed type No.5 tank in the same area, the water level of the said tank was checked to find that the level was lower by approximately 3m (equivalent to approx. 300m<sup>3</sup>) compared to neighboring tanks, which was judged as high density contaminated water leakage having occurred (Aug. 20).
- To grasp the contamination status and investigate the impact, the investigation shown at figure 3 is underway. At sampling point, E-1, near the tank, the gross  $\beta$  radioactive density increased to approx. 300,000 to 400,000 Bq/L from 80~90Bq/L for the water taken after October 17, which makes it hard to deny the effect of the leakage in August.

- In response to the increase of the gross  $\beta$  radioactive density, currently the removal of contaminated soil on the west side of E-1 is underway. In addition, testing of water abstraction from well point is under way. (from Nov. 26).
- To realize early detection of leakage, it was decided to set a water level gauge to all of the bolt-fixed type tanks (planned on Nov. 30) and start remote monitoring (from early December).
- Monitors for consecutive surveillance to detect radioactivity in drainage will be installed (planned on Nov. 30), and from December, trial operation will start.

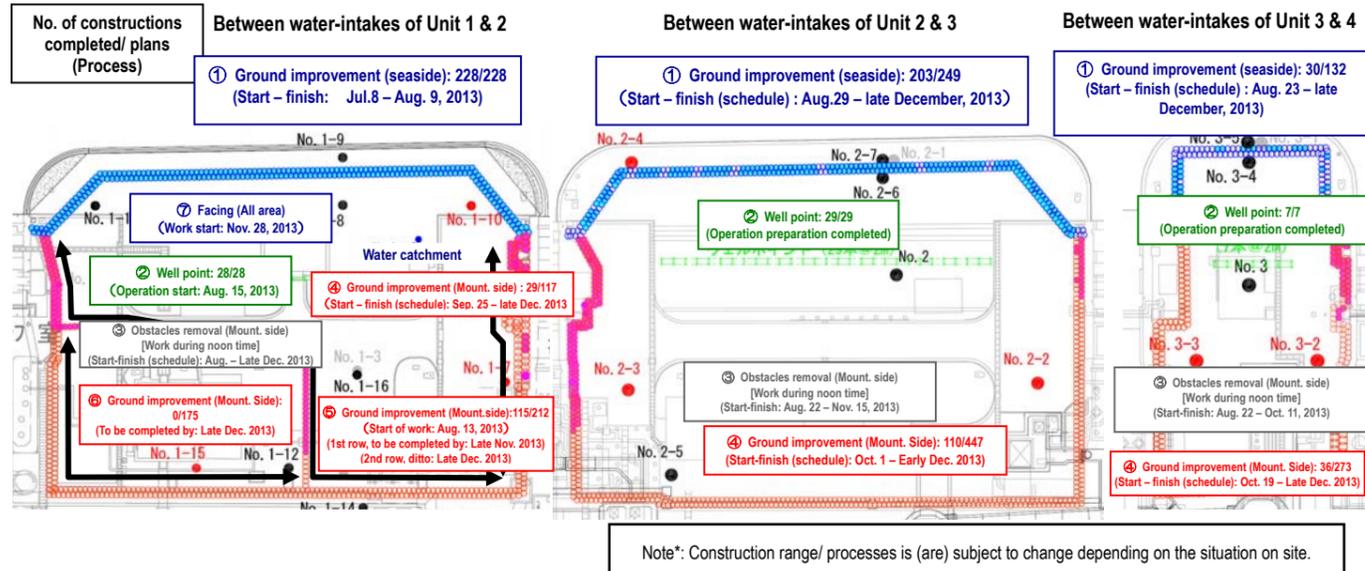
Figure 4: Progress in the constructions around the bank protection area

- Analytical results of data concerning the density and water levels of groundwater on the east (sea) side of the reactor buildings showed that contaminated groundwater have leaked into seawater.
- No significant fluctuation was found with radioactive materials in seawater within the port for the past month. The same is true of offshore, showing no significant fluctuation in the continuous measurement.
- Water quality survey of the water penetration layer at lower part (the second layer from the ground (alternate layer)) on the east side (sea side) of the turbine building in Unit 3 (one location) was conducted to find that the radioactive density is below the detection limit for Cs-134, Cs-137, and the gross  $\beta$ , and H3.
- As (emergency) measures to prevent expansion of the contamination to sea, the following shall be implemented. (see Figure 4)

- Ground improvement behind the bank protection to prevent spread of radioactive materials.  
Between Unit 1 and 2: completed on Aug. 9; between Unit 2 and 3: started from Aug. 29 and to be completed by late December; between Unit 3 and 4: started from Aug. 23 and to be completed by late December.

- Enclosure of the mountain side bank protection by improving ground foundation  
Between Units 1 and 2: started from Aug. 13 and to be completed in the end of December; and between Units 2 and 3: started from Oct. 1 and to be completed early December.  
Between Units 3 and 4: Started from Oct. 19 and to be completed in the end of December.
- To prevent ingress of rainwater, ground surface will be paved with asphalt for the range enclosed by the ground improvement. (between Units 1 and 2: start from Nov. 28)

- Removal of contaminated water from branch trench, etc., and fill in the trench. (completed on Sep. 19)
- Purification and removal of contaminated water in the main trench.  
Purification of the main trench of Unit 2 and 3 started (Unit 2: from Nov. 14, Unit 3: from Nov. 15).  
Freezing method and water removal of the main trench (freezing is planned to start from February, 2014).  
Currently, freezing method is under demonstration.

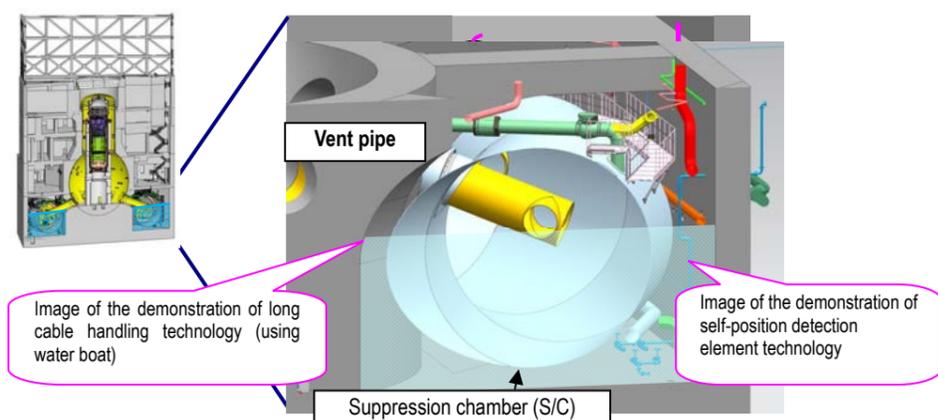
Figure 7: Investigation outline of swimming inspection robot

technology basis)" (Agency for Natural Resources and Energy) (November 13 and 14) (see figure 7), checks on the existence of leakage from sand cushion drain pipes and vent pipes; and the exterior appearance which was undertaken through camera image installed on a water-boat were conducted.

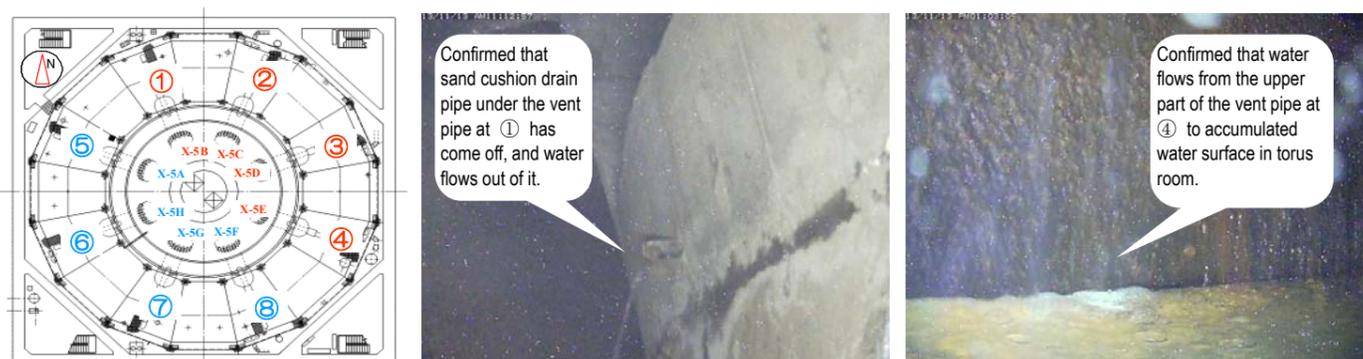
Figure 8: Water leakage from sand cushion drain pipe and upper part of vent pipe at Unit 1

- Water leakage from a part of the upper part of vent pipe and sand cushion drain pipe was confirmed (see figure 8). It is planned to analyze the information gained and undertake investigation.
- **Decontamination in the reactor buildings of Unit 1 to 3**
  - It is planned to start works such as investigation for the purpose of repairing primary containment vessels at the first floor of the reactors from FY2014. Currently, it is difficult to have operators work at the site for many hours due to the high radiation dose inside the reactor buildings, for which, the environment is addressed in such a way as to remove rubbles using unmanned heavy machine and to reduce such dose using remote-control typed equipment.
  - Decontamination work has started at the first floor of the reactor building of Unit 2 from Nov. 28 using remote-control type equipment.
