Main works and steps for decommissioning

Progress status

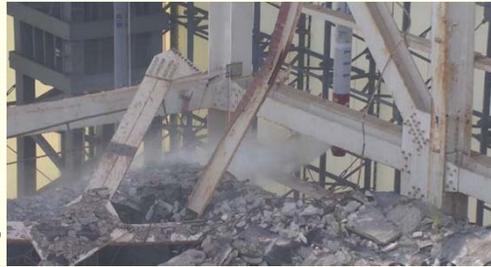
<Spraying anti-scattering agents from sides>

Prior to the dismantlement of wall panels, sprinklers were installed in the event of dust scattering and small rubble on the upper part of the fallen roof was sucked up. In addition, anti-scattering agents have also been sprayed from all sides onto the rubble under the fallen roof.

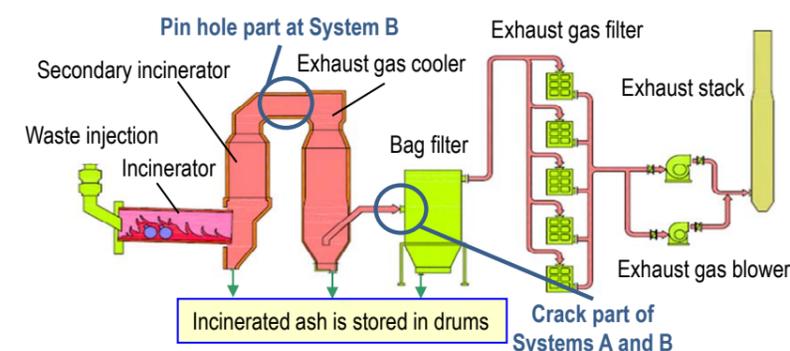
Figure 4: Overview of Radioactive Waste Incinerator

On August 10, traces of water drippage were detected at the Radioactive Waste Incinerator System B^(Note) during operation. An investigation identified pin holes at the bellows and the operation was suspended. As investigations into other bellows identified cracks at Systems A and B, the operation of System A was also suspended.

- On August 10, traces of water drippage were detected in the lower joint part between the secondary incinerator and the exhaust gas cooler of the Radioactive Waste Incinerator System B during operation. An investigation identified a pin hole at the bellows and the operation was suspended. As investigations on other bellows identified cracks at the joint bellows between the waste gas coolers and bag filters of Systems A and B, the operation of System A was also suspended (see Figure 4).

- Though the cause is being investigated, the pin hole is considered attributable to pitting corrosion and cracks are considered attributable to underestimated displacement due to heat. Investigations into the cause continue and countermeasures will be examined.

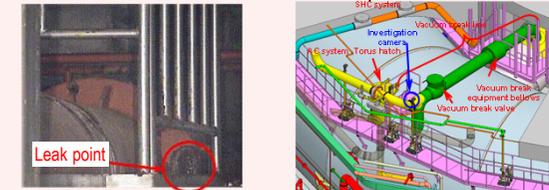
Leak point Image of the S/C upper part investigation

Investigation in the leak point detected in the upper part of Unit 1 S/C from May 27, 2014 from one expansion joint cover among the lines installed there. As no leakage was identified from other parts, specific methods will be examined to halt the flow of water and repair the PCV.

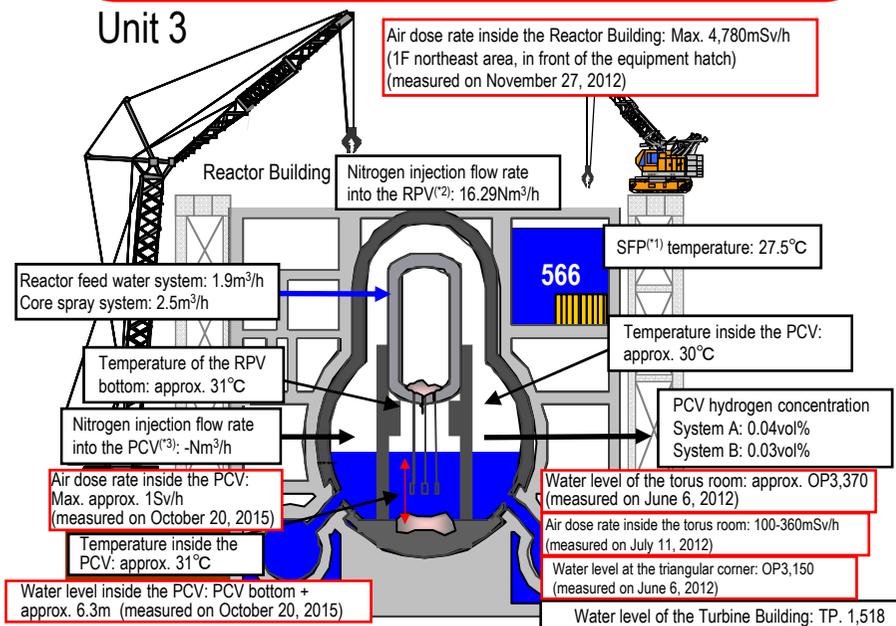
From April 23, 2014, image data has been acquired by camera and the radiation dose measured via pipes for measurement instrumentation, which connect the air-conditioning room on the Reactor Building 2nd floor with the Main Steam Isolation Valve Room on the 1st floor. On May 15, 2014, water flow from the expansion joint of one Main Steam Line was detected.

This is the first leak from PCV detected in the Unit 3. Based on the images collected in this investigation, the leak volume will be estimated and the need for additional investigations will be examined. The investigative results will also be utilized to examine water stoppage and PCV repair methods.
