# Current Situation of Fukushima-Daiichi Nuclear Power Plants and Difficulties in the Defueling Plan

International Experts' Symposium on the Decommissioning of TEPCO's Fukushima Daiichi Nuclear Power Plant Unit 1-4

March 14, 2012 Tokyo, Japan

**Tokyo Electric Power Company**

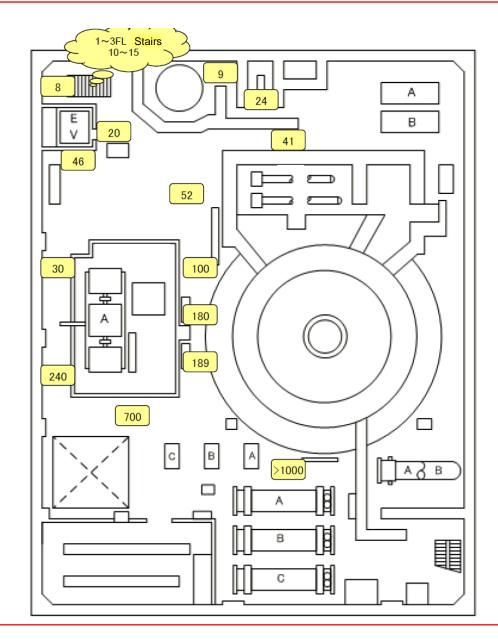
#### Dose Rate Map of Inside of R/B (2nd Floor of Unit 1)

Monitored from Apr. to Nov. 2011

Aisles: ~200 mSv/hr

Highest: >1000 mSv/hr

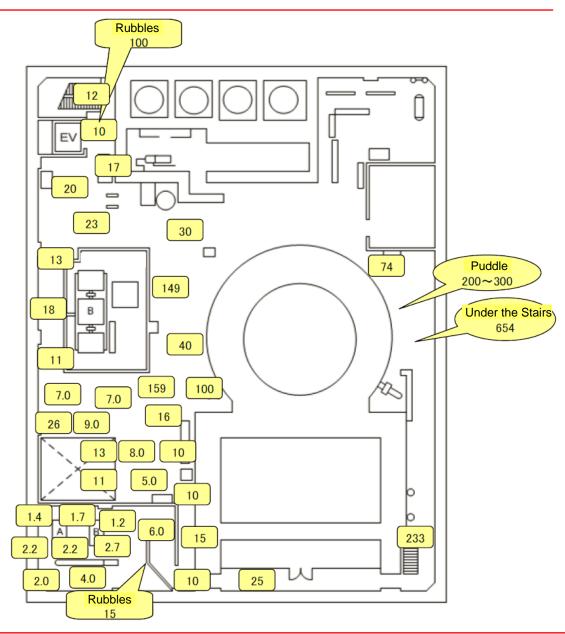
#### Dose Rate Map of Inside of R/B (3rd Floor of Unit 1)

Monitored from Apr. to Nov. 2011

- Aisles: ~150 mSv/hr
- Water on the Floor:
  ~650 mSv/hr

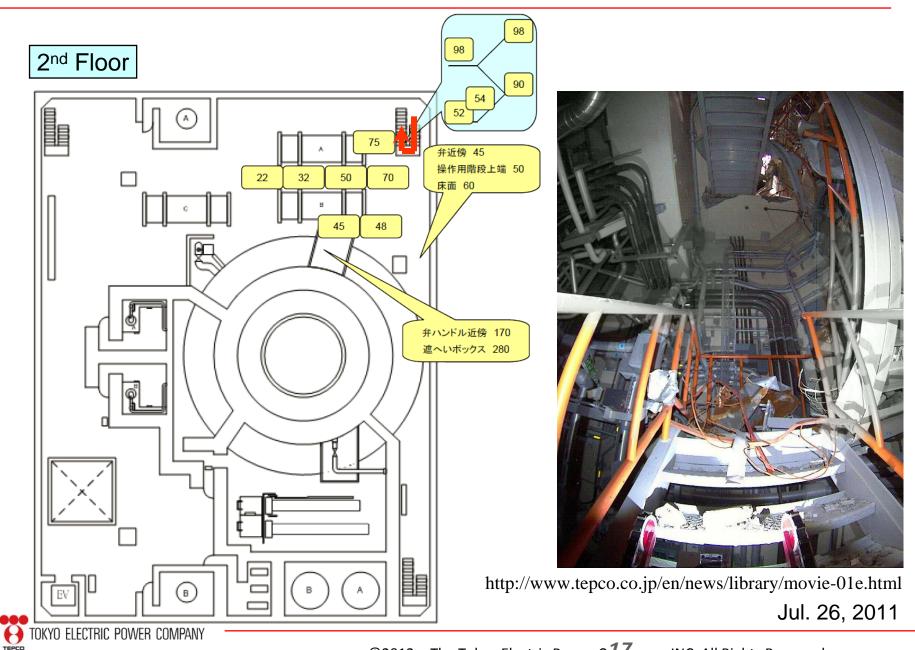
#### [Movie taken by Quince] Obstacles on the stairs (Unit 3)

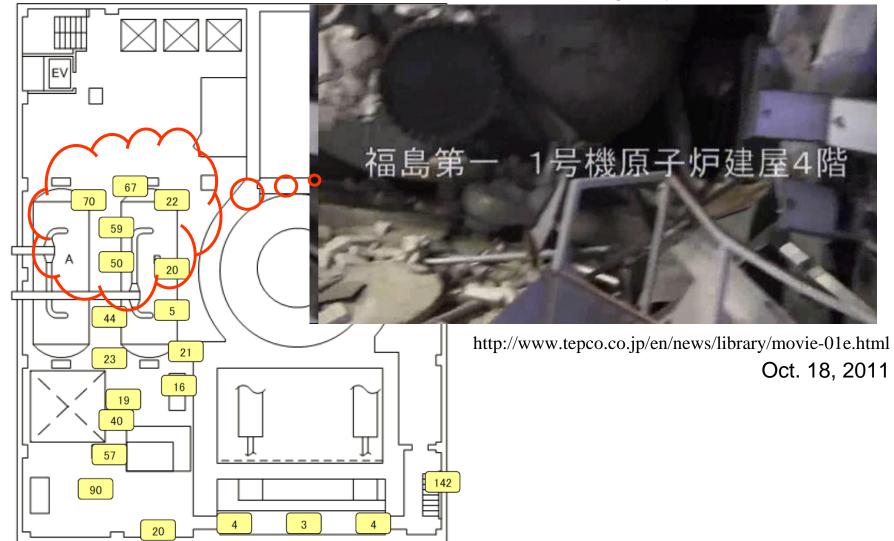
#### [Movie] Rubbles on 4<sup>th</sup> Floor (Unit 1)

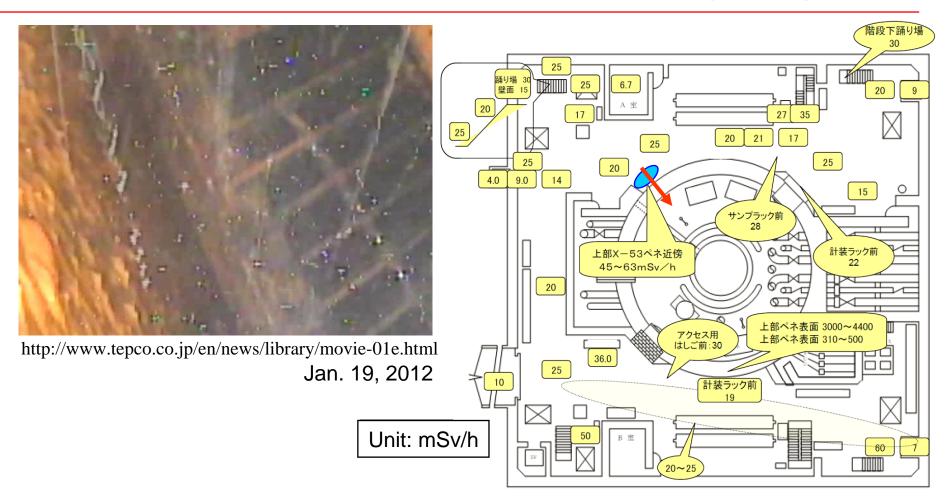
#### [Movie] Inside of Pressure Containment Vessel (Unit 2)

- Primary objective (temperature measurement) was achieved successfully
- Water level was not confirmed within the reach of the fiber camera
