Assumed cause

# Tentative planned countermeasure construction

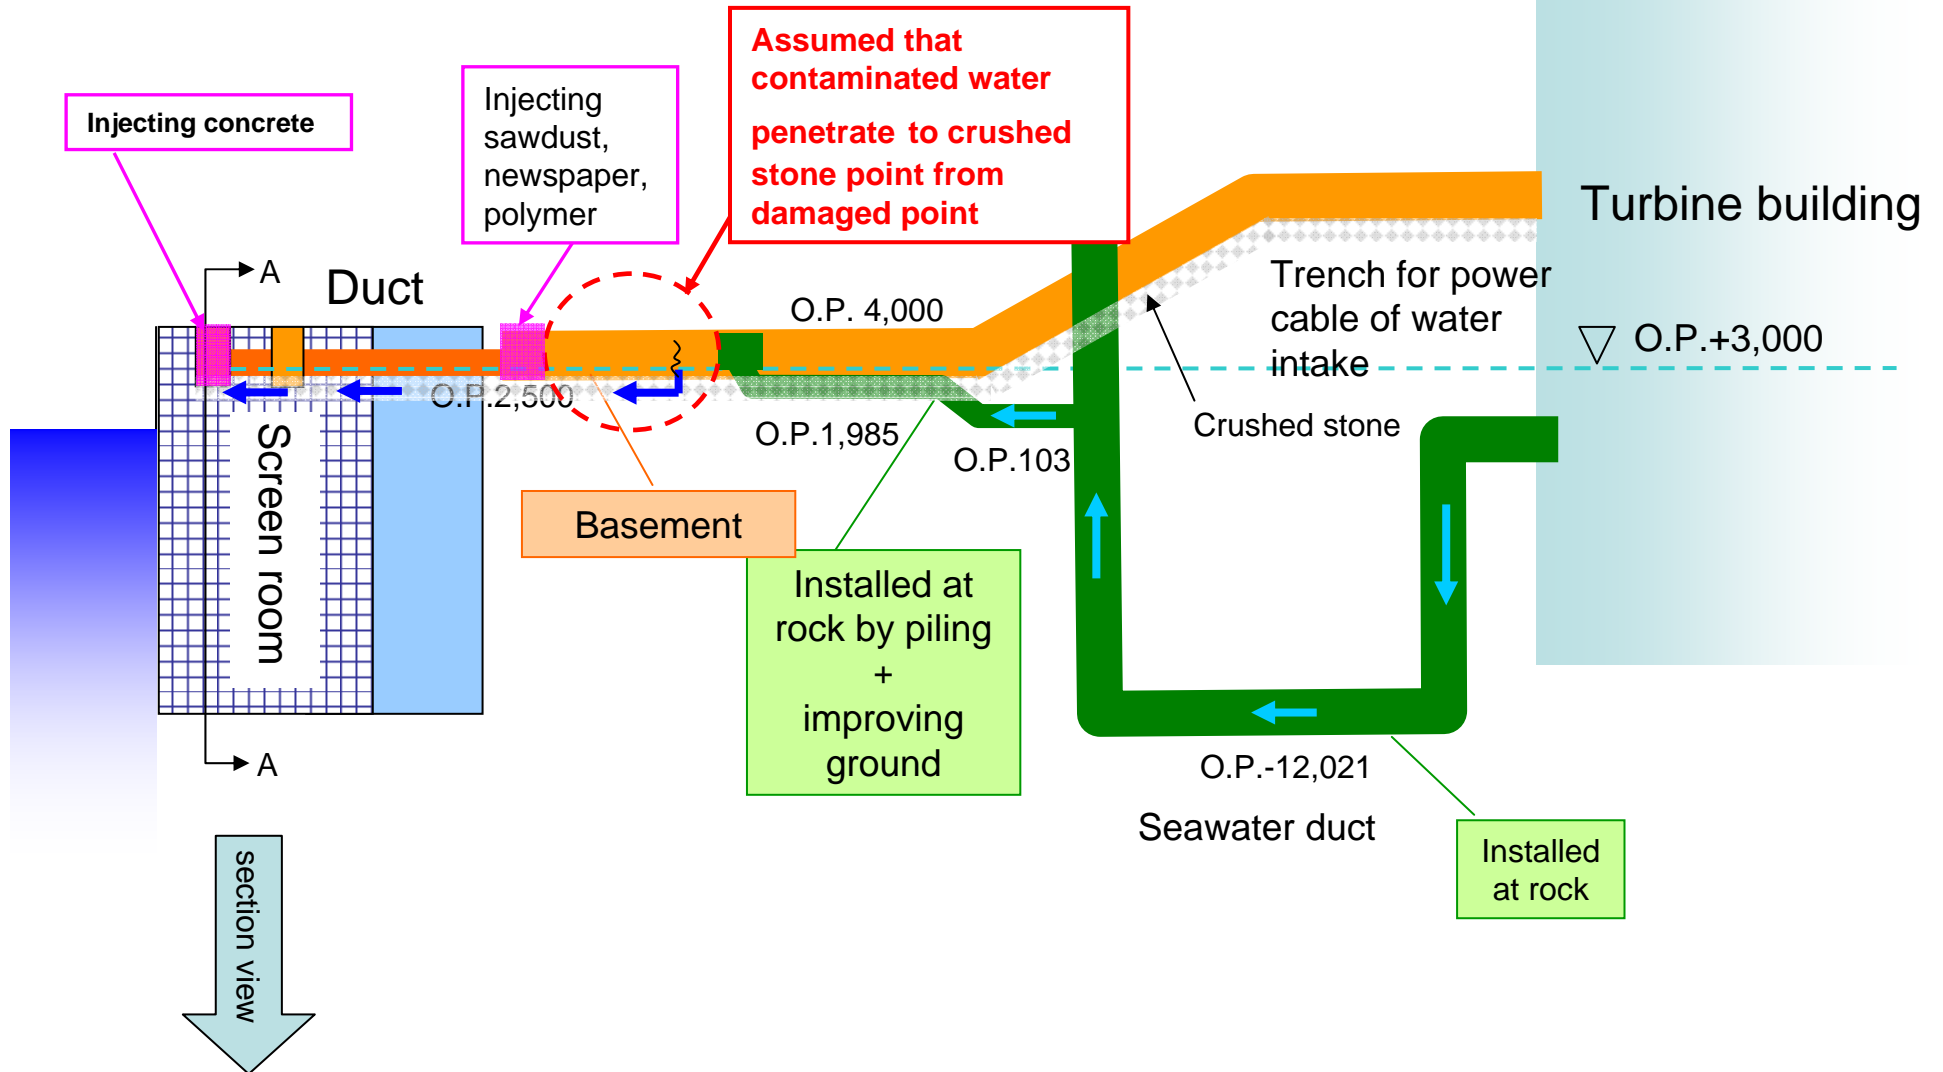
**< Assumed cause >**  
• Water flowed due to filled with water at crushed stone point installed at the bottom of trench
