**1. Core Damage Ratio of Unit 1 of Fukushima Daiichi Nuclear Power**

Reference 2

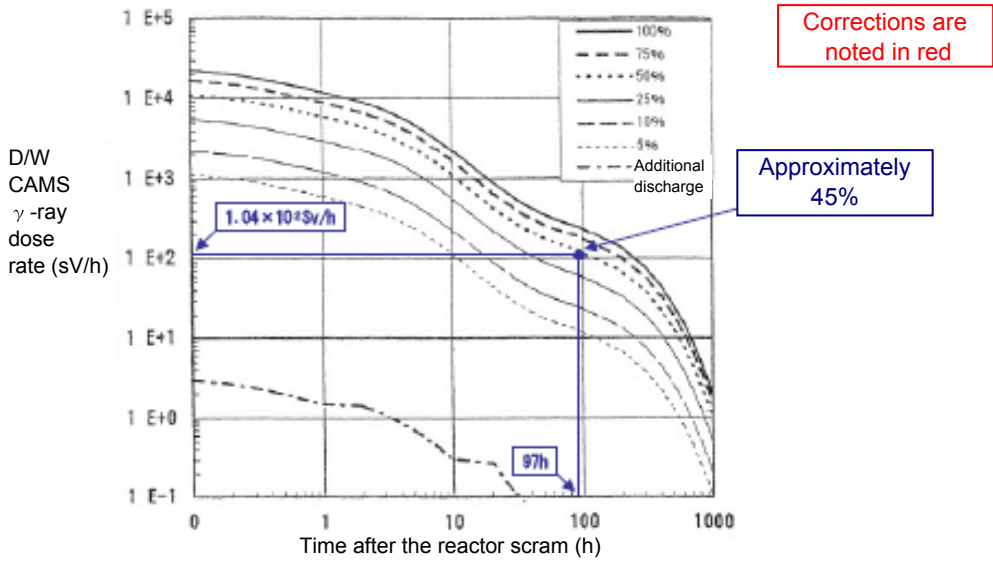
Figure 1-1 Behavior of the  $\gamma$ -ray dose rate in dry well area of Unit 1

Before Correction: Approx. 45% + Approx. 25% = Approx. 70%  
 After Correction : Approx. 45% + **Approx. 10%** = **Approx. 55%**

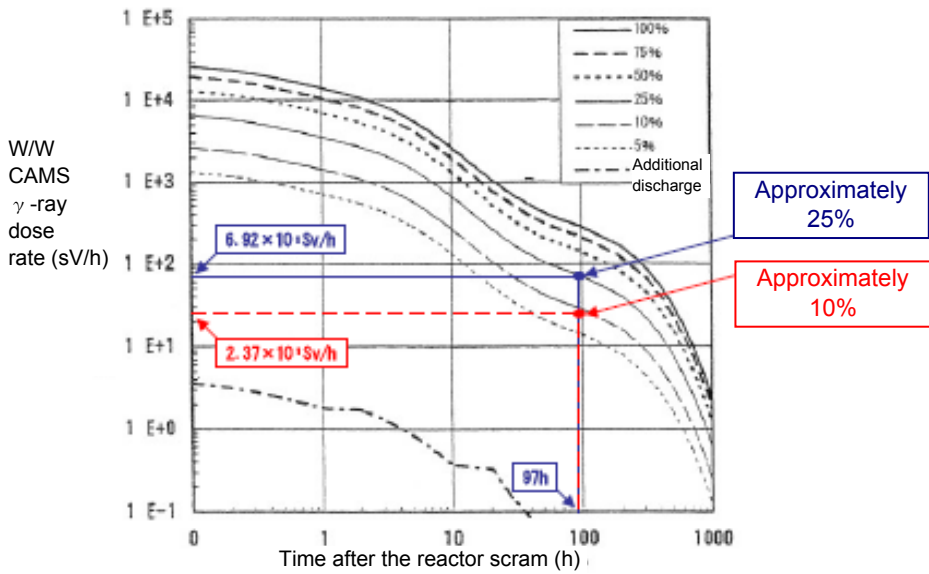
Figure 1-2 Behavior of the  $\gamma$ -ray dose rate in wet well area of Unit 1

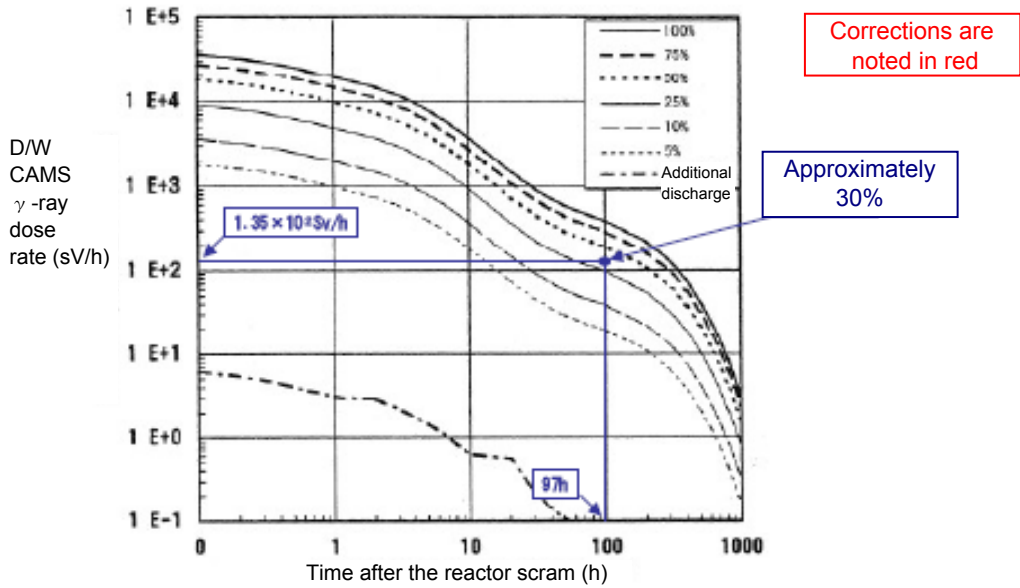
Figure 2-1 Behavior of the  $\gamma$ -ray dose rate in dry well area of Unit 2

Before Correction: Approx. 30% + Approx. 3%  $\doteq$  Approx. 30%  
 After Correction : Approx. 35% + Below 5%  $\doteq$  **Approx. 35%**

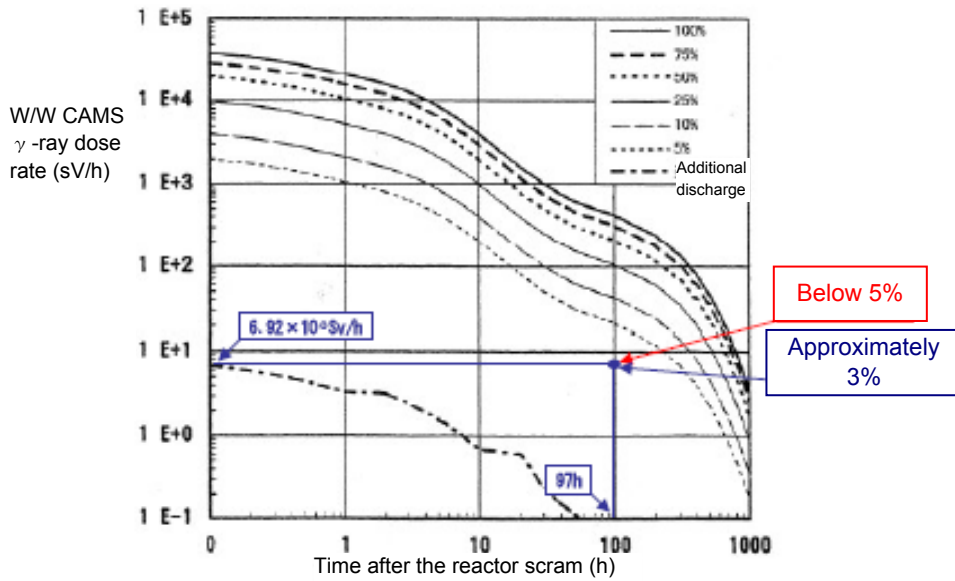
Figure 2-2 Behavior of the  $\gamma$ -ray dose rate in wet well area of Unit 2

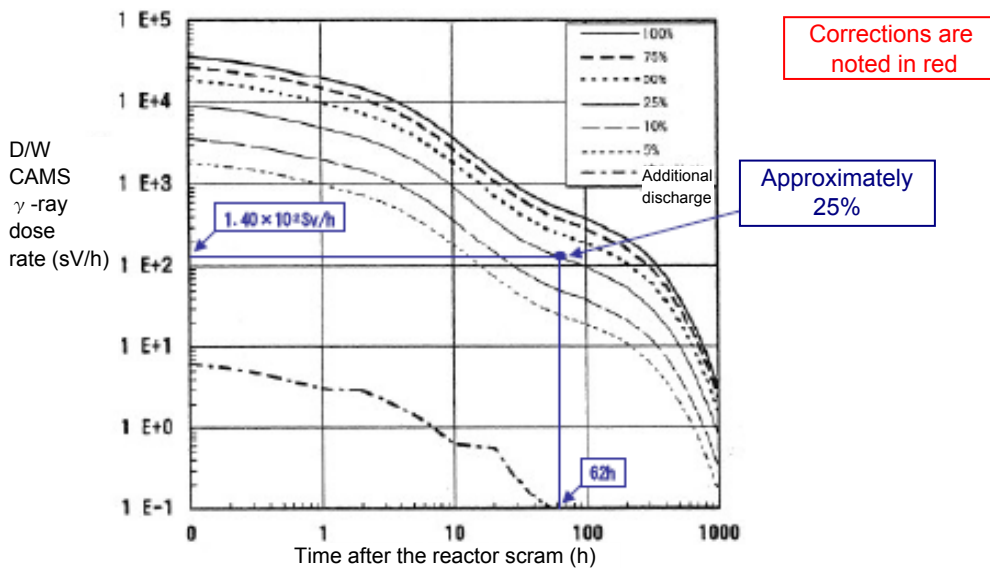
Figure 3-1 Behavior of the  $\gamma$ -ray dose rate in dry well area of Unit 3

Before Correction: Approx. 25% + 0%  $\doteq$  Approx. 25%  
 After Correction : Approx. 25% + Below 5%  $\doteq$  Approx. 30%

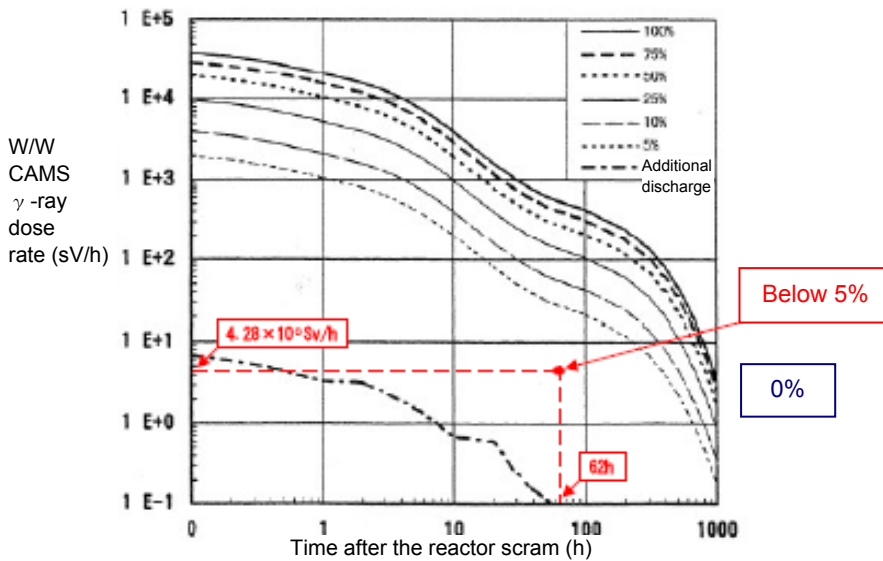
Figure 3-2 Behavior of the  $\gamma$ -ray dose rate in wet well area of Unit 3
