Report on investigation of cause and development of preventive
measures regarding exposure exceeding dose limit to radiation
dose engaged person at Fukushima Daiichi Nuclear Power Station

May 2nd, 2011

The Tokyo Electric Power Company, Incorporated

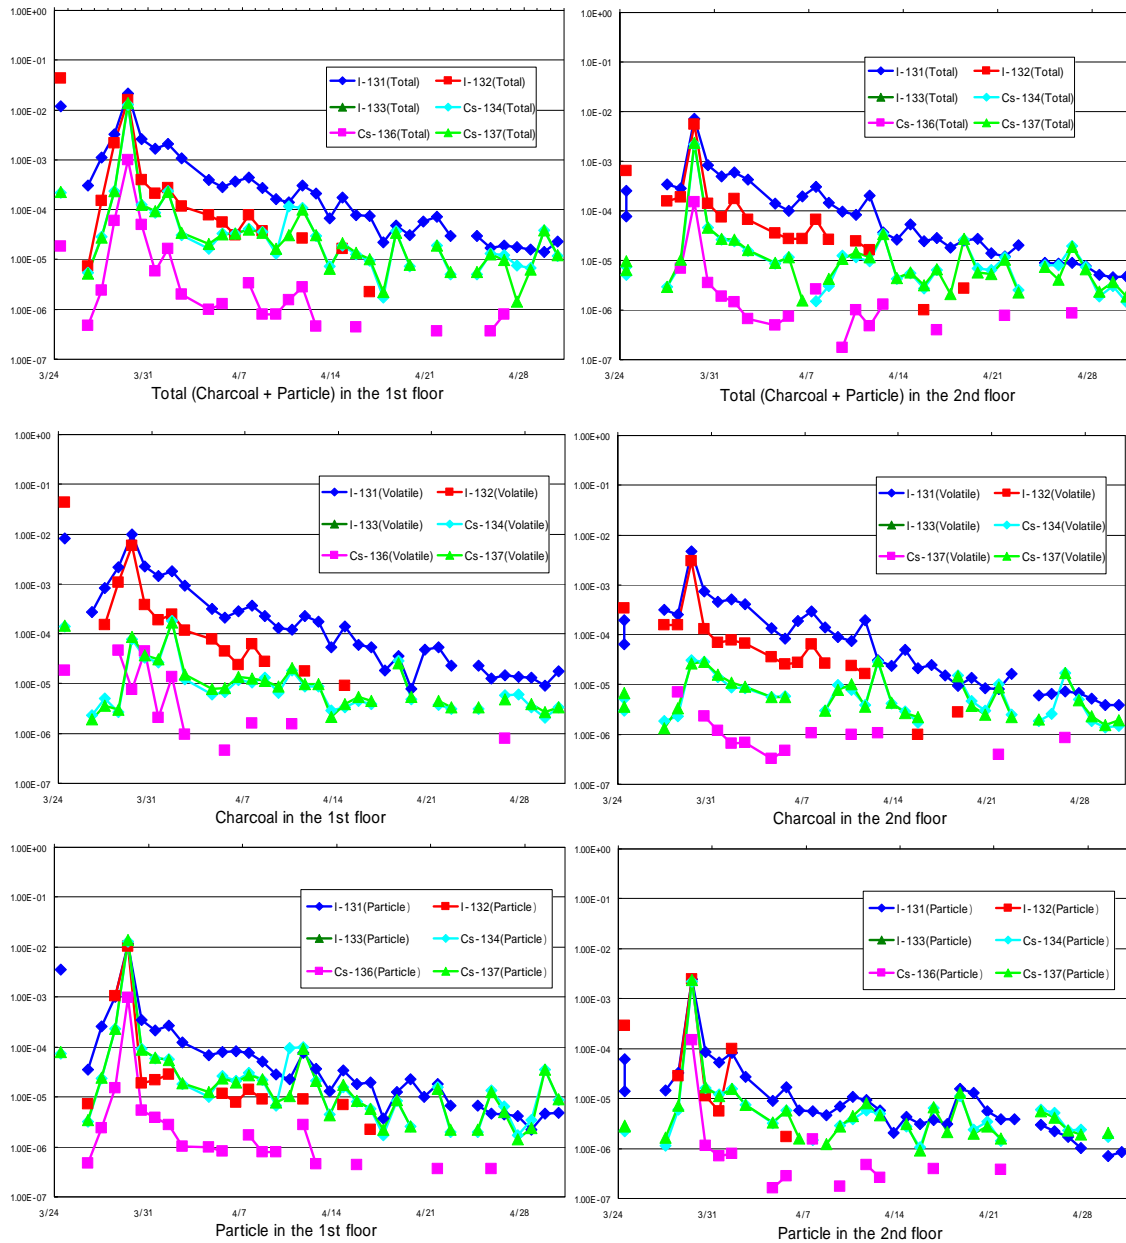
Trends in Radioactive Density in the Air in the Main Anti-Earthquake Building

The density of radioactive materials on the first floor was higher than that of the second floor in the Main Anti- Earthquake Building.

Before improvement radiation circumstance, it was likely that persons stayed in the Main Anti-Earthquake Building took in the radioactive materials to some extent as the persons worked inside the building without wearing mask.

The possible reasons for high density of radioactive materials in the Main Anti-Earthquake Building would be as follows;

- Before setting up the buffer area to block to bring radioactive materials into the Main Anti-Earthquake Building when put on and take off the protective equipment, management of in-coming and out-going didn't properly work, so that the ambient very high radioactive materials flowed into the Main Anti-Earthquake Building when opened the door and/or those were brought in with workers, machinery or materials.
- The entrance of the Main Anti-Earthquake Building was structured as double door and instructed not to open at the same time; however, the door was not airtight.
- The double doors were distorted due to the impact of hydrogen explosion of Unit 1 & 3, so that there were some gaps on the doors.

- Exhauster system with charcoal filter was installed (March 26).
- Unit house was installed in the entrance of the Main Anti-Earthquake Building and the exhauster system was introduced in the house (March 26).

- OA floor mat that radioactive substances are easy to cling to was replaced for tiles that are easy to wash. And the floor was covered by sheets (April 1 – April 8).
