Reinforcement to prevent scattering liquid containing radioactive materials

Results of survey on trenches and pits there is a risk of outflow from

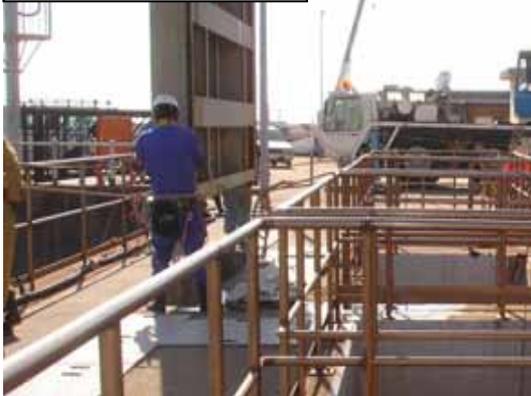
Install waterstop

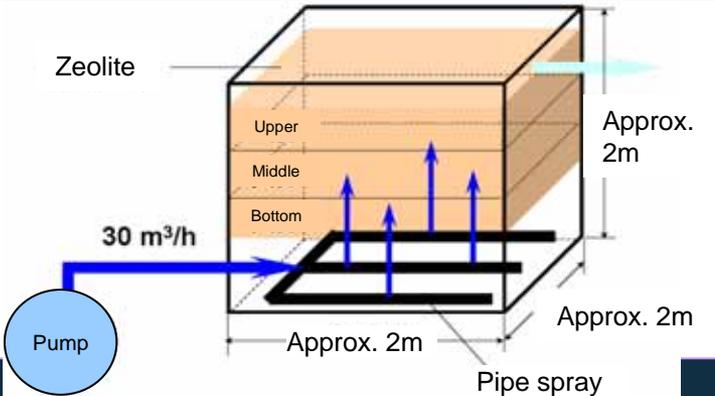
Install circular sea water purification equipment

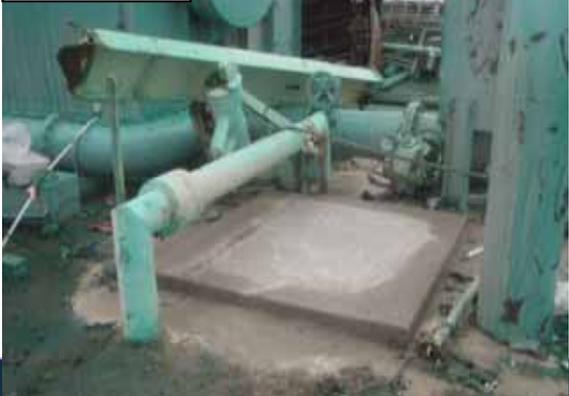
Block pits
