Outline of "Reports about the study regarding current seismic safety and reinforcement of reactor buildings at Fukushima Daiichi Nuclear Power Station (1)"

May 28, 2011
Tokyo Electric Power Company

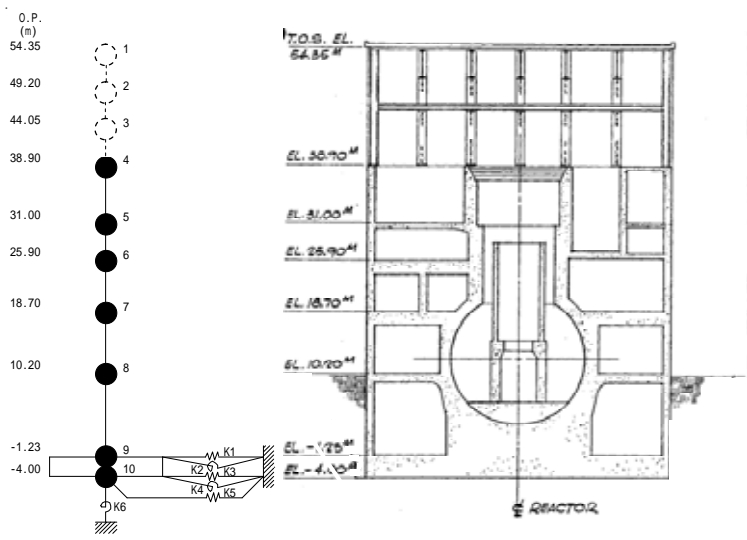
- Regarding reactor building of unit 1, the building above the operating floor on the 5th floor was destroyed by the event what is believed to be hydrogen explosion occurred on March 12, the next day of Tohoku - Pacific Ocean Earthquake. Reflecting this information to the model of mass point system, we conducted the analyses of time history response against basic earthquake ground motion "Ss", studied whether the seismic walls reach terminative condition of shear failure (Fig1).

Fig 1 Reactor Building of unit 1
Earthquake analysis earthquake response
(NS direction)

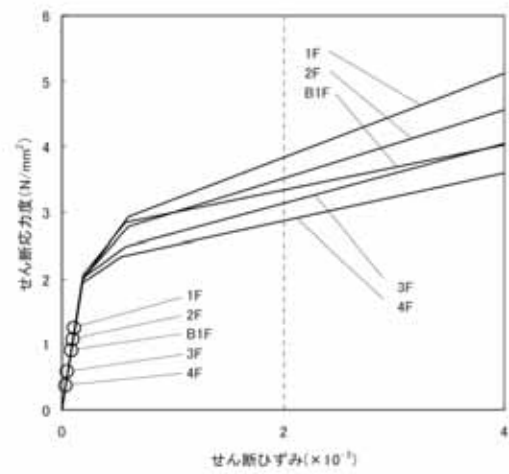
-As a result of the time history response analysis against basic earthquake ground motion, shear strain occurred on remaining seismic wall below 5th floor was estimated 0.12×10^{-3} (the direction of Ss-1 and Ss-2 on 1st floor) at maximum and the value fall much below 4×10^{-3} . Therefore we evaluated that it has adequate security (Fig2).

Fig 2 Maximum response values on the shear skeleton curve
(Unit1, Ss-1, NS direction)

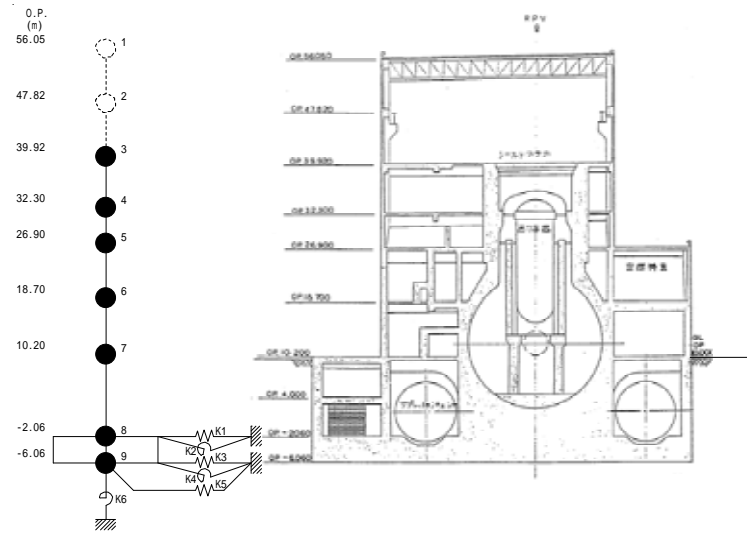
-Regarding reactor building of Unit 4, although the cause has not been identified, it is confirmed that remaining frame construction of posts and beams above 5th floor, but most of the roof slabs and walls were lost and most of the walls on 4th floor and a part of walls on 3rd floor have been destroyed on March 15. Unlike the case of Unit 1, the walls below 5th floor of Unit 4 has been also destroyed, we

reflected this information to mass point system model and decided to evaluate totally whether the seismic wall reach terminative condition of shear failure(Fig3). Then, we decided to implement local evaluation including spent fuel pool by 3 dimension FEM analysis, and decided to implement the evaluation of combined the input maximum value which has been got from the analysis of time historical response as an earthquake load and other load such as temperature load.

Fig 3 Reactor Building of Unit 4
Earthquake response analysis model
(EW direction)

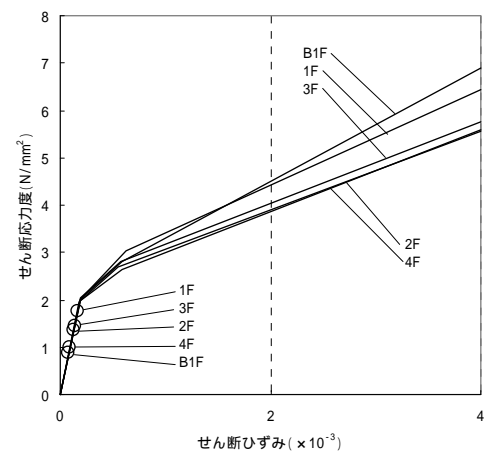
-Intended to the mass point system, as a result of the time history response analysis against basic earthquake ground motion, shear strain occurred on remaining seismic wall below 5th floor was estimated 0.17×10^{-3} (Ss-1 and Ss-2, EW direction, 1st floor) at maximum and the value fall much below 4×10^{-3} which is the standard value. Therefore we evaluate it has adequate security (Fig4).

Fig 4 Maximum response values on the shear skeleton curve
(Unit 4, Ss-1 EW direction)

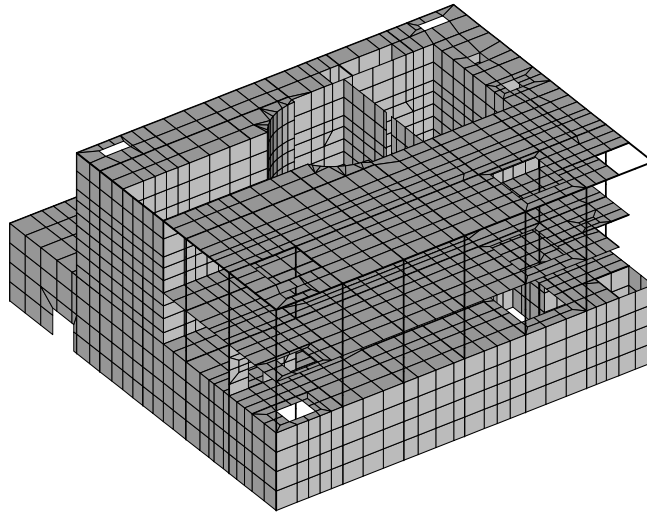
-As a result of seismic safety evaluation by 3 dimension FEM analysis (Fig5), combining with earthquake load occurred by basic earthquake ground motion Ss and other load, the maximum strain of rebar is 1230×10^{-6} , therefore we evaluate it has an adequate margin against 5000×10^{-6} the plastic limit strain which is the standard value. And regarding out-of-plane shear force at the minimum part was 800(N/mm) against 1150(N/mm) which is the standard value, therefore we estimate it has the adequate safety.

Fig 5 Local evaluation model by 3 dimension FEM
(Unit 4)
