Plan to prevent water leakage containing highly concentrated radioactive materials to
outside environment in Fukushima Daiichi nuclear power plant

June 1, 2011

Tokyo Electric Power Company

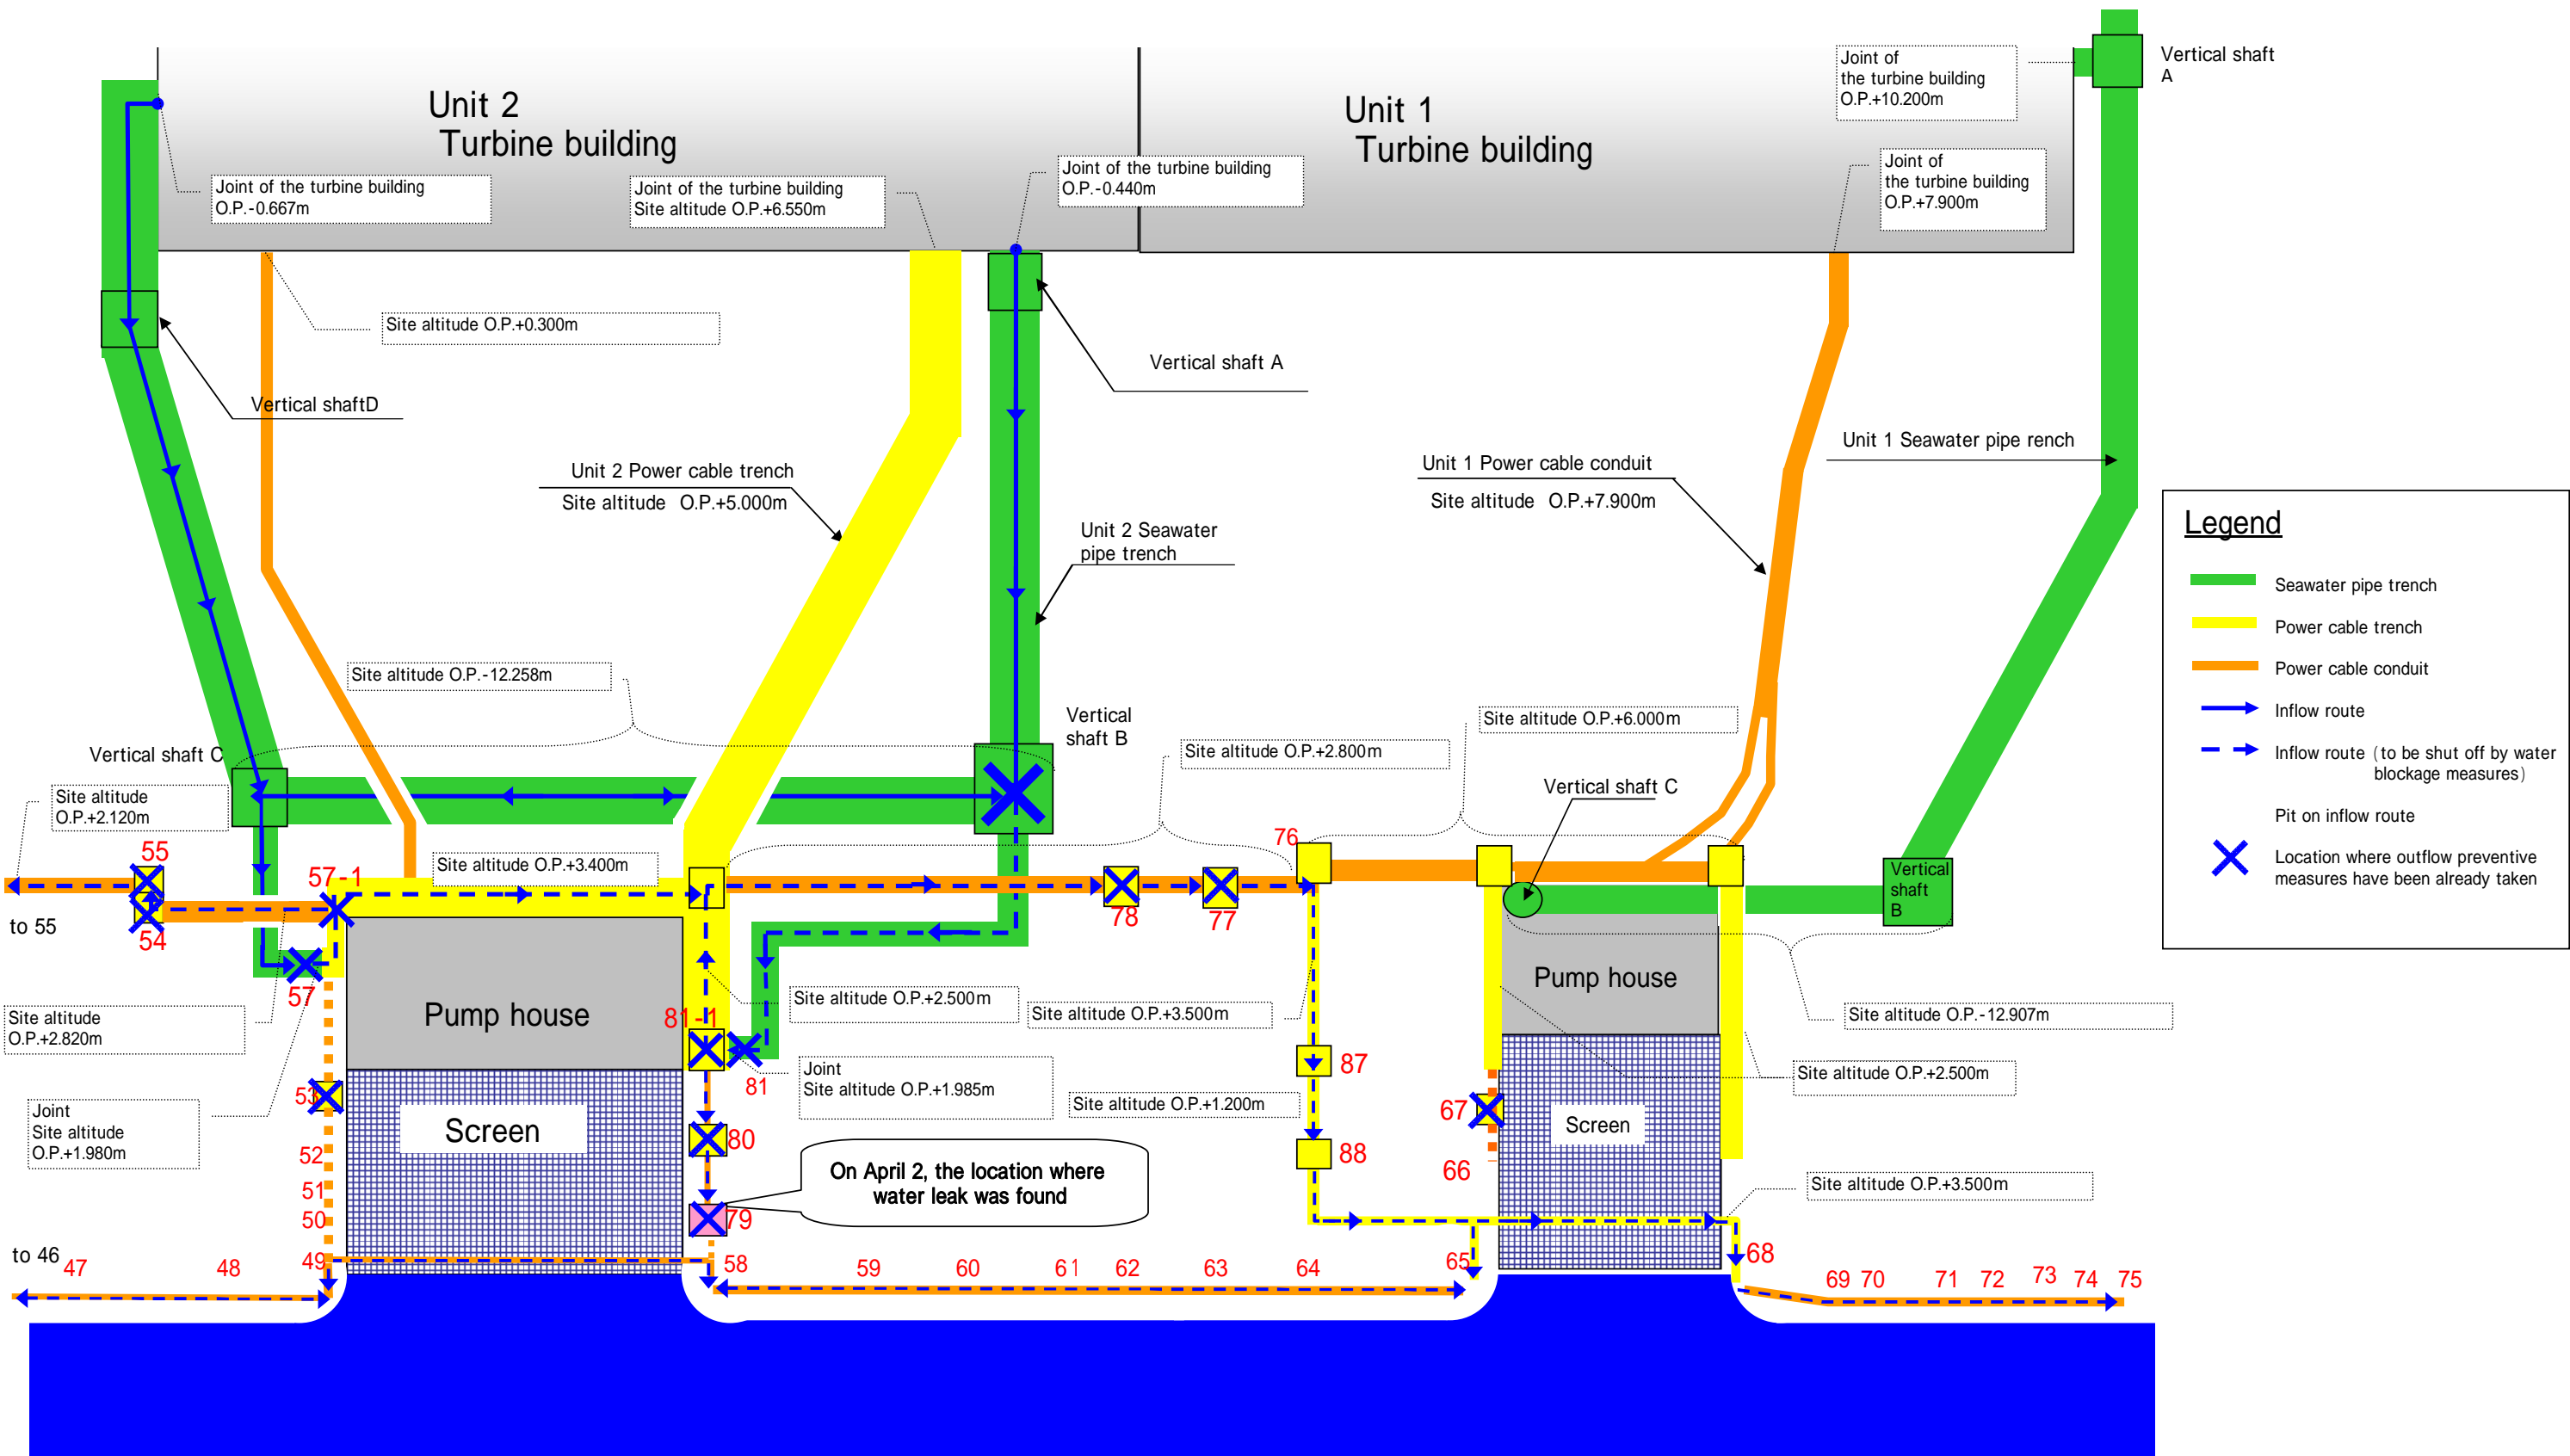
Map of Survey Result of Inflow Route of Radioactive Water (Unit 1 and 2)

As leakage routes in the yard on seaside at the height of O.P. + 4.0 m, the route from seawater pipe trench to power line conduit through power cable trench was specified. The feasibility of closing such route was also confirmed by site survey (appendix 9: Map of survey result of inflow route of radioactive water).

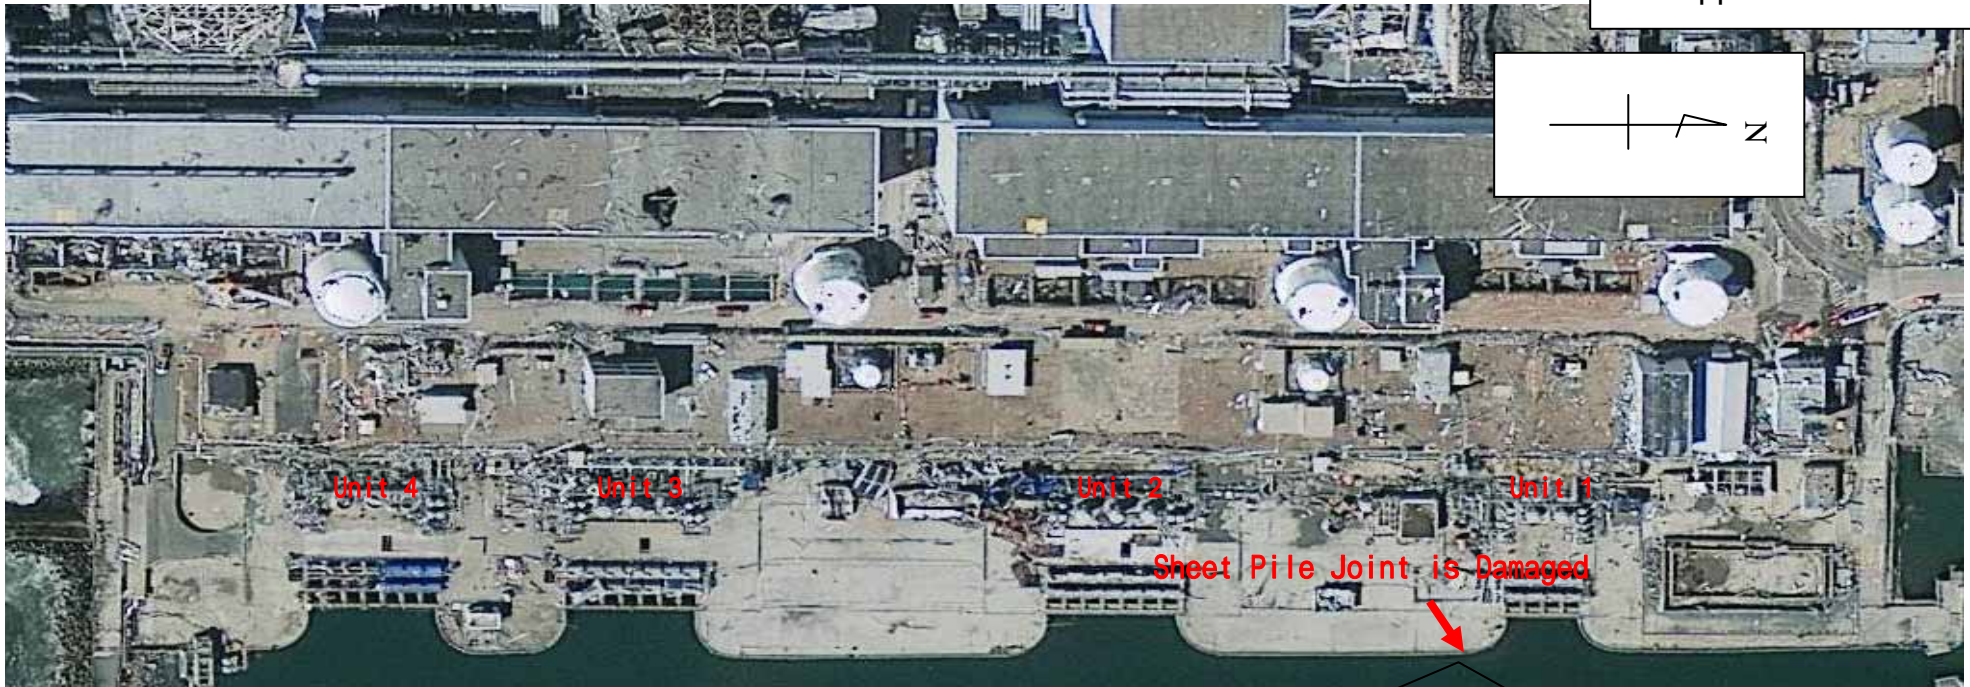
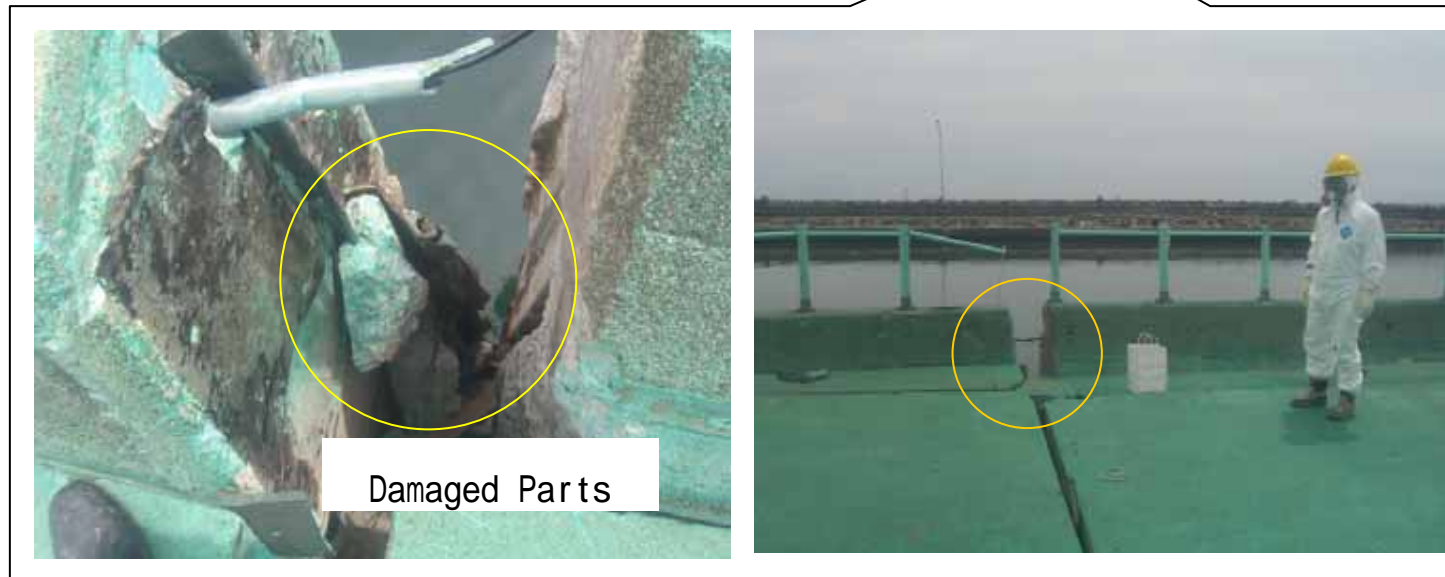
Shore protection Survey Result

A connecting part of steel sheet pile at the south side of Unit 1 screen room was found to be damaged (appendix 11: Protected shore survey result). This damage is considered to be caused by the transformation of connecting part due to the earthquake. While the damaged part locates above the seawater level, water leakage from that part is not found at the moment. It locates near the corner of Unit 1 screen room. No trace of contaminated water was found as no trenches nearby had inflow of contaminated water and radiation dose in the closest pit was low.

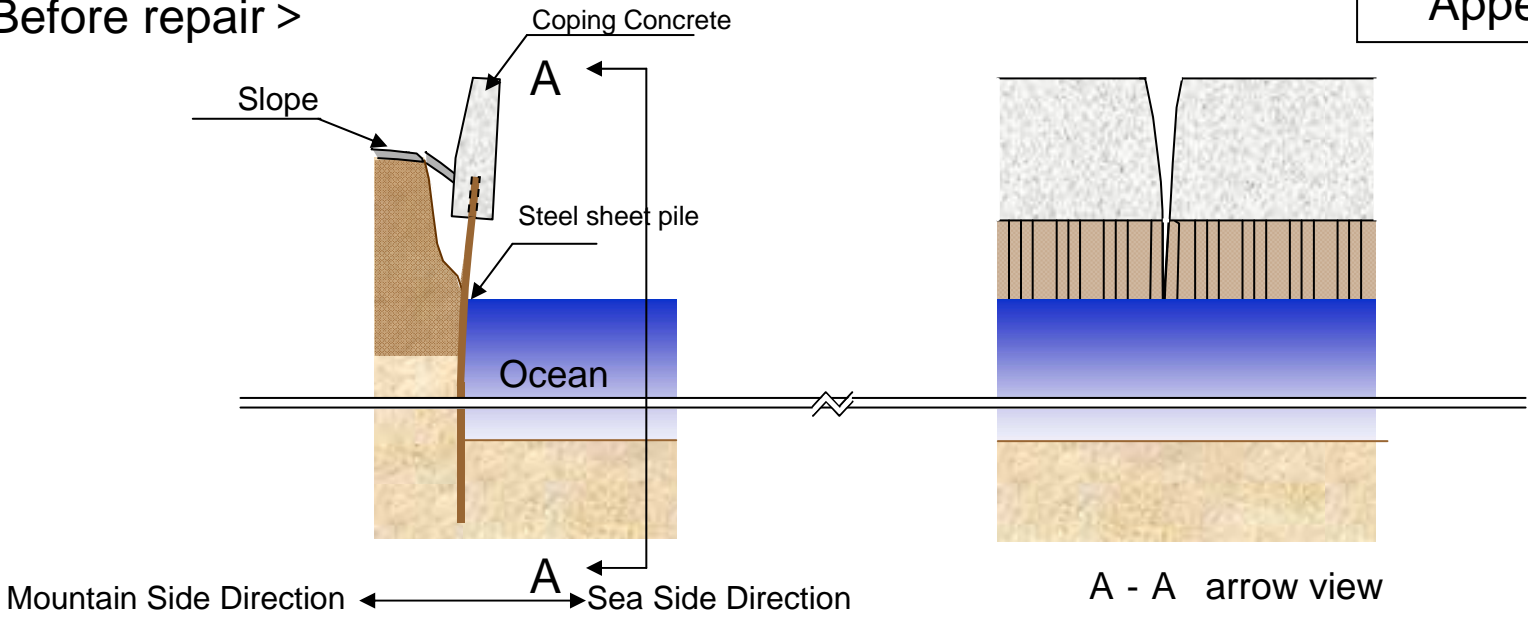
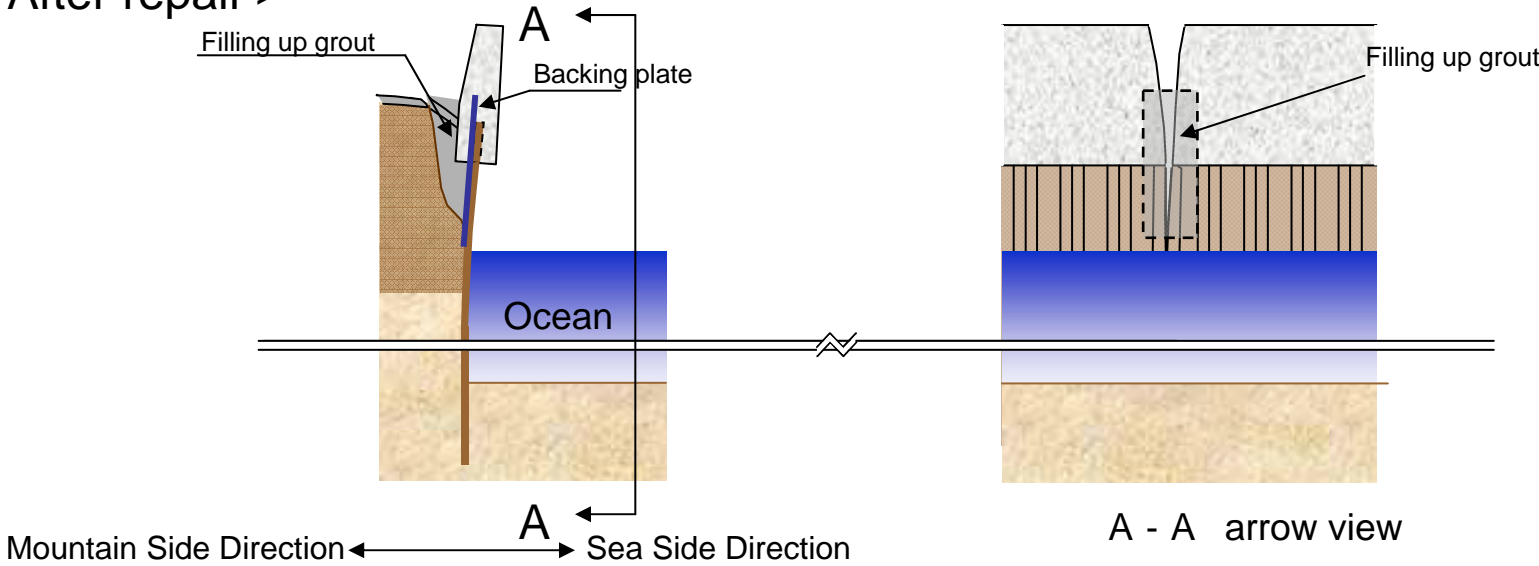
Image of repair of damaged shore protection

The survey described above found that a connecting part of steel sheet pile at the south side of Unit 1 screen room was damaged. However, it is unlikely that contaminated water flows into the sea through this damaged part as there is no trench nearby and other trenches with

potential contaminated water inflow will be closed at the upstream. To make sure, damaged part will be closed using grout materials (appendix 17: Image of repair of damaged shore protection).

Damaged parts will be closed using grout materials by the middle of June.
