**Report on investigation results regarding tsunami generated by the Tohoku - Taiheiyou - Oki - Earthquake in Fukushima Daiichi and Daini Nuclear Power Stations (vol.2) [outline]**

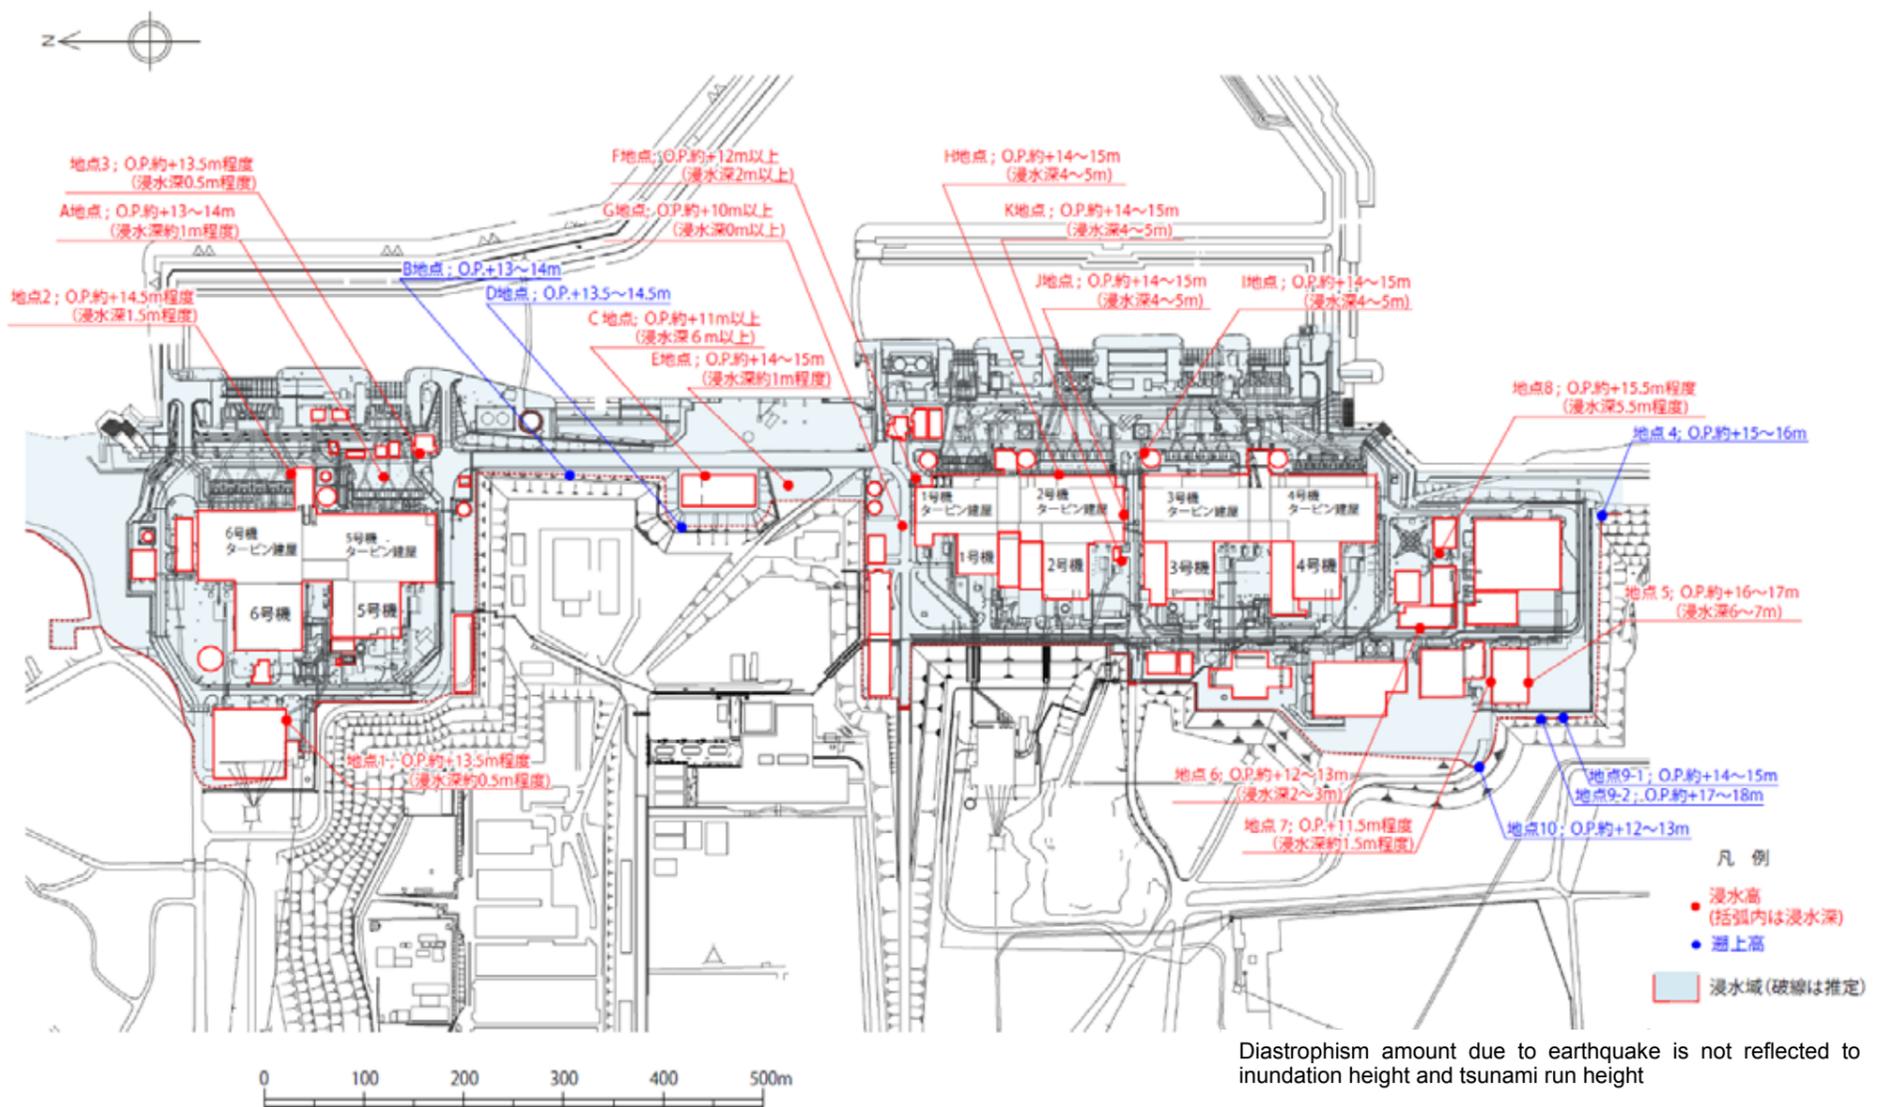
Figure 2 ( 1 ) Investigation result of tsunami at Fukushima Daiichi(Inundation height, Inundation depth and inundated area )

Inundation height

- Areas where main building are located (Units 1 to 4, Site height O.P.+10m)

O.P. approx.+11.5-approx.+15.5 m\* (inundation depth approx. +1.5-approx.5.5m)

\* O.P.approx.16-approx.17m (inundation depth approx.6-approx.7m)

- Areas where main building are located (Units 5 and 6, Site height O.P.+13m)

O.P. approx.+13-approx.+14.5 m (inundation depth equal to or blow approx.

Inundated area Almost all areas at seaside area and main building area

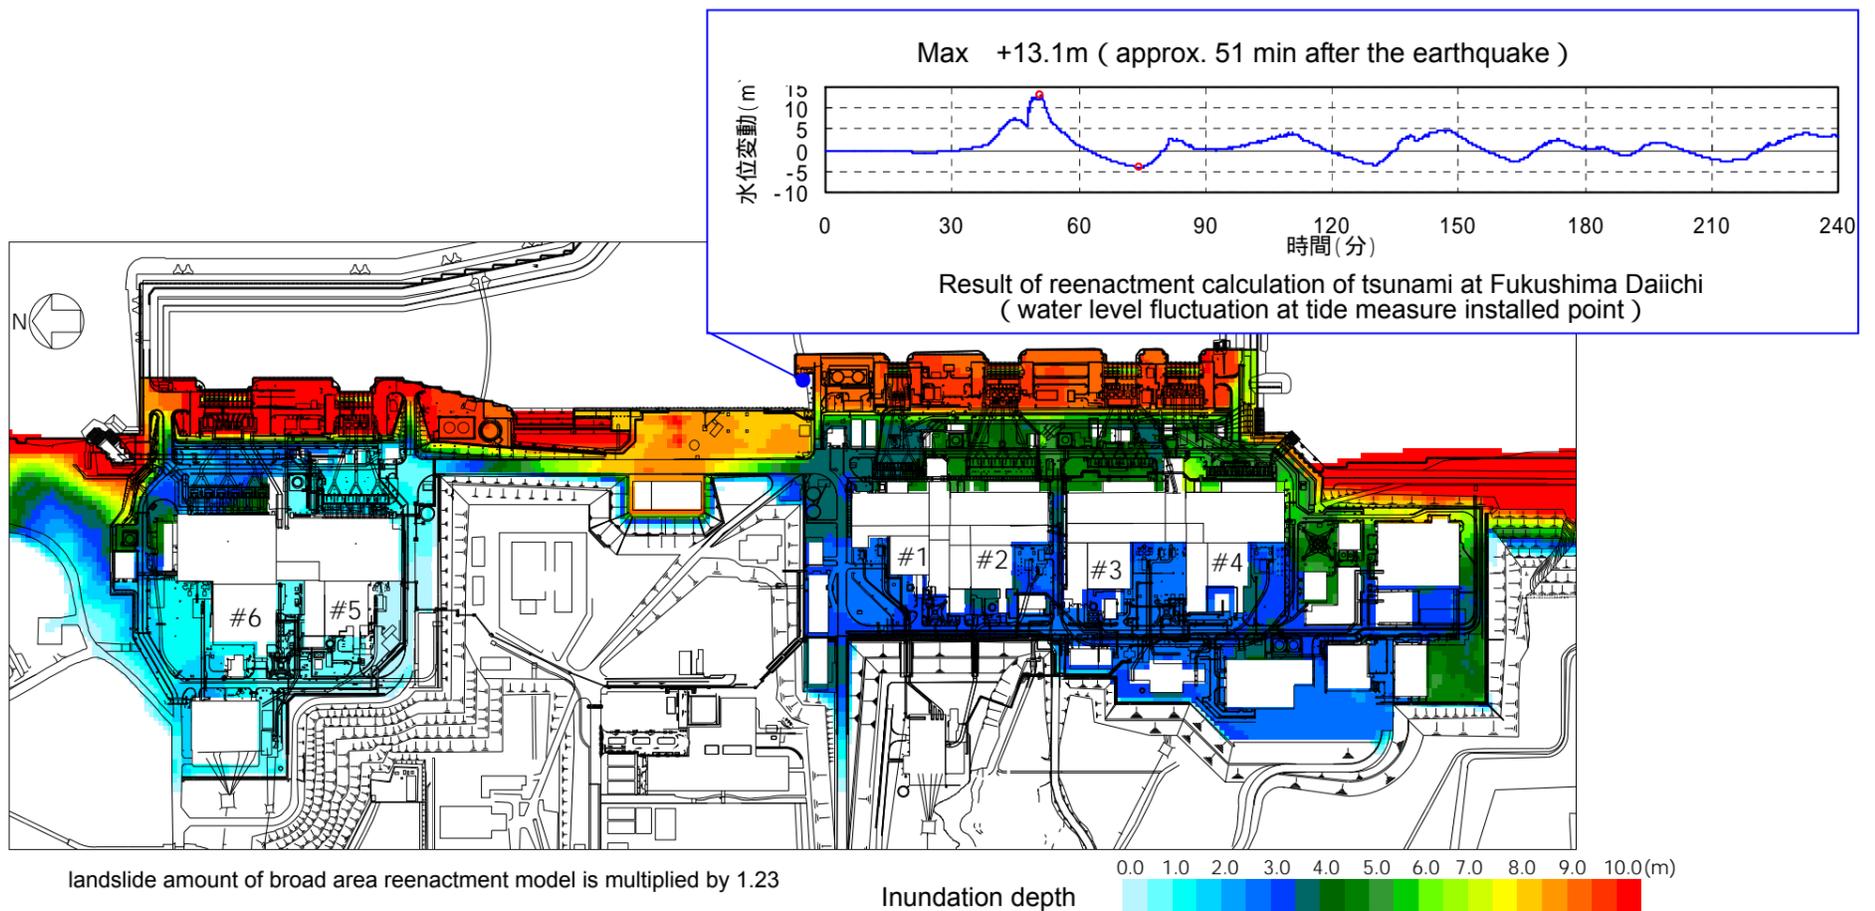
Figure 2 ( 2 ) Reenactment calculation result of Fukushima Daiichi tsunami ( Inundation depth and inundated area )

As a result of reenactment calculation, inundation height and inundated areas at both stations reenacted well.

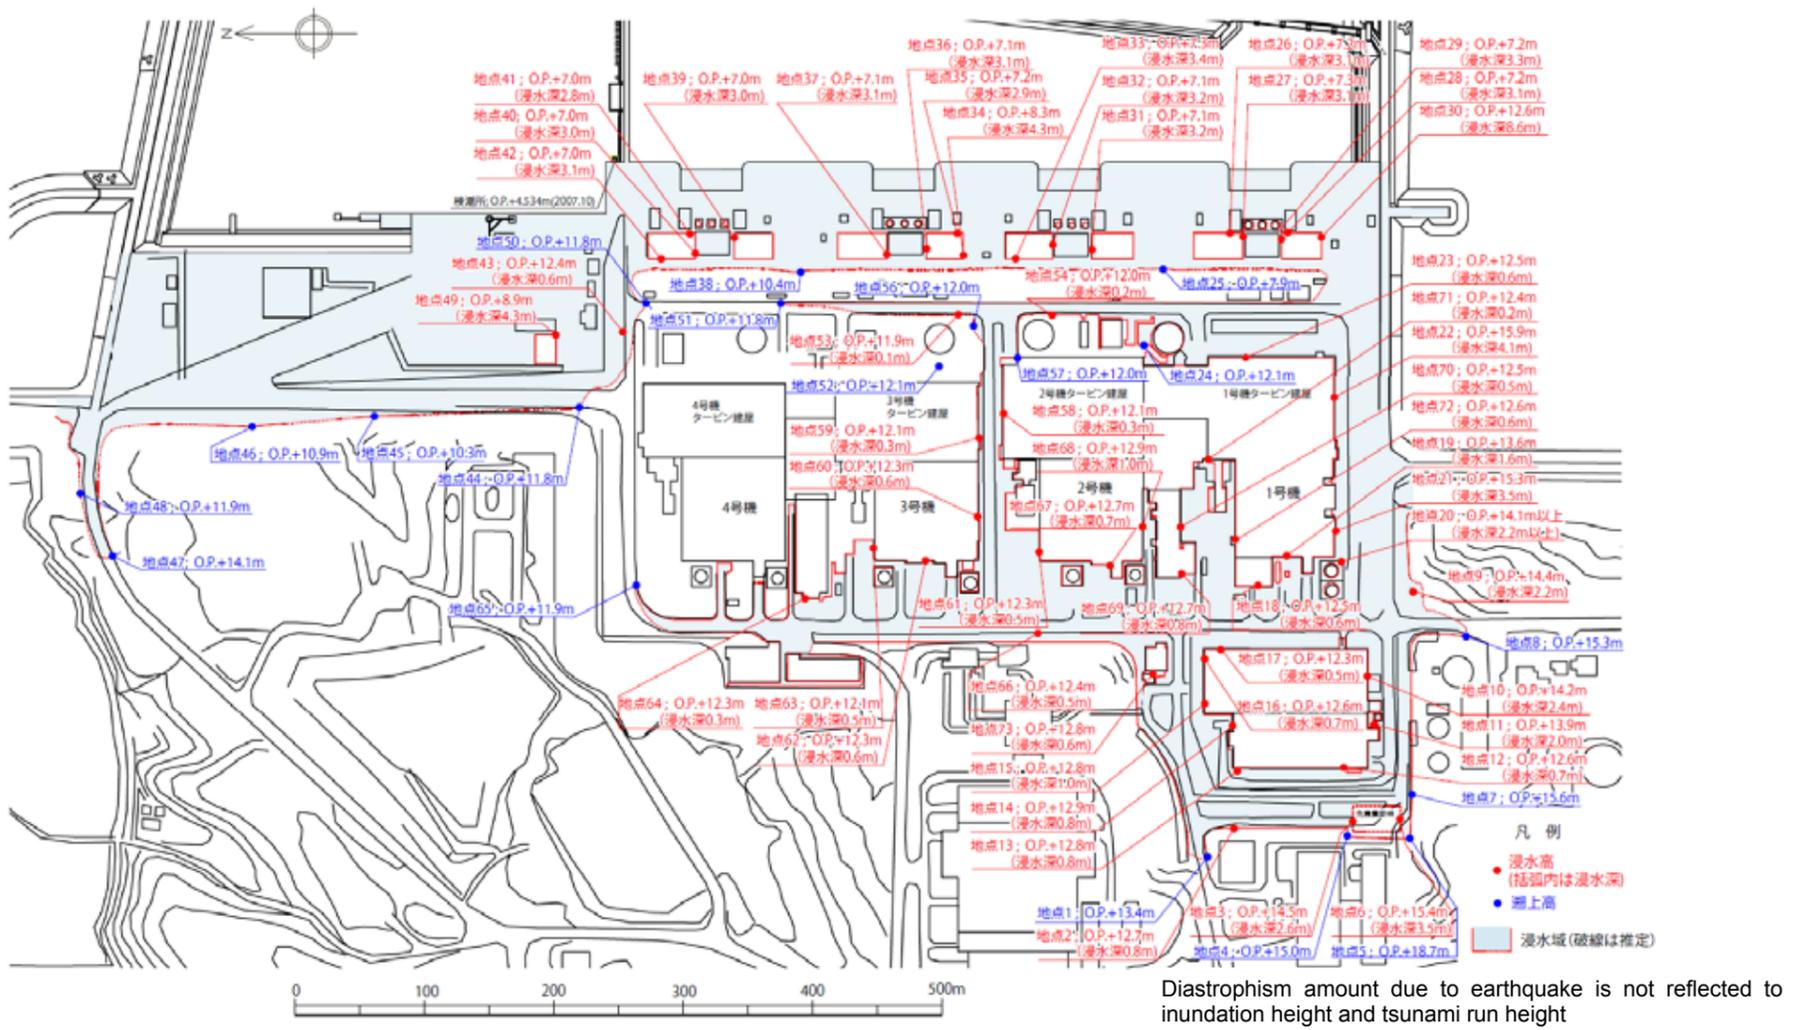
Figure 3 ( 1 ) Investigation result of tsunami at Fukushima Daini(Inundation height, Inundation depth and inundated area )

Sea side area ( site height O.P. + 4m )

• O.P. approx. + 7m ( inundation depth approx. 3m ) : There were limited areas of high area at Unit 1 heat exchanger building south side south surface, etc

Areas where main building are located ( site height O.P. + 12m )

• O.P.approx. + 12 ~ approx. + 14.5m ( inundation depth approx. under 2.5m )

: Between Unit 1 south of building to Main Anti-Earthquake Building, there were limited areas of O.P. approx. + 15 ~ approx. + 16m ( inundation depth approx.3 ~ approx.4m )

all areas of seaside, however there are no evidence at main building area

Flood was concentrated at the road from south east of main building area to Main anti earthquake building, and areas around Unit 1/2, and south of Unit 3 building was flooded (No inundation at Unit 4)

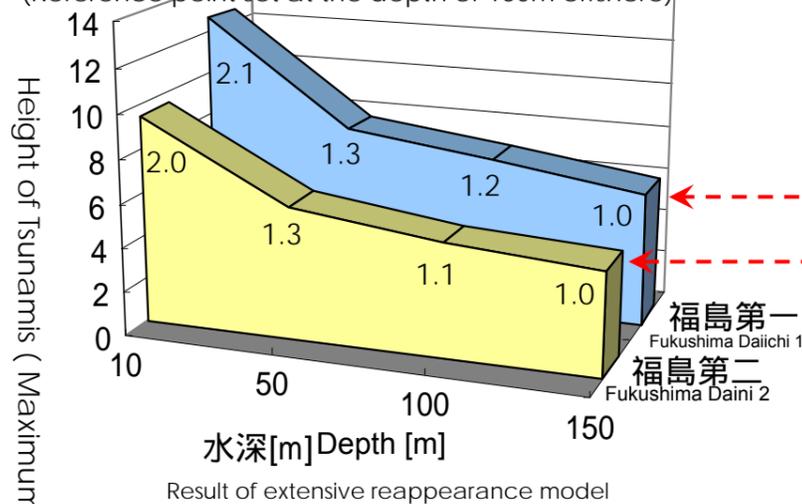
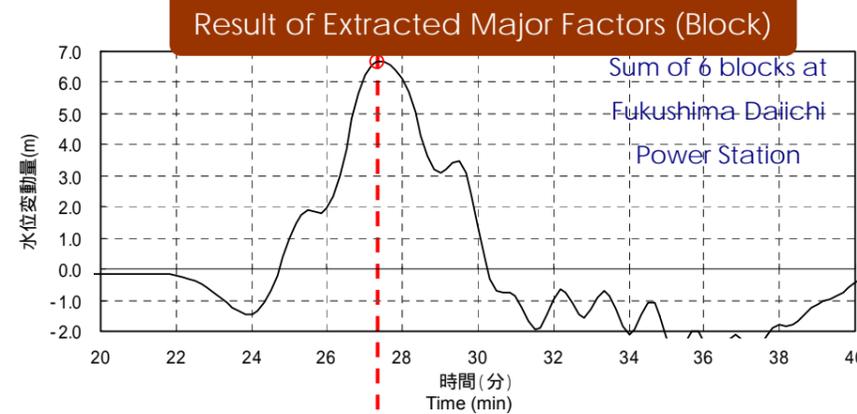
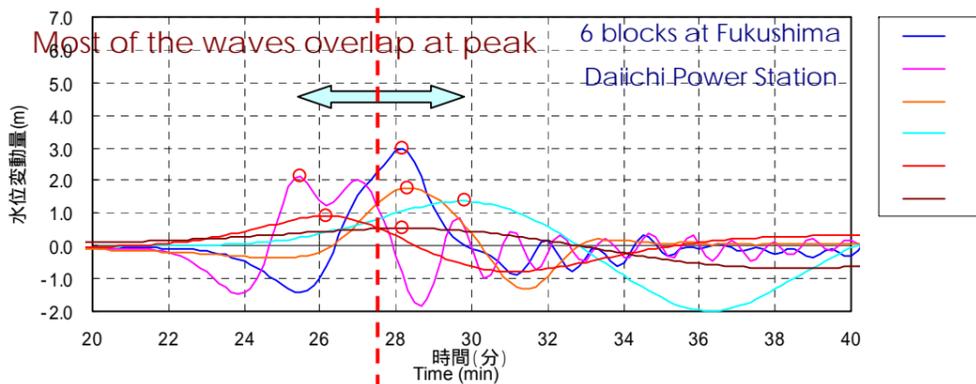
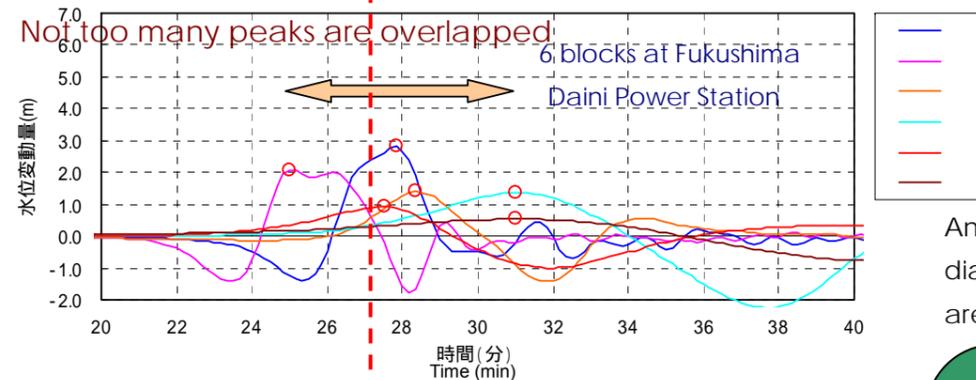
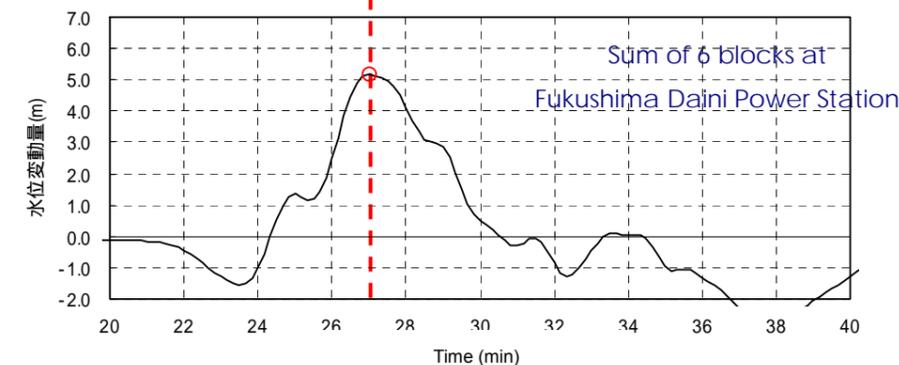
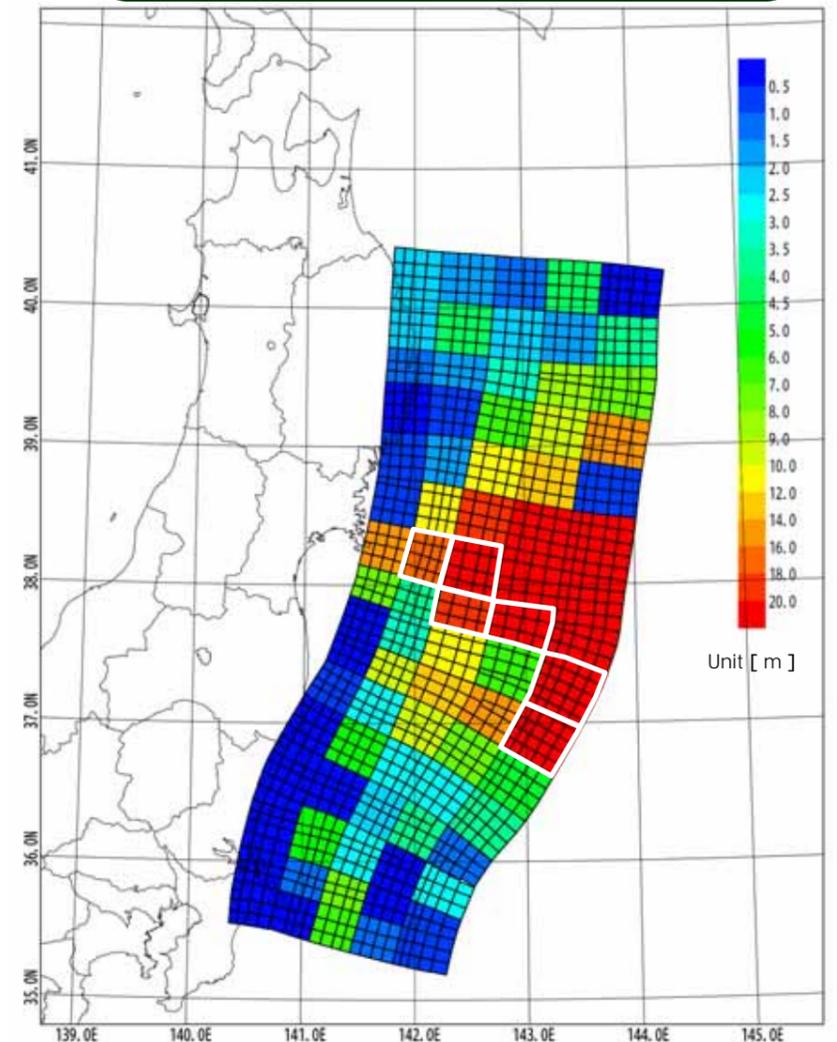
Fig4 Analysis for differences in tsunamis

As a result, it is considered that the difference of the overlap level of the peak of the tsunami from the large landslide area expected off the coast of Miyagi Prefecture and Fukushima Prefecture may have affected ( Figure 4 ) .

No significant difference in tsunami from each block at the depth of 150m was confirmed between 2 power stations. The height of tsunami increased as most of waveforms from each block overlap at its peak.

No significant difference in tsunamis from each block at the depth of 150m was confirmed between 2 power stations. The height of tsunami was low as most of waveforms from each block did not overlap at its peak.

Almost all the differences can be explained by the sum of 6 blocks

The main cause for the difference in tsunamis at Fukushima Daiichi and Daini Power Stations is that the peak of tsunamis generated at the area with large slippage estimated to be located at offshore of Fukushima and Miyagi was greater at Fukushima Daiichi and weaker at Fukushima Daini.

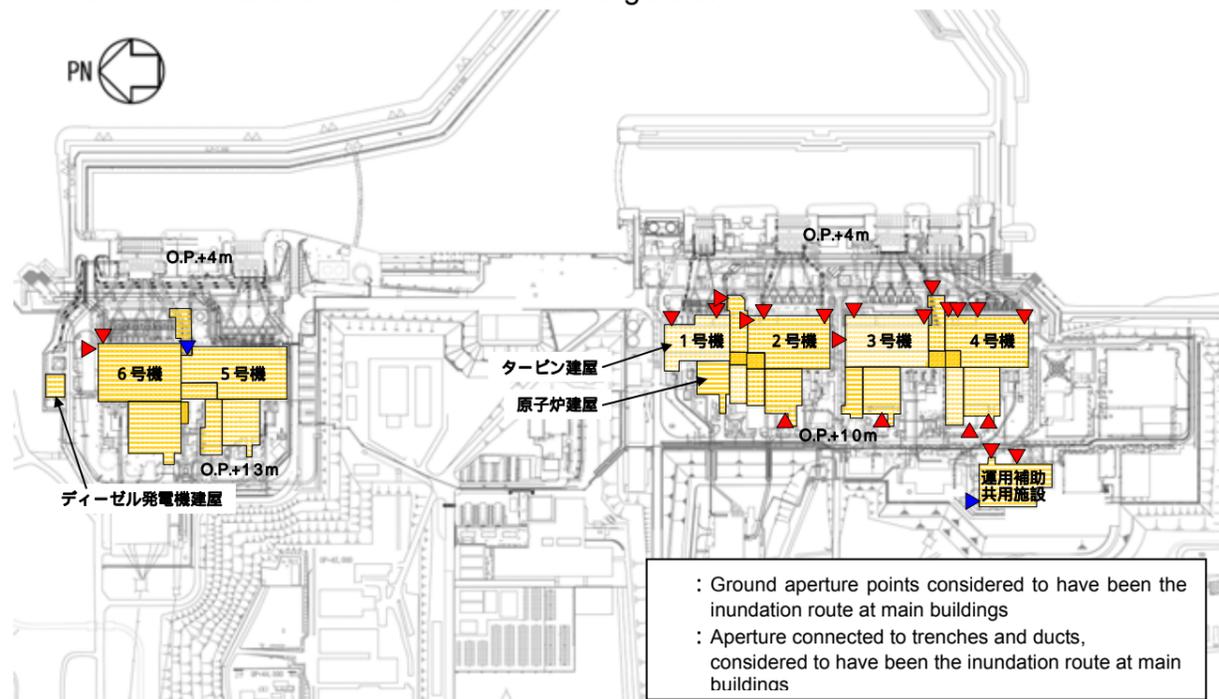
Figure 5 Aperture points considered to have been the inundation route at main buildings (Fukushima Daiichi Nuclear Power Station)

Although around the main buildings located at O.P.+10m site, almost all areas were considered to be flooded, there have been no damage confirmed at the main buildings outer walls and pillars.

Due to inundation, main buildings' open parts (such as buildings entrance/exits and equipment bay doors (hatches), inlets/outlets (louvers), apertures connected to trenches and ducts buried underground of sites (pass-through slots for cables) is considered to have become the inundation route; we confirmed parts of Unit 1 to 4 east side of turbine building (sea side) doors and shutters have mainly been damaged by the tsunami. Within the building, broad area of the underground has been considered to be inundated by water running via passage and stair rooms, etc. Aperture points considered to have been the inundation route is shown on Figure 5.

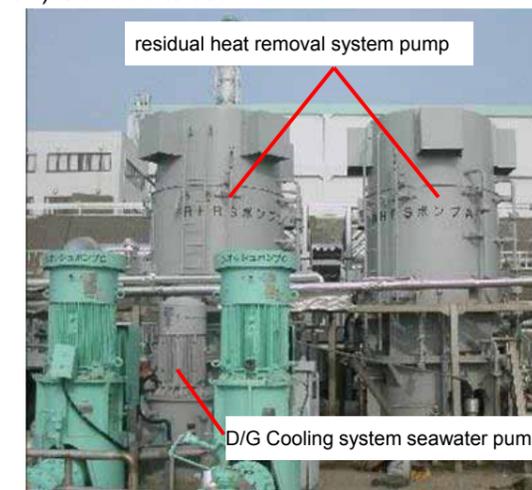
Figure 6 Condition of Unit 6 Emergency seawater cooling facility

Also with regard to emergency seawater cooling system facilities installed at outdoor yard area, apart from pumps removed due to inspection, all of them kept their position after the tsunami, and no pumps itself were flown out. Figure 6 shows the condition of Unit 6 emergency seawater system facility.

However, we also confirmed the collapse of cranes for facility inspection, damage to pumps and ancillaries by drifts, and infection of seawater to motor bearing lubricant oil.

With regard to D/G (6A) cooling system seawater pump, although it was inundated due to tsunami, we confirmed the intactness of cooling system seawater pump motor, and we confirmed the operation of D/G(6A) the next day on 19 March.

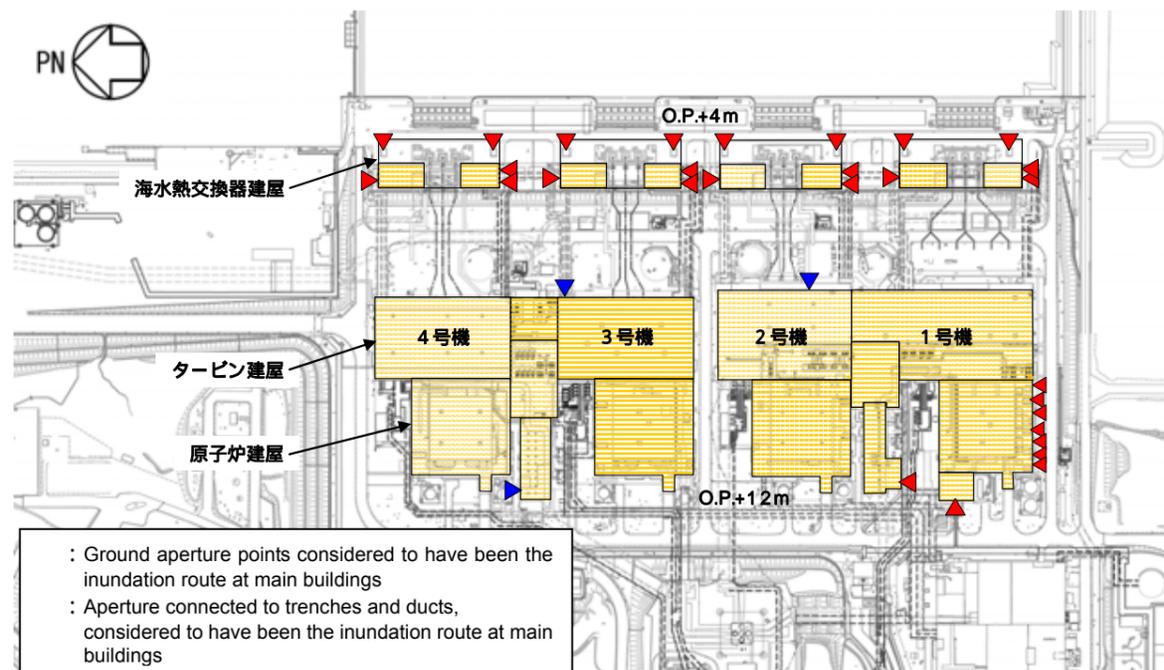
Figure 7 Aperture points considered to have been the inundation route at main buildings (Fukushima Daini Nuclear Power Station)

Although around the main buildings, areas at O.P.+4m at east side of the site (sea side), and O.P. +12m at south side of the site, were considered to be flooded, similar to Fukushima Daiichi, there have been no damage confirmed at the main buildings outer walls and pillars.

Due to inundation, main buildings' open parts (such as buildings entrance/exits and equipment bay doors (hatches), inlets/outlets (louvers), apertures connected to trenches and ducts buried underground of sites (pass-through slots for cables) is considered to have become the inundation route; we confirmed seawater heat exchanger buildings located at O.P. +4m, and at south of Unit 1 reactor building located at O.P. +12m, parts of doors and shutters have been damaged by the tsunami. Within the building, inundation area expanded via passage and stair rooms, etc, and we confirmed that basement floor of the main buildings at Unit 1, Unit 3 turbine building basement second floor, seawater heat exchanger at all units were inundated due to tsunami. . Aperture points considered to have been the inundation route is shown on Figure 7.
