Fukushima Nuclear Accident Analysis Report (Interim Report)

December 02, 2011
The Tokyo Electric Power Company, Inc.

This report identifies causes of the accident at the Fukushima Daiichi Nuclear Power Station (hereinafter referred to as “Fukushima accident”) based on the facts and analysis results that have been verified to date and proposes necessary countermeasures to enhance the safety of existing nuclear power plants.

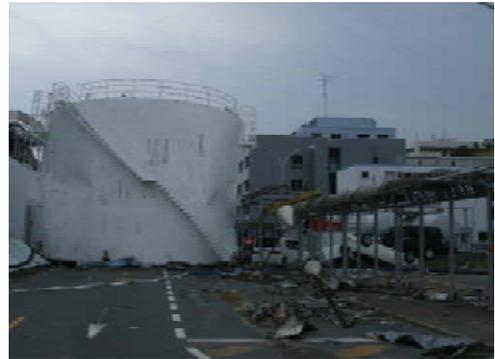
Fuel oil tank swept away by the tsunami and blocking a road
(11.7m in diameter X 9.2 m high)

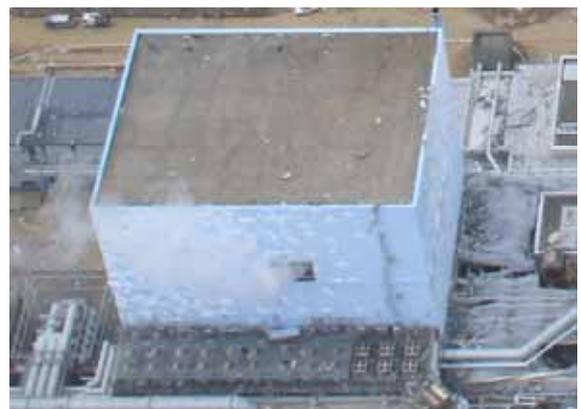
Although, at Unit 2, core damage resulted, just as at the other units, the opening up of a blowout panel at the top floor of the reactor building can be cited as one factor why a hydrogen explosion did not occur. The opening of the blowout panel is postulated to have occurred due to the shock of the hydrogen explosion at Unit 1. Hydrogen in the Unit 2 reactor building was released to outside the building through this opening. It is considered to be highly possible that the hydrogen remaining inside the building was released through this opening.

Opening the Unit 2 blowout panel

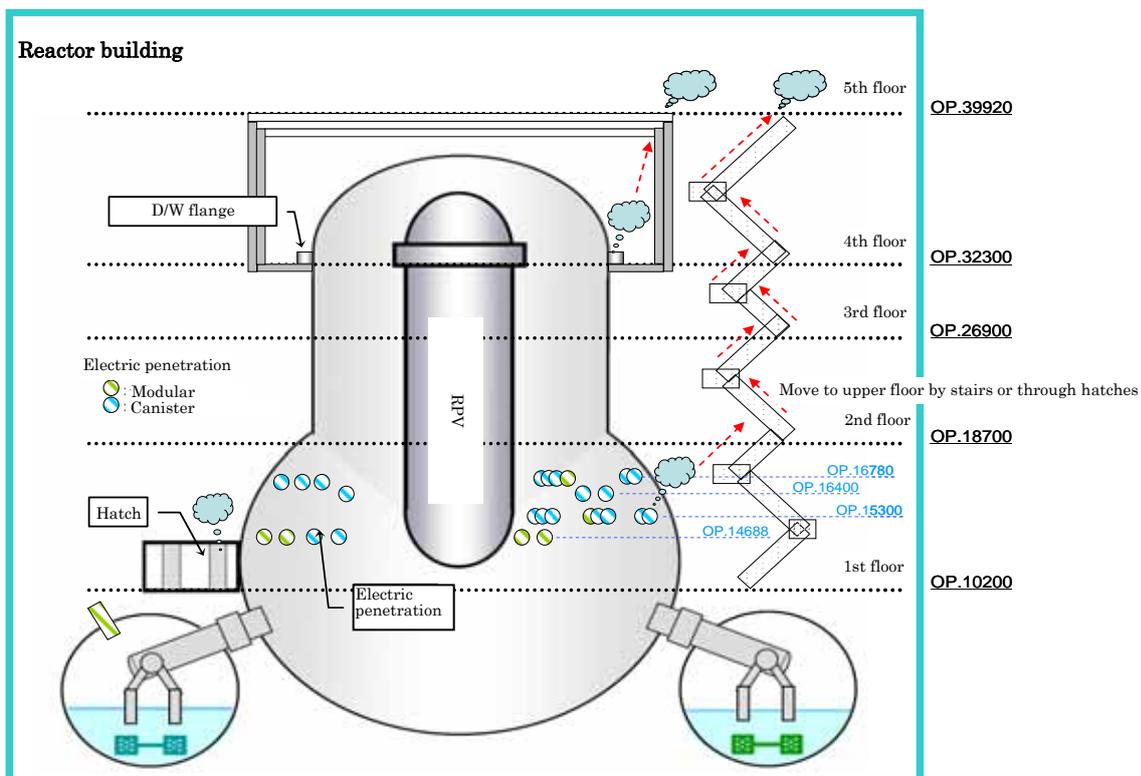
The fuel damage inside the Units 1 and 3 reactors generated hydrogen from the reaction between water and zirconium. Although the exact pathway through which the hydrogen flowed out is unknown, it is believed that seals on the head of the PCV, seals on the hatch where equipment and people enter, as well as other such seals with silicone rubber and other substances that are used for leak proofing were possibly exposed to high temperature and their functionality decreased. Hydrogen is postulated to have leaked into the reactor building from these sorts of places where it was then retained, resulting in a hydrogen explosion.

There are possibilities that the inferred leakage flow paths differ between Unit 1 and 3 according to system configuration

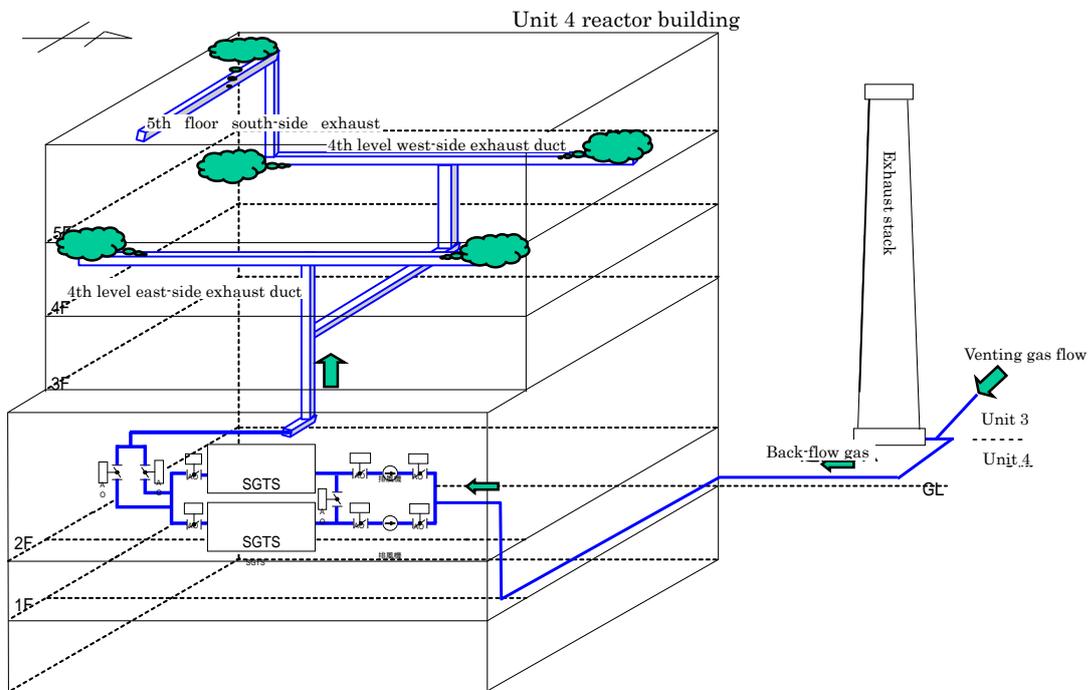
Based on the above, when the cause of the explosion at Unit 4 was investigated, it was considered that the venting inflow, which comprised hydrogen gas from Unit 3, might have flowed into Unit 4 through an area where both sides merge at the exhaust stack. The Unit 4 PCV venting piping is connected to the Unit 4 SGTS piping and guided to the exhaust stack, but near the stack, it joins a Unit 3 SGTS pipe.

Flow path of the PCV venting gas flow from Unit 3 to Unit 4

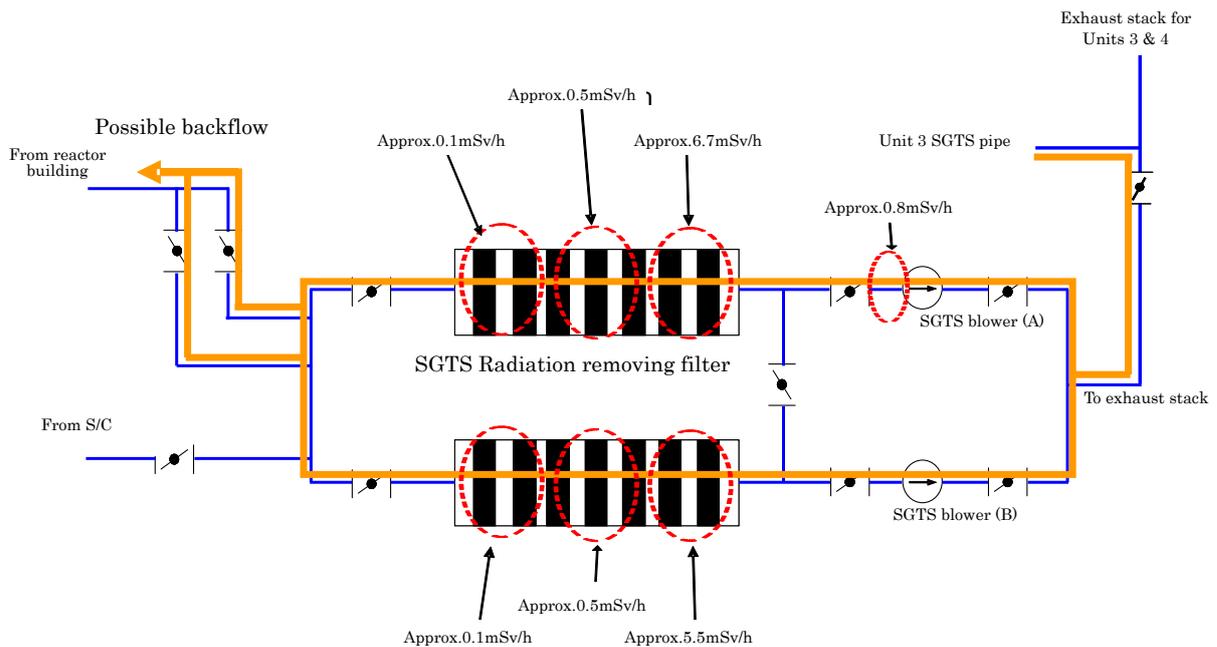
Results of measurement of amount of radiation in Unit 4 SGTS
(conducted on August 25, 2011)
