Regarding the steps to be taken regarding the leakage of water containing radioactive materials at the water desalination of Fukushima Daiichi Nuclear Power Station

December 8, 2011  
Tokyo Electric Power Company

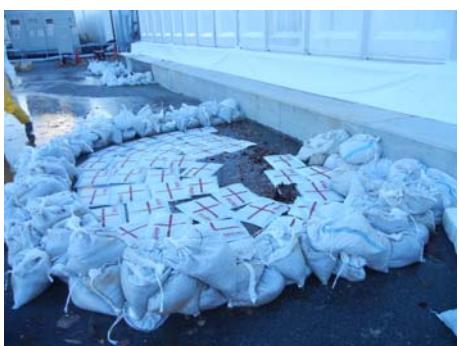
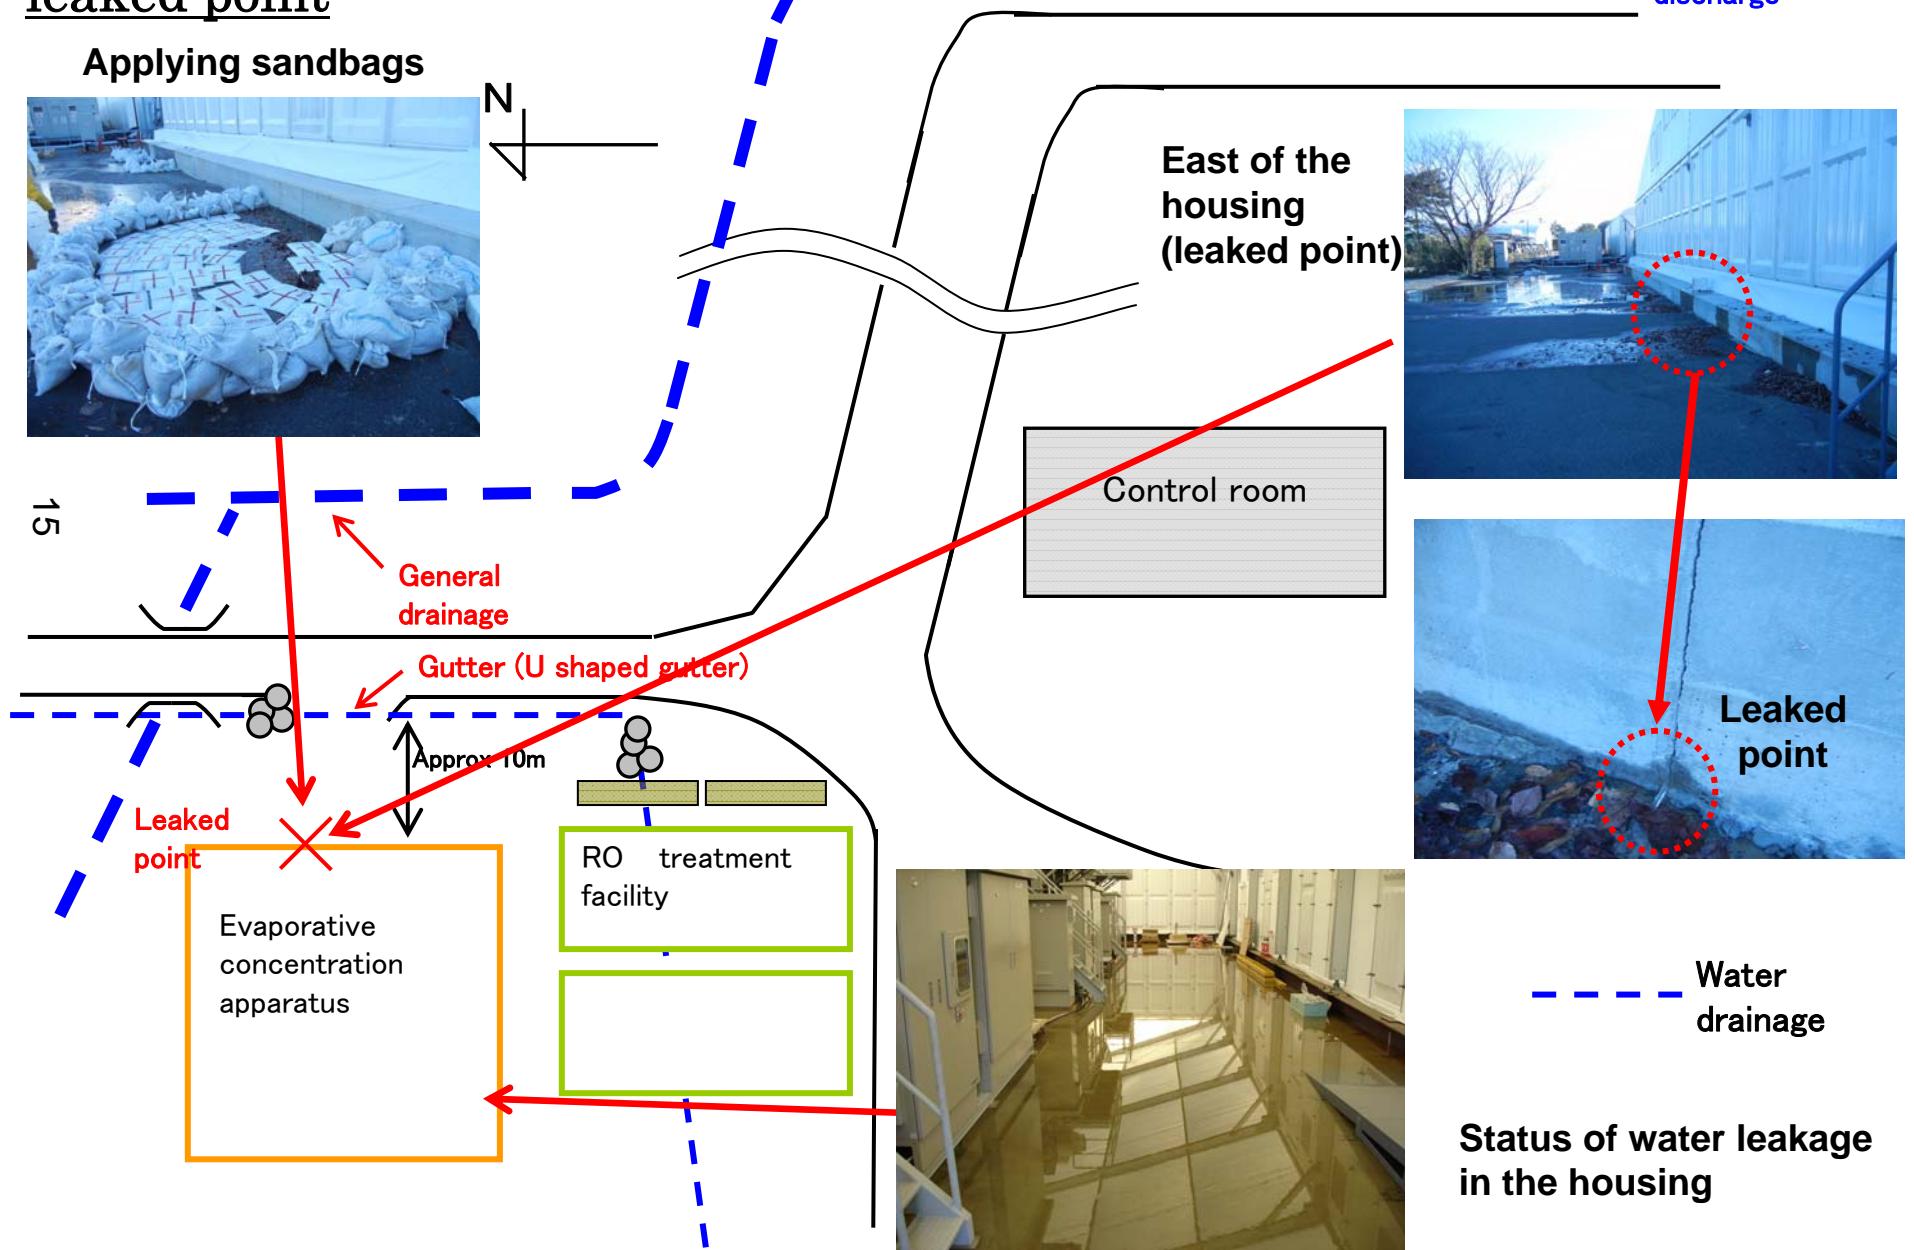
## Appendix 4

On December 5, leaked water in the housing was discharged and as a result of site inspection, wide spreading gap was confirmed due to the deformation of the sealing substance in the part of joint of the concrete bottom which was built segmental.

Judging from the leaked part to the outside of the housing, it is estimated most of the outflow was flown out through this point.

## Schematic diagram of leaked point

## Applying sandbags

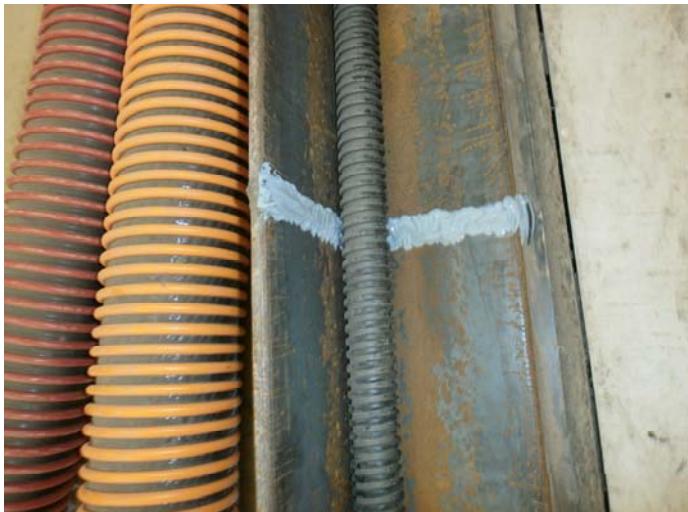
RO3 bellows housing

- Maintain caulking
- Confirm tiny cracks on the floor (recent repair by epoxy painting)

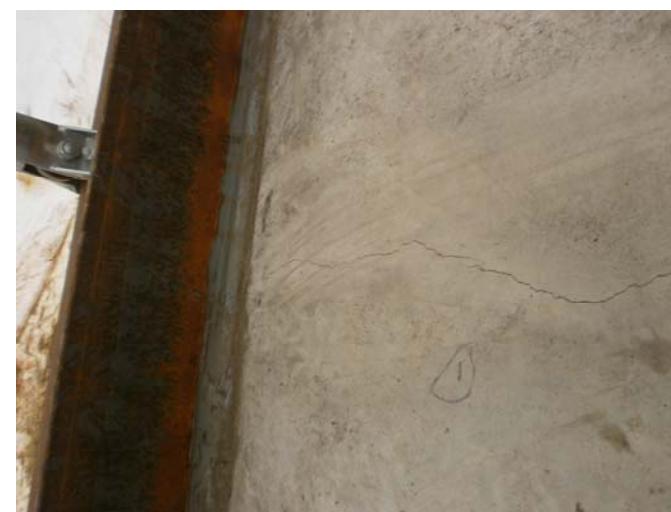
RO3 bellows housing (to be repaired)

Crack was also found in the concrete bottom, though it is not considered to be resulted in immediate outflow of out side of the housings, repair work was implemented for making sureness by injecting epoxy painting and completed by December 6.

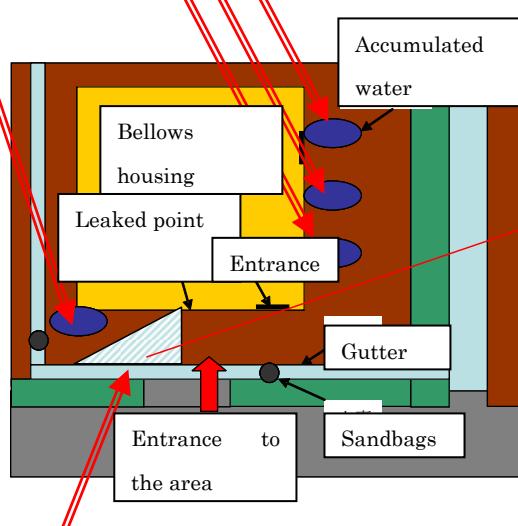
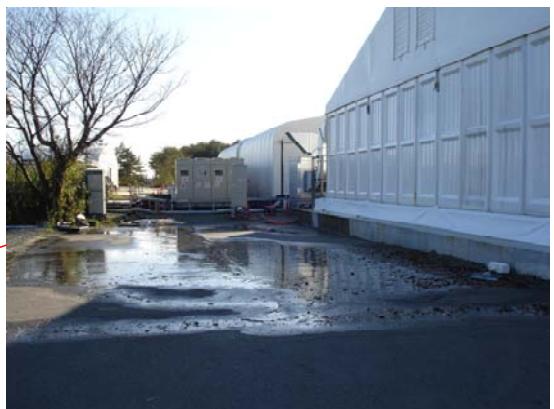
In the part of the gap between the joint of concrete bottom and barrier, damage was found due to the deterioration of the seal substance, and it is estimated a part of the leaked water was also flown out from this point.

The assumed leaked point at the connecting part between the concrete floor and the barrier

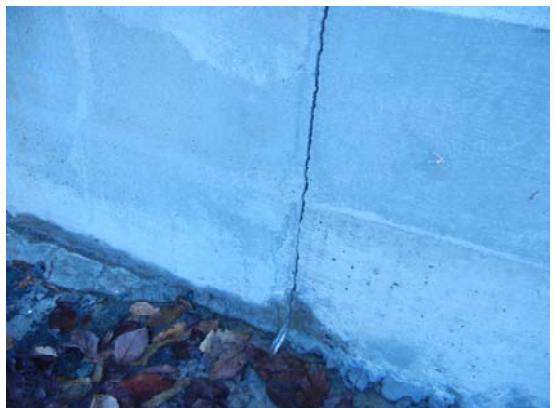
The assumed leaked point from the crack in the concrete floor

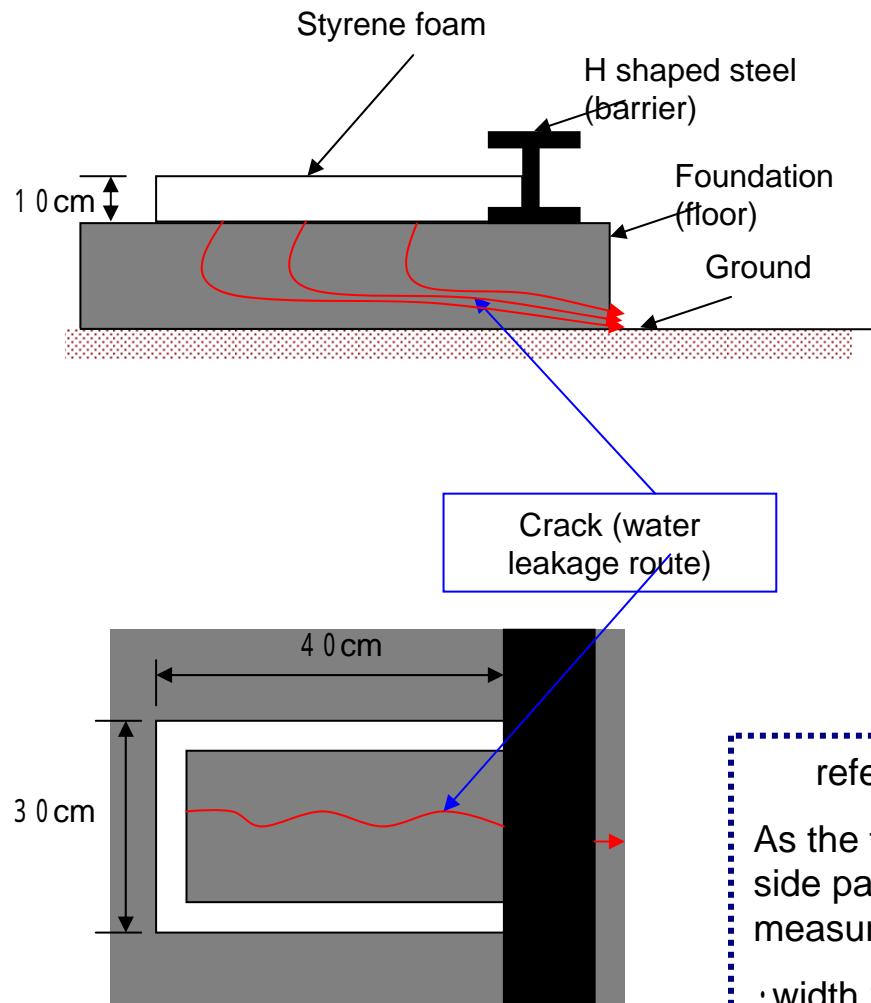
## Leaked volume test result from the crack in the floor

We formed an enclosure (width 30cm, length 40cm, height 10cm) around the crack in the foundation (floor) of the bellows housing by styrene foam, poured 5cm of water and measured the leaked volume of water to the outside of the housing.

As the test was not successful, we made a slit to the lower side part of a plastic container, poured 5cm of water and measured the water outflow.

- width 2mm, height 20mm: 120cc/min
- width 3mm, height 30mm: 270cc/min
