Measures Taken at Fukushima Daiichi Nuclear Power Station and
Fukushima Daini Nuclear Power Station (December 2011 Edition)

Fukushima Daiichi Nuclear Power Station

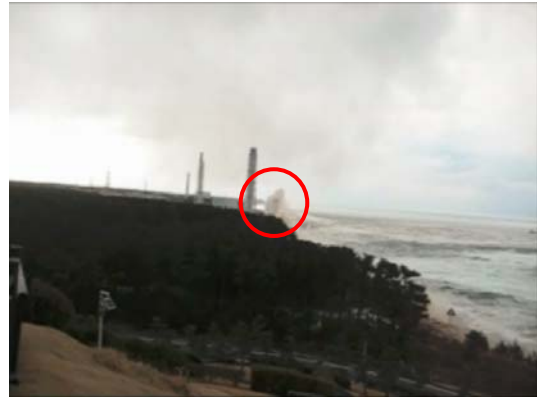
Some 50m tall spray of tsunami

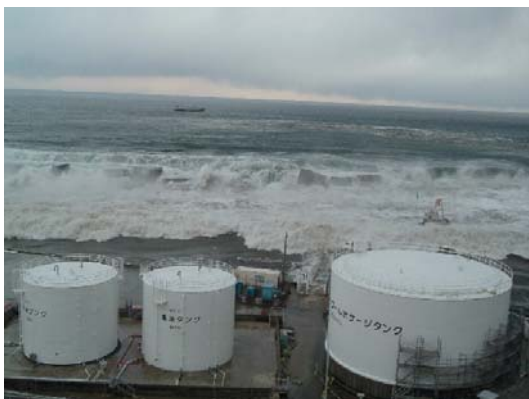
Tsunami destroying the breakwater over 10m tall and flooding over

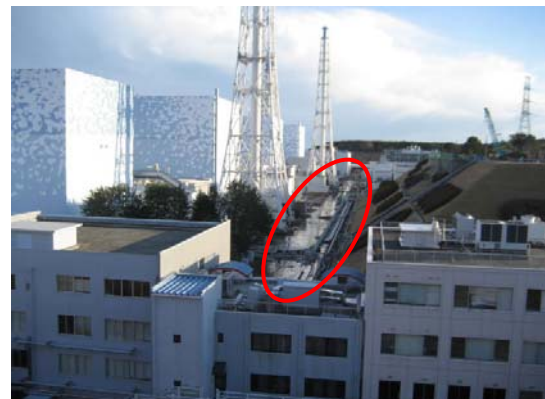
Entire areas of Units 1 to 4 flooded in the tsunami

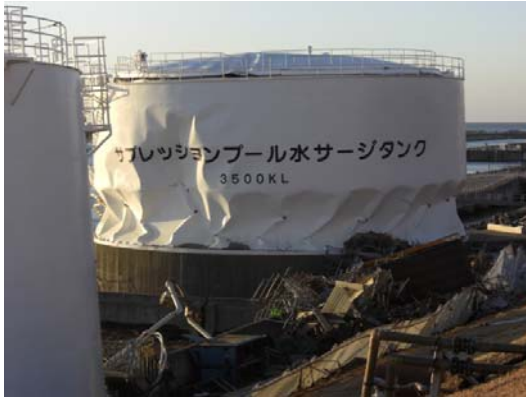
Tank deformed in the tsunamis
(One of the tanks in the photo above)

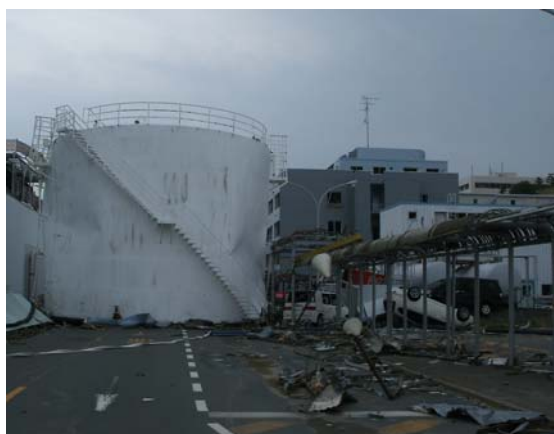
A heavy oil tank washed away in the tsunami onto the road
(Diameter: 11.7m×Height: 9.2m)

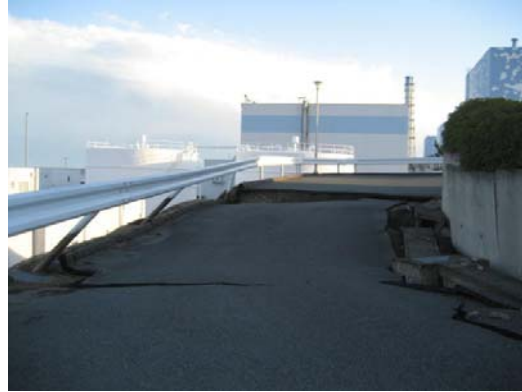
In-site road with cracks that bars vehicle traffic

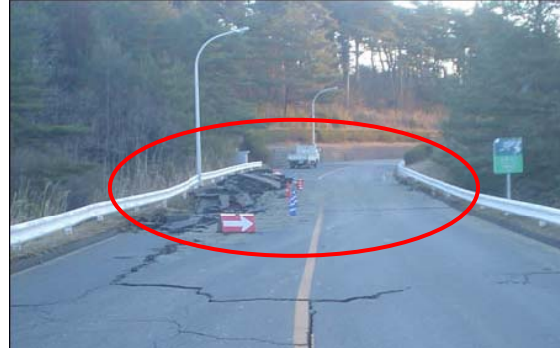
Damage to the access road to Units 5 and 6
(After restoration. Some pavement on the other side was stripped to obtain ballast and gravel to fill in bumps on the other side of the road.)

- Three TEPCO employees who put on service uniforms, winter clothing and helmets left for the road for recovery. In cooperation with the workers of the contractor company, which had brought heavy equipment into the Power Station site, a total of some ten workers started recovery. In addition to ballast brought in by the dump truck, aggregate and

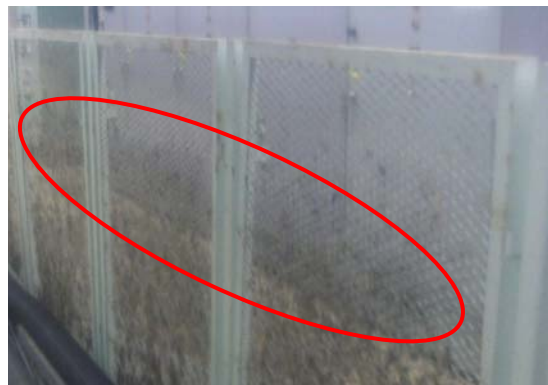
- When the team members entered the Unit 1 Turbine Building via the bulk delivery entrance and checked the 6.9kV high-voltage power supply panel (hereafter the "M/C") and the 480V low-voltage power supply panel (hereafter the "P/C") installed on the first floor, the team identified traces of flooding.

State of M/C on the first floor of the Unit 1 Turbine Building

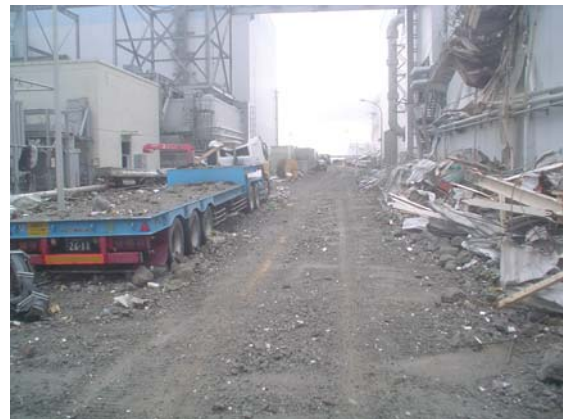
- The team members left the building, passing a heavy tank that had been washed onto the road in the tsunami, and headed for the outside transformer areas. Although the transformer areas of Units 1 and 2 showed no apparent damage to the equipment, the team confirmed traces of submergence in the tsunami.

Units 3&4 transformer area after a trailer and debris were cleared aside (photo taken on a later day)

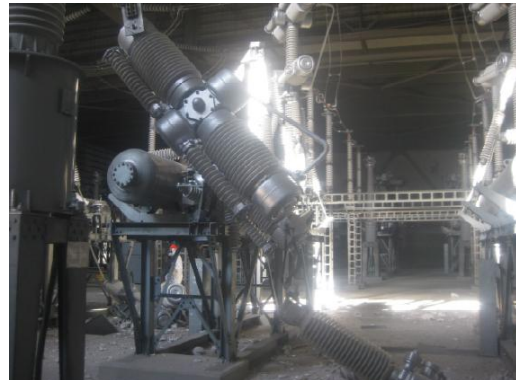
- Three to four members of the restoration team headed for the switching stations to check conditions of offsite power.
 - The team identified damage to circuit breakers, etc. in the switching station of Units 1 and 2.

Part of the circuit breakers, damaged in the tsunami, in the switching station fell off.

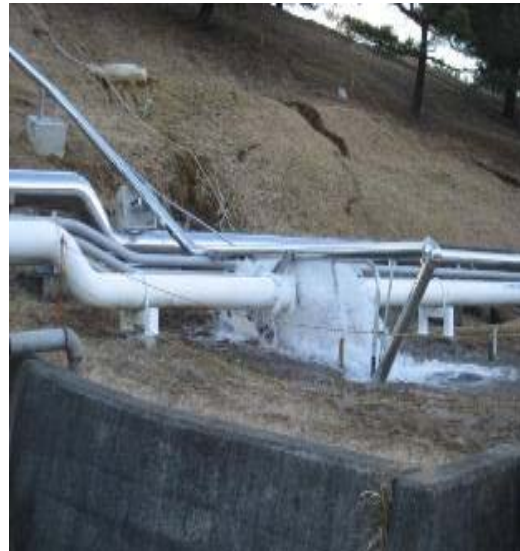
- Operators identified spouts from fire hydrants and leaks from disaster prevention piping for transformers. The fire brigade and power generation team started work to stop these leaks from the filtrate tank, the FP water source, to prevent loss of water. To stop the leak from the disaster prevention piping for transformers, the work team closed the valve near the Main Office Building. However, it did not stop completely. Thus, the work team started an operation to close the outlet valve of the filtrate tank.

Leak from the disaster prevention piping for transformers

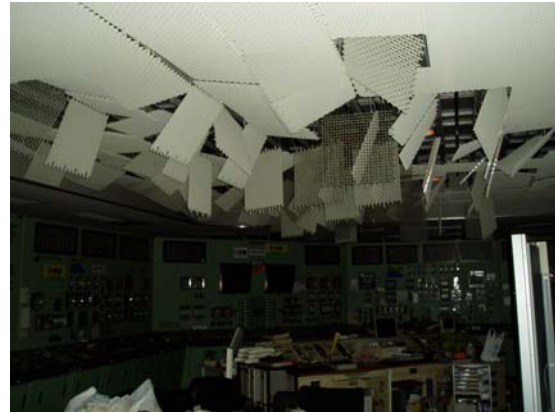
- The entire Main Control Room shook vertically with a thundering sound. The whole room was covered in dust. Operators were unable to do anything.

Main Control Room after the explosion

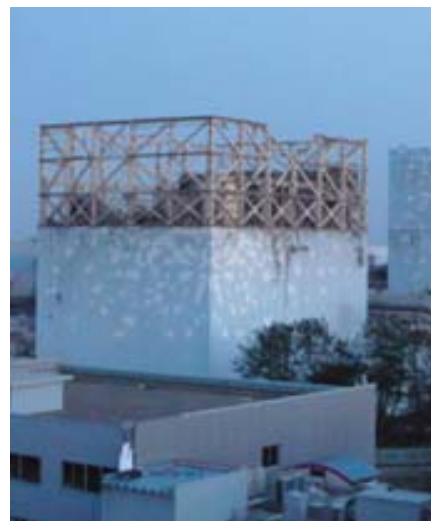
Reactor building of Unit 1 after the explosion

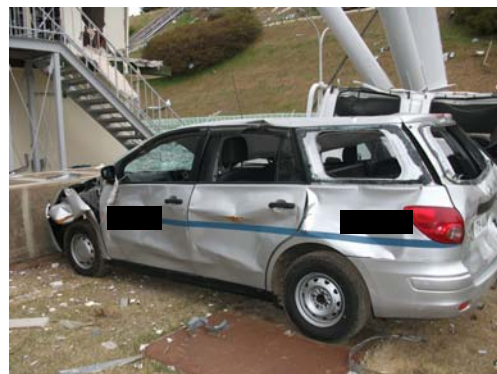
Vehicle heavily damaged in the blast

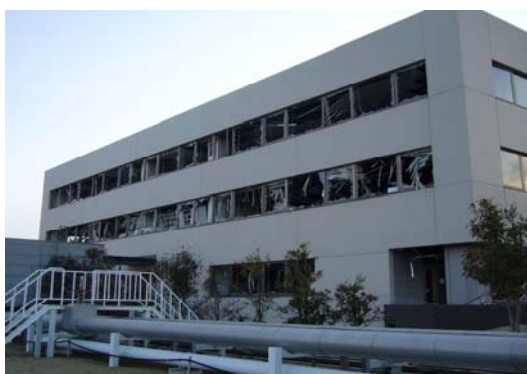
Main office building with shattered windows in the blast

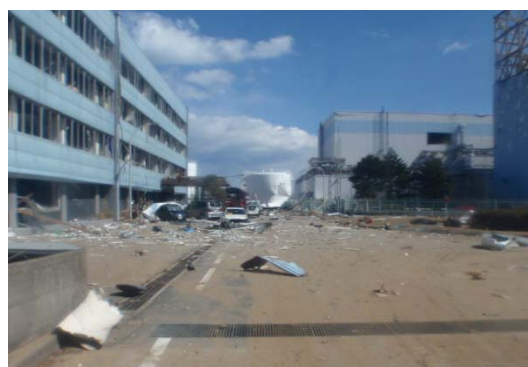
Former main office building with shattered windows (Unit 1 on the extreme right)

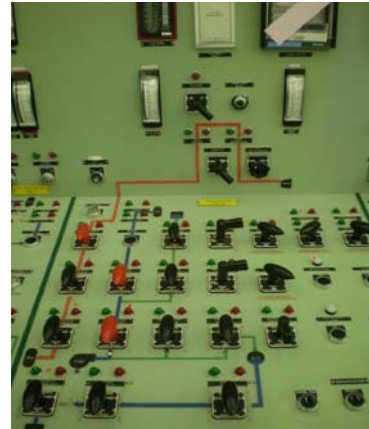
HPCI control panel (photo taken on a later day)
All the status indicators went out on the day.

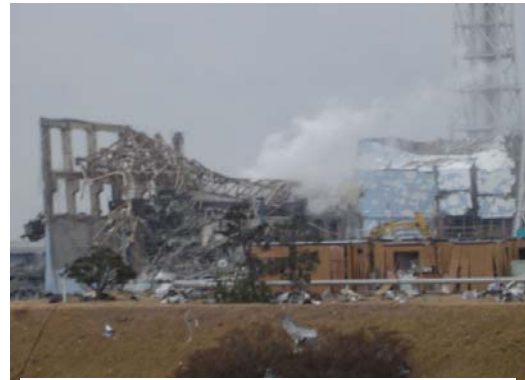
Damage to Unit 4 (right side in photo)
(Unit 3 is on left side in photo)

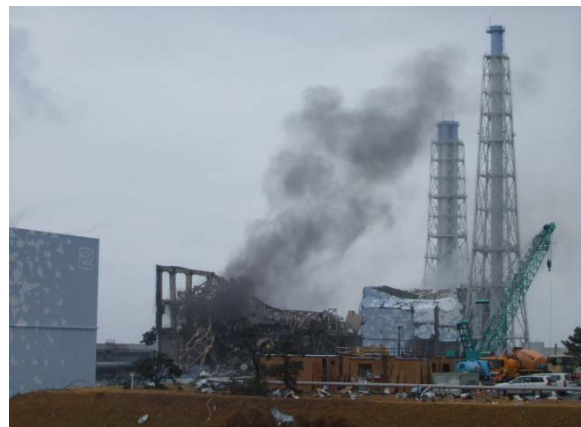
Appearance of Unit 3 immediately after the explosion
(Photo taken on March 21, 2011)
