Visual inspection of the inside of Unit 3 PCV

Visual inspection of the inside of Unit 3 PCV was completed on April 5, 2012. As a result, we found no leakage of reactor coolant or deformation/damage of equipments and piping inside PCV and that there are no factors hindering the cold shutdown function. Though minor issues were found such as the paint inside PCV partially coming off (due to the temporary temperature rise after the plant shutdown) and rust on the surface of some equipments (due to humidity change), these do not have impact on the cold shutdown function (Press release issued on April 6, 2012).

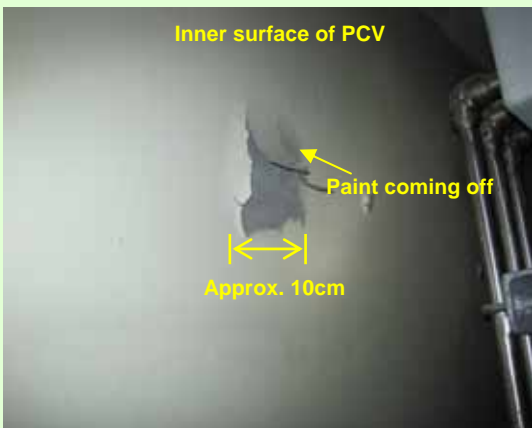
7. Paint coming off on PCV inner surface
(Photo taken on March 28, 2012)

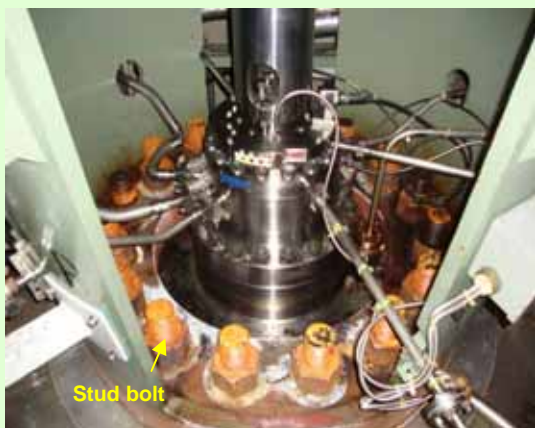
8. Rusted stud bolt on the reactor recirculation pump (B)
(Photo taken on February 16, 2012)
