The Impact of the Earthquake and the Tsunami on Unit 1-4 Turbine Buildings and the Current Statuses

**The Impact of the Earthquake on Unit 4 Turbine Building (Unit 4 Turbine Inspection)
(Mentioned in the press release on January 12, 2012)**

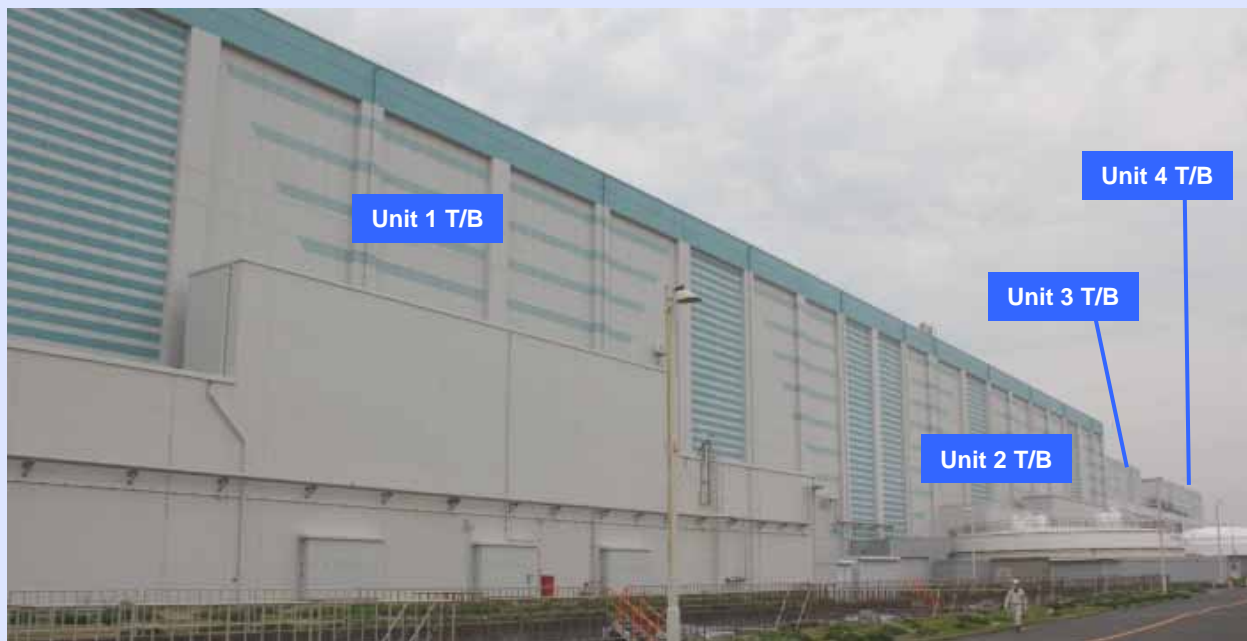
No major damage found on the appearance of Turbine Buildings.

Appearance of Turbine Buildings
(Photo taken on May 25, 2012)

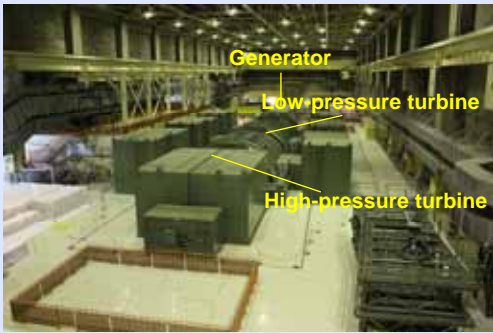
No major damage was found on the equipments/facilities in Unit 1-4 Turbine Buildings.

The 2nd floor of Unit 1 T/B
(Photo taken on May 15, 2012)

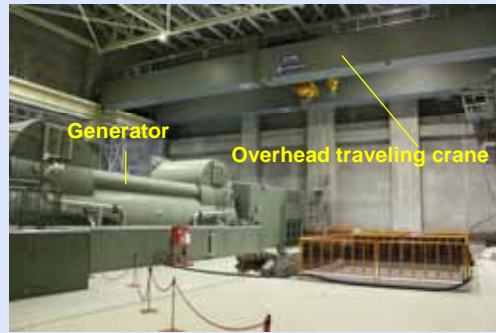
The 2nd floor of Unit 2 T/B
(Photo taken on May 15, 2012)

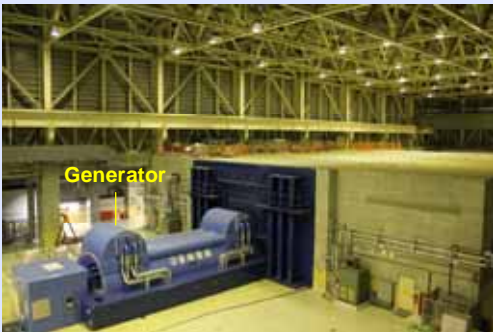
The 2nd floor of Unit 3 T/B
(Photo taken on May 15, 2012)

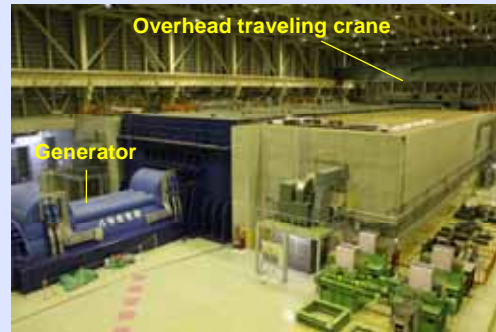
The 2nd floor of Unit 4 T/B
(Photo taken on May 15, 2012)

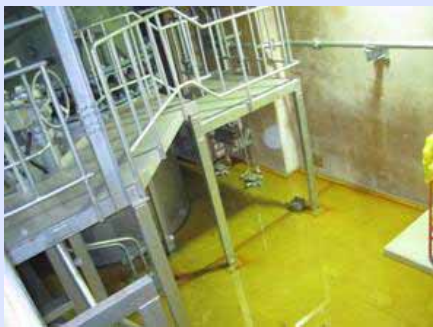
Flooded condenser room in Unit 1 T/B basement
(Photo taken on March 20, 2011)

Water removal and cleaning have been completed in the flooded buildings.

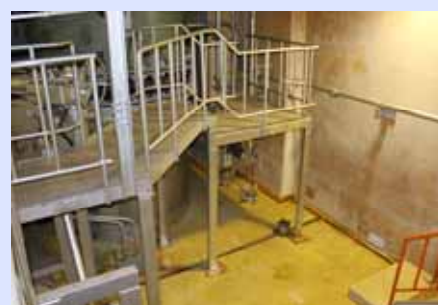
Current condition of the condenser room in Unit 1 T/B basement
(Photo taken on May 24, 2012)

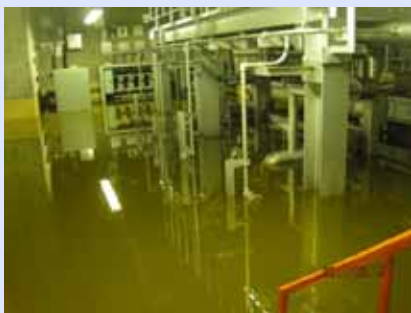
Flooded heating steam condensate water transfer pump in Unit 3 T/B 2nd basement
(Photo taken on March 19, 2011)

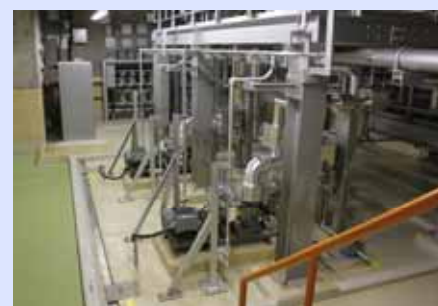
Current condition of the heating steam condensate Water transfer pump in Unit 3 T/B 2nd basement
(Photo taken on May 24, 2012)

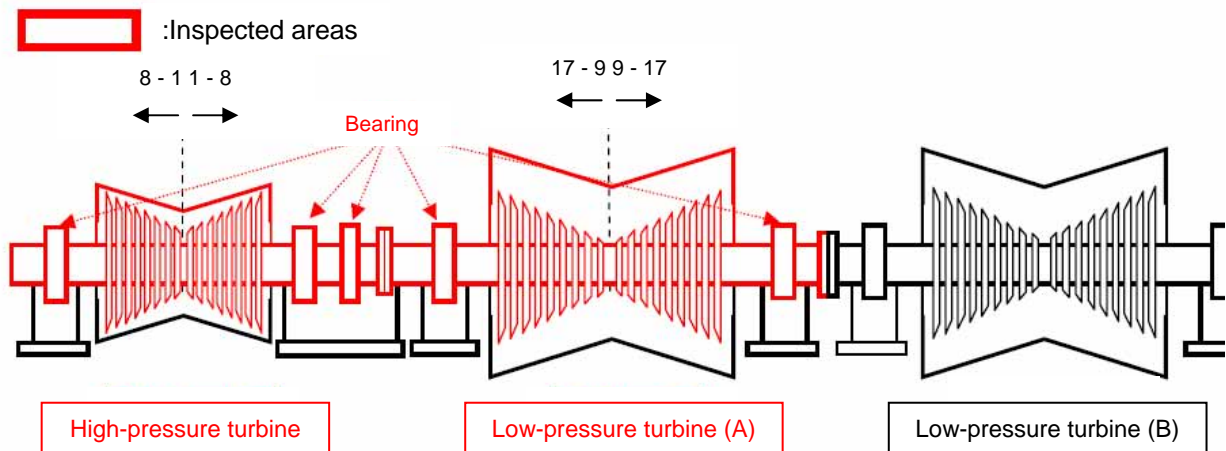
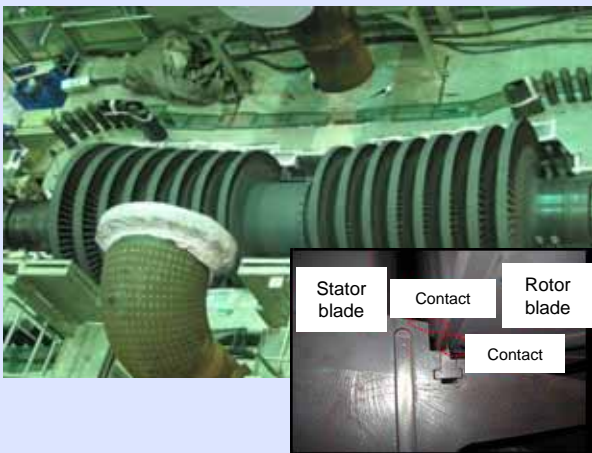
**Unit 4 high-pressure turbine inspection
(December 7, 2011)**

The high-pressure turbine has 1-8 rotor blades and stator blades on both sides (symmetrically aligned). Upon inspection, contact marks were found on the tip of 1-8 rotor/stator blades caused by the earthquake. However, these do not have impact on safety.

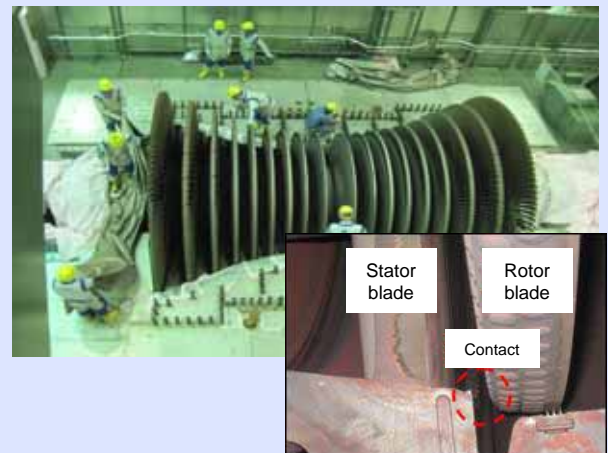
**Unit 4 low-pressure turbine inspection
(December 2, 2011)**

The low-pressure turbine (A) has 9-17 rotor blades and stator blades on both sides (symmetrically aligned). Upon inspection, contact marks were found on the tip of 9-14 rotor/stator blades caused by the earthquake. However, these do not have impact on safety.
