Fukushima Nuclear Accident Analysis Report

<Summary >

June 20, 2012
Tokyo Electric Power Company, Inc.

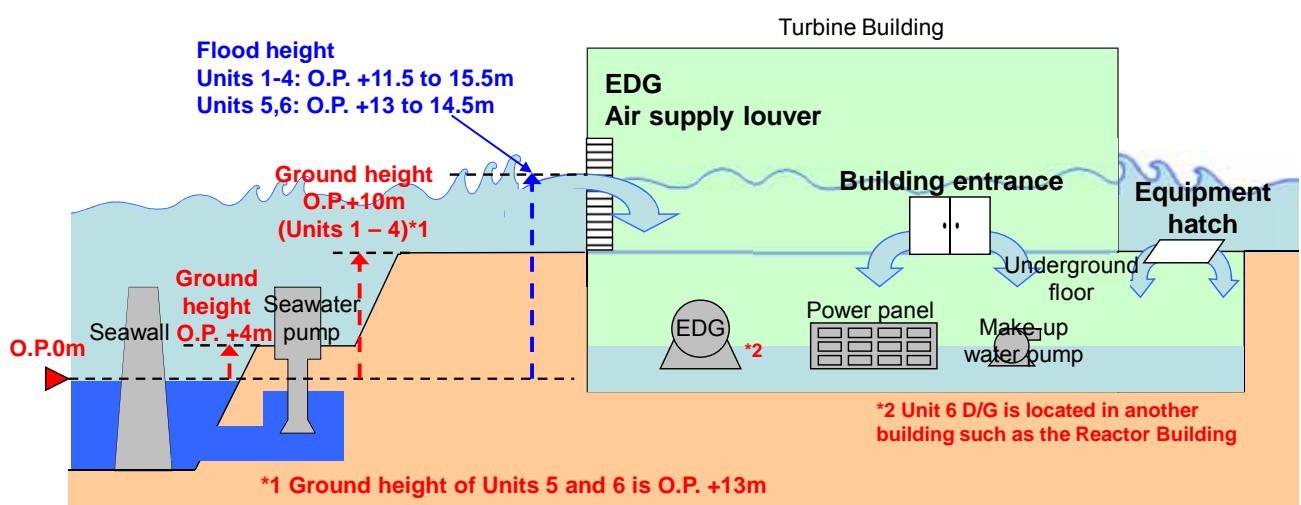
Figure 4: Path of inundation of major buildings

- The tsunami ran up all throughout the area surrounding the major buildings of Fukushima Daiichi inundating the area. The flooding was most severe in the Units 1 to 4 areas, with the depth of floodwater around the buildings reaching up to 5.5 meters.
- The routes of the tsunami floodwater entering inside the building are assumed to be the building entrance/exit points, emergency D/G air supply louvers, above ground machinery hatches, building basement trenches and ducts for cables and piping openings.

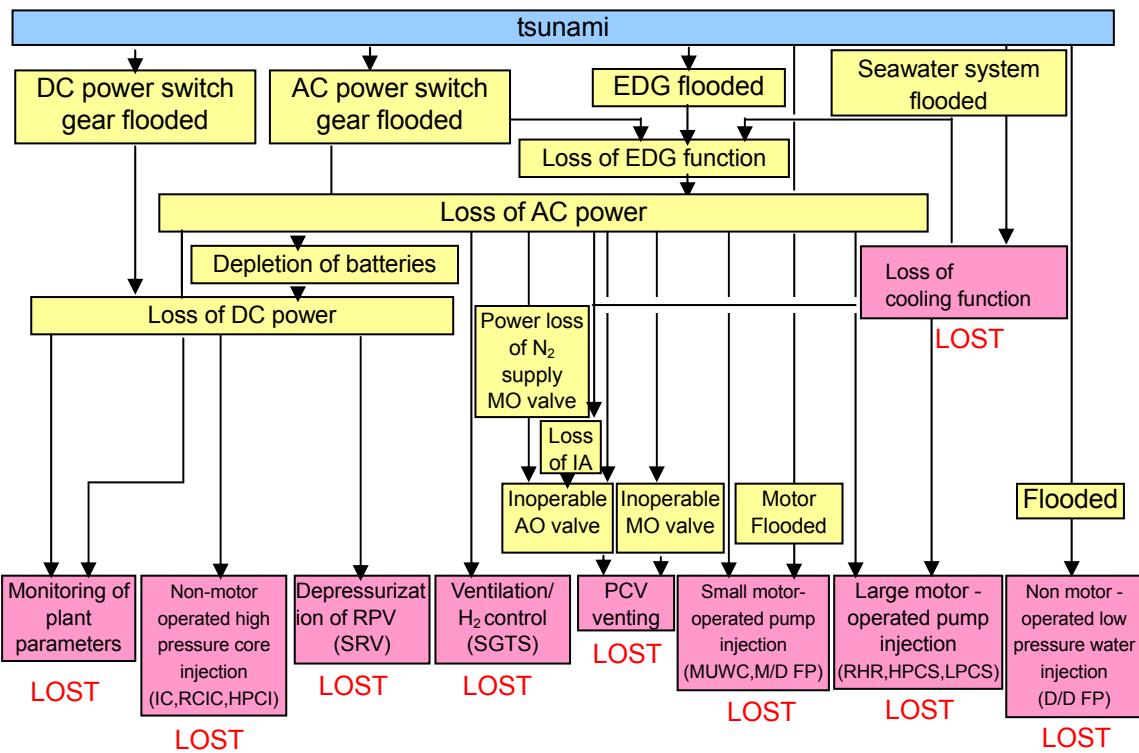
The accident was caused by the fact that multiple safety functions were lost simultaneously due to the tsunami inundation, and the causes in terms of the event are the "simultaneous loss of all DC power and AC power for an extended period of time" and "the loss of the heat removal function of the emergency seawater system for an extended period of time."

Correlation of the factors in the progression of the accident leading up to the loss of vital functions is shown in the following.
