# Fukushima Nuclear Accident Analysis Report

June 20, 2012  
Tokyo Electric Power Company, Inc.

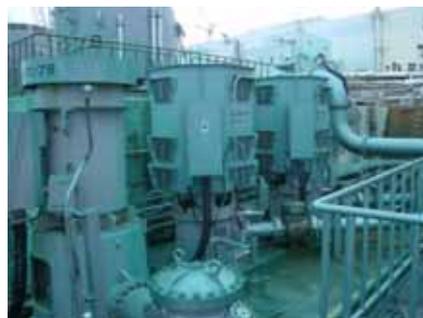
In regards to the emergency seawater system pump facilities installed outdoors on the sea side, it was found that the facility inspection crane had collapsed, the pump and ancillary equipment was damaged by collision with floating debris, and seawater had intruded into the motor bearing lubricating oil. However, except for RHR seawater system pumps A and C at Unit 4, which had been removed for inspection, the pumps remained self-standing in their original locations even after being hit by the tsunami. No pumps were washed away, indicating that mechanical damage to the emergency seawater system pumps was limited. For example, because, on March 18, 2011, it was possible to start up the seawater pump to cool Unit 6 EDG (6A) without repairing it, it was started up on March 19, 2011.

Unit 1 Containment Cooling Spray  
Seawater System Pump

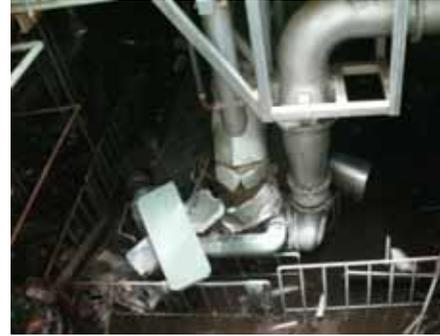
Water damaged Unit 1 D/G (1B)

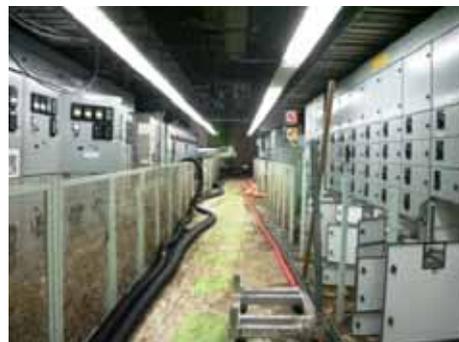
Water damaged Unit 1 T/B 1F P/C

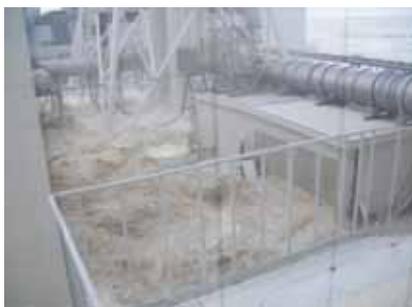
State of tsunami in the premises of buildings (Unit 1 south side)

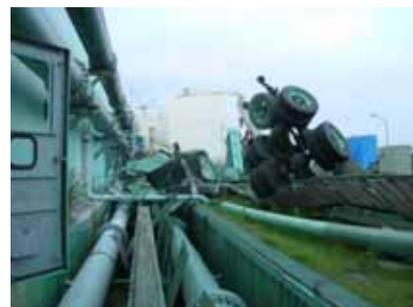
Unit 4 T/B east side

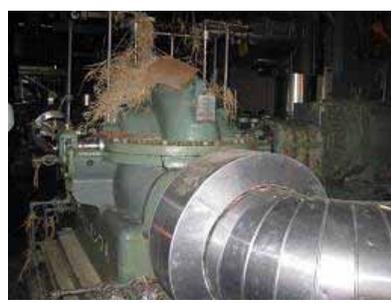
Water damaged Unit 1 RHR seawater system intermediate loop recirculation pump

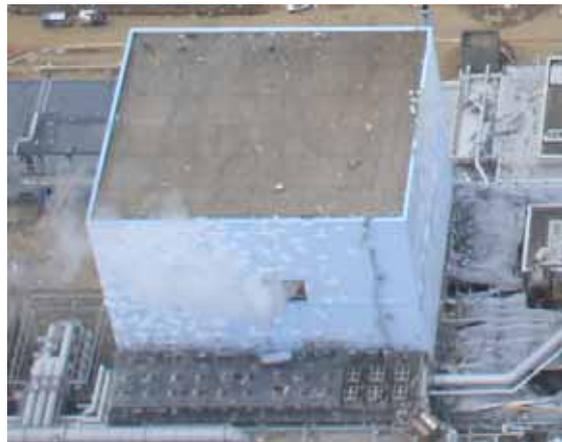
Opening of the Unit 2 blowout panel

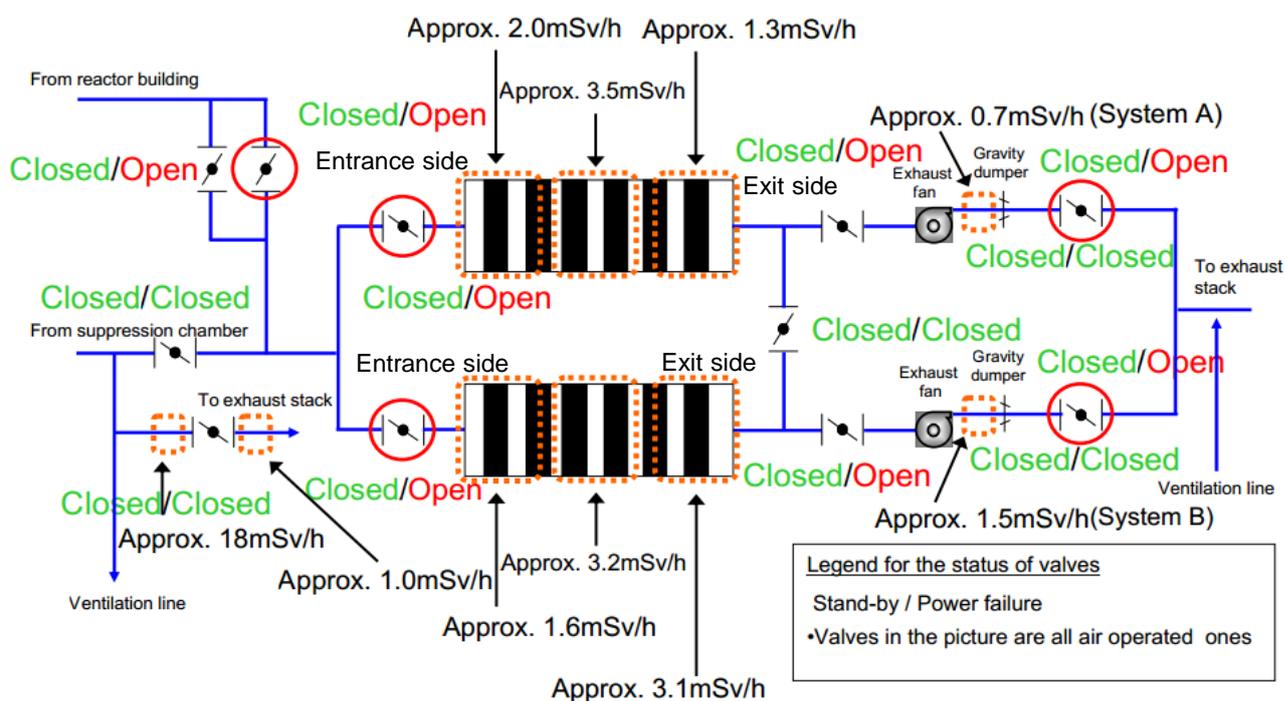
Unit 3 SGTS condition investigation results  
(Examined on December 22, 2011)
