Inspection of the Structures inside Unit 4 Reactor

From November 27, 2012, the structures inside Unit 4 reactor (representative unit) for which opening of the reactor and fuel removal have been completed are being visually inspected for the purpose of obtaining more information on seismic impact. (Previously announced on November 26, 2012)

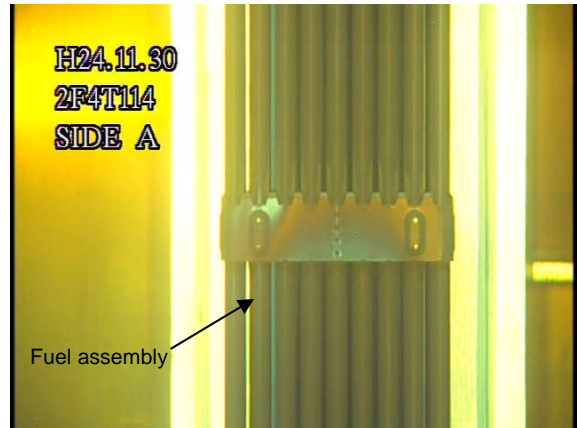
As of November 30, fuel assemblies (2 out of 8), core shroud*³, fuel support*⁴, (part of) shroud support and control rod guide pipe*⁵ have been visually inspected and no problem was found.

Fuel assembly (Photo taken in the spent fuel pool on November 30, 2012)

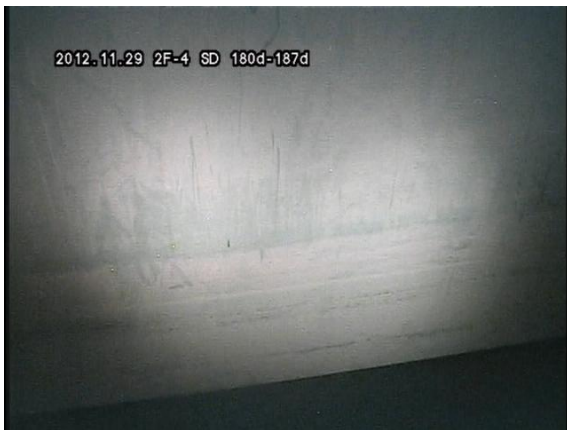
Core shroud (lower part and outer surface) (Photo taken in the reactor on November 29, 2012)

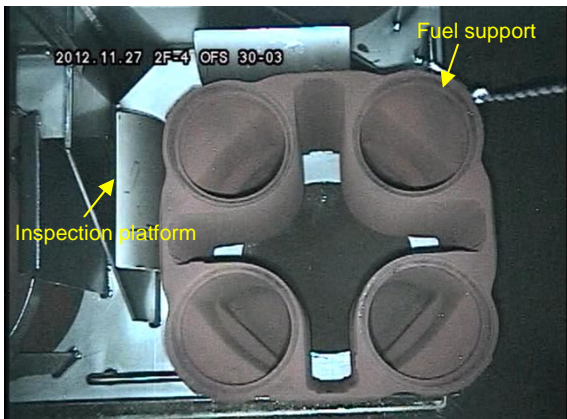
Fuel support (Photo taken in the spent fuel pool on November 27, 2012)

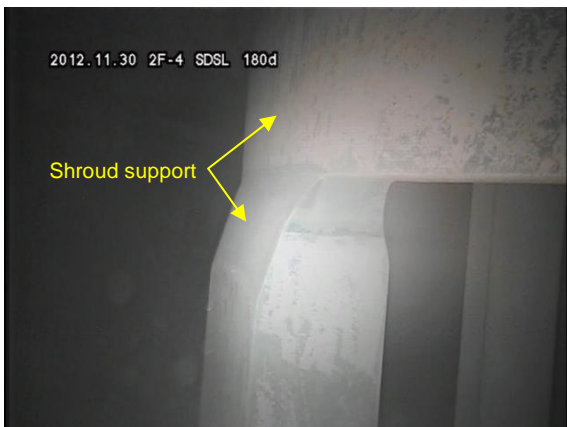
Shroud support (Photo taken in the reactor on November 30, 2012)

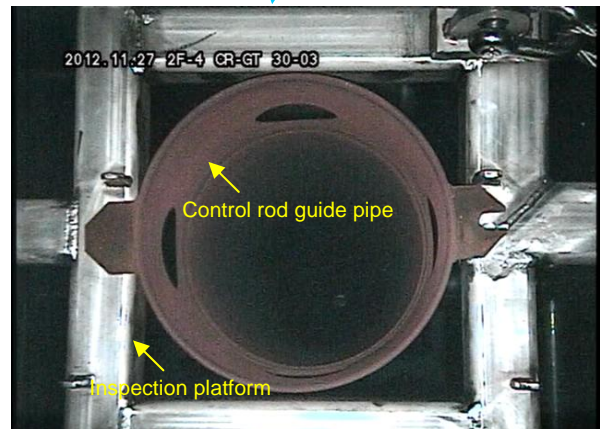
Control rod guide pipe (Photo taken in the spent fuel pool on November 27, 2012)
