Report on the Current Seismic Safety and Reinforcement of the Reactor
Buildings at Fukushima Daiichi Nuclear Power Station (No.1)
(Supplement) (Revision 2)

December 2012
Tokyo Electric Power Company

Report on the Current Seismic Safety and Reinforcement of the Reactor Buildings at Fukushima Daiichi Nuclear Power Station (No.1) (Supplement) (Revision 2)

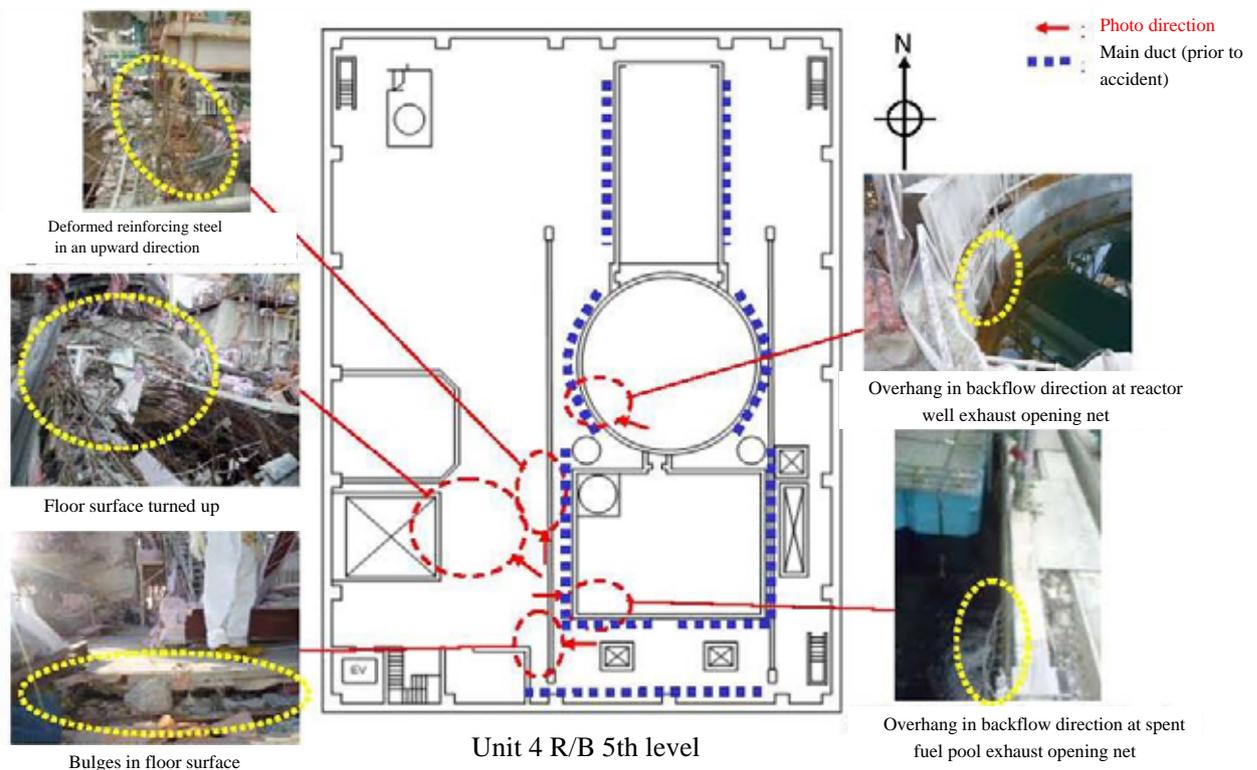
Figure-2.2.1 Investigation Results of Conditions of Damage inside Building (5th level)

The investigation results on the condition of damage inside the Unit 4 reactor building as shown in the Accident Investigation Report are shown in Figure-2.2.1 to Figure-2.2.3.

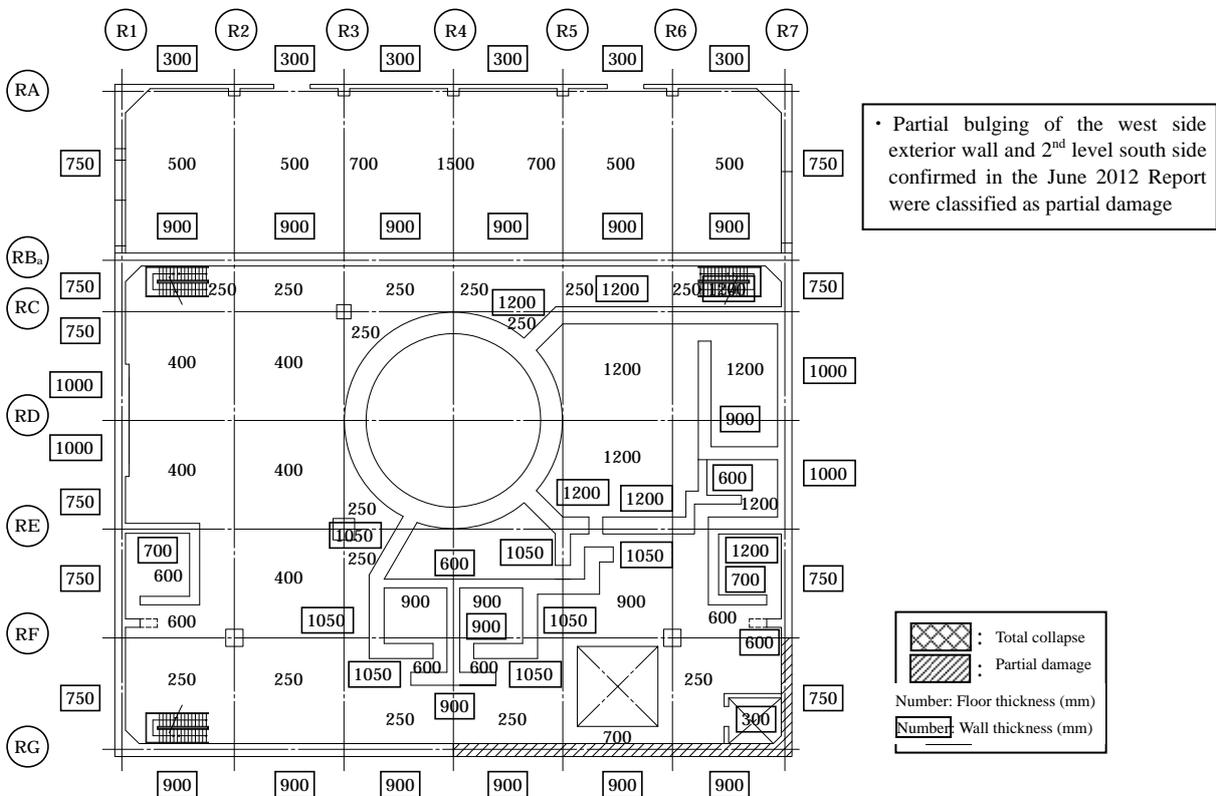
Figure-2.3.2 Damage Conditions (2nd Level)

Taking into account the investigation results of the Accident Investigation Report, the specific details of the damage to the reactor building frame have been consolidated based on visual inspections conducted of the walls and floors affecting seismic safety. For each span, the degree of damage was classified into three grades (no damage, partial damage, total collapse). The conditions of the damage to each reactor building levels are shown in Figure-2.3.1 to Figure-2.3.8. Locations where partial bulging was confirmed in exterior walls in the "Report on the Seismic Safety of Unit 4 Reactor Building at Fukushima Daiichi Nuclear Power Station in Consideration of the Partial Expansion of the Exterior Wall" (Tokyo Electric Power Company, June 2012) (hereinafter, "June 2012 Report") were classified as partial damage.

Of the damaged areas, locations where repairs are desirable from the standpoint of human safety or durability of components are scheduled to be repaired to the extent possible.

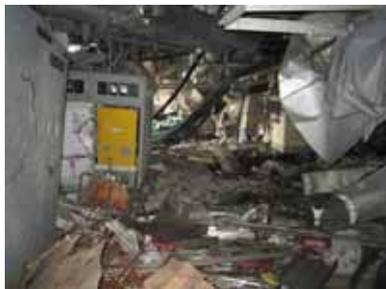
Floor deformation

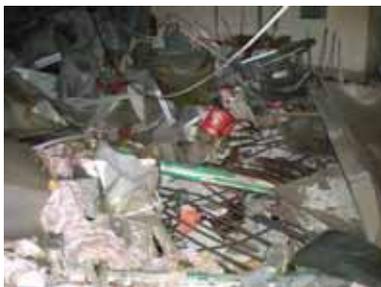
Floor collapsed

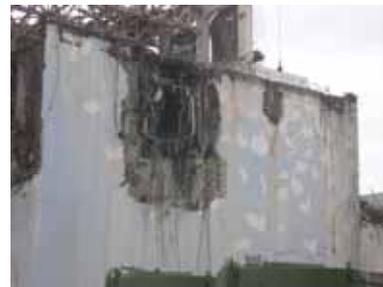
Partial flaking of exterior wall

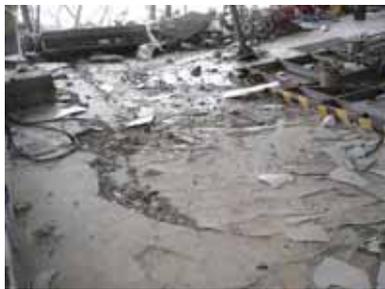
Floor deformation

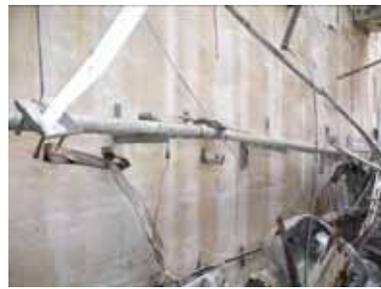
No pool wall abnormalities

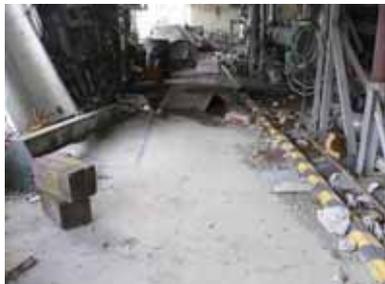
No floor abnormalities

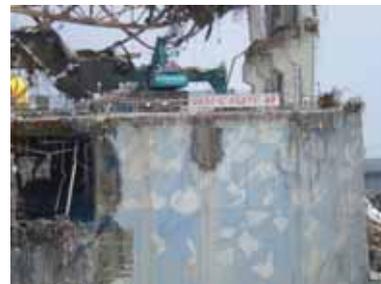
Partial flaking of exterior wall

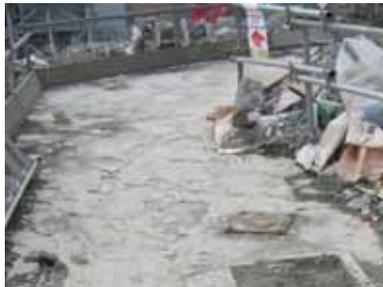
Floor deformation

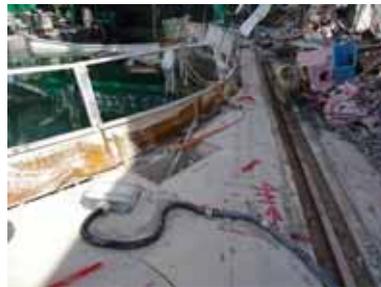
No shell wall abnormalities

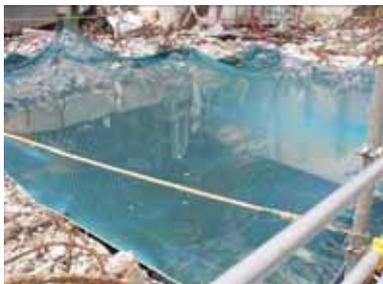
Floor collapsed

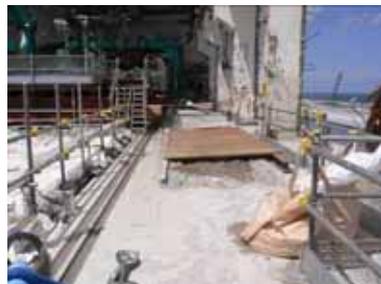
No floor abnormalities

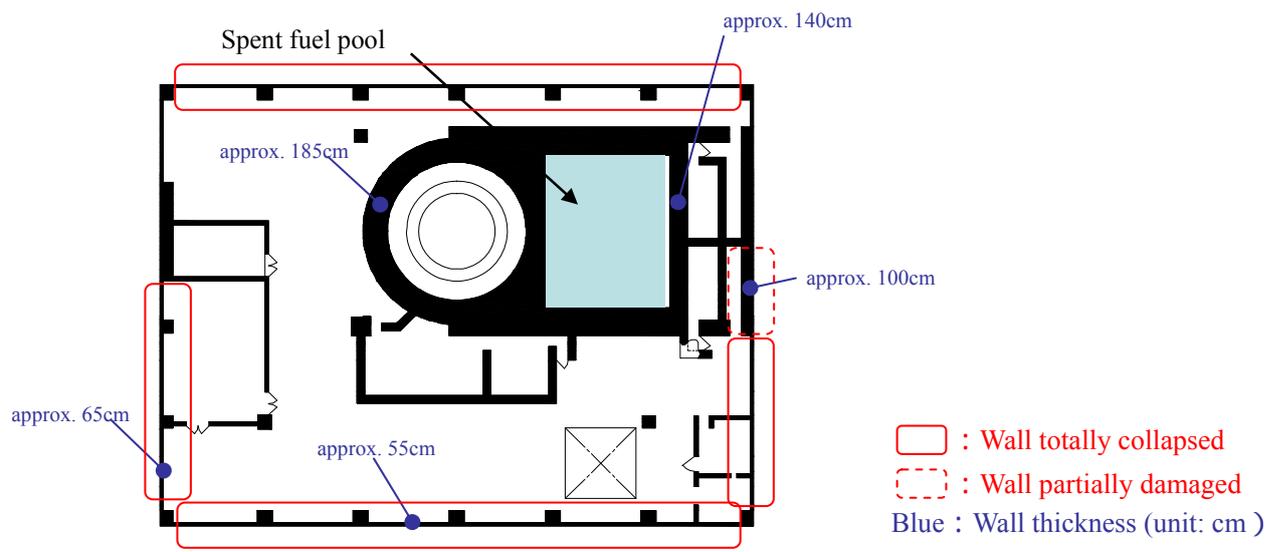
Figure-3.7.2 Damage Condition and Thickness of Exterior Walls (Example of 3rd Level)

In addition, when comparing the current examination results and the 2010 Earthquake Back Check, no significant differences have resulted. As shown in Figure-3.7.2, the main cause of this is considered to be because the shell walls and spent fuel pool walls thicker than the exterior walls were sound, and that the 5th level is lighter due to the removal of debris from the upper part of the refueling floor, despite the fact that there is damage to the exterior walls.
