The seismic response analysis results based on the observation record of the Tohoku-Chihou-Taiheiyou-Oki Earthquake in 2011 indicate that the structures inside Units 1-4 RPV were evaluated to maintain sufficient safety functions. (Previously announced on August 18, 2011) From November 27 to December 12, 2012, the structures and equipment inside Unit 4 reactor (representative unit) for which opening of the reactor and fuel removal have been completed were visually inspected utilizing an underwater camera for the purpose of obtaining more information. As a result, no abnormality which may affect the reactor's function was found. (Previously announced on December 13, 2012)

Equipment inspected and results of inspection (Photos)

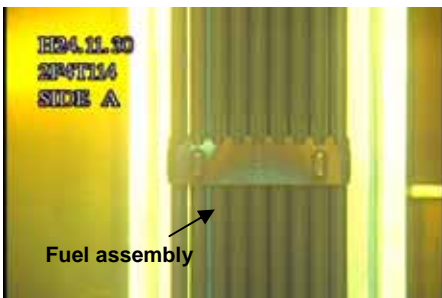
1. Fuel assemblies (8 were inspected)

Photo taken in the spent fuel pool (Taken on November 30, 2012)

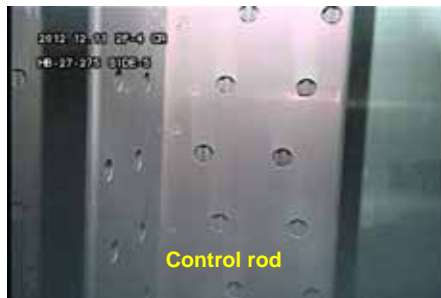
2. Control rods (4 were inspected)

Photo taken in the reactor (Taken on December 11, 2012)

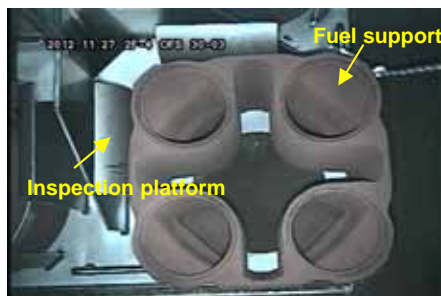
4. Fuel support

Photo taken in the spent fuel pool (Taken on November 27, 2012)

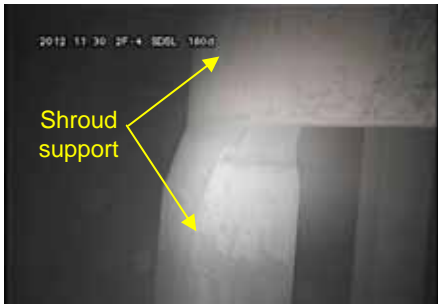
5. Shroud support

Photo taken in the reactor (November 30, 2012)

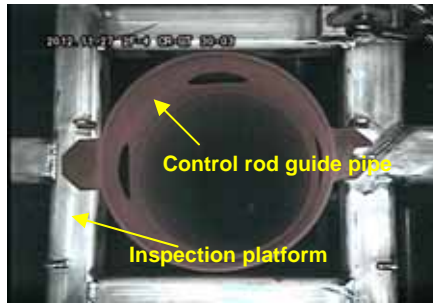
6. Control rod guide pipe

Photo taken in the spent fuel pool (November 27, 2012)

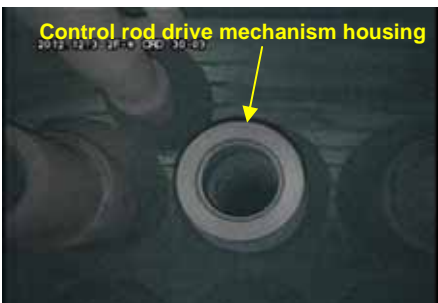
7. Control rod drive mechanism housing

Photo taken in the reactor (December 3, 2012)

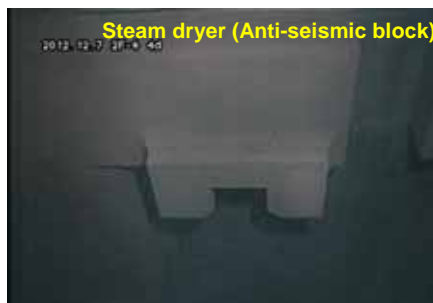
8. Steam dryer

Photo taken in the temporary storage pit for the steam dryer and steam-water separator (December 7, 2012)

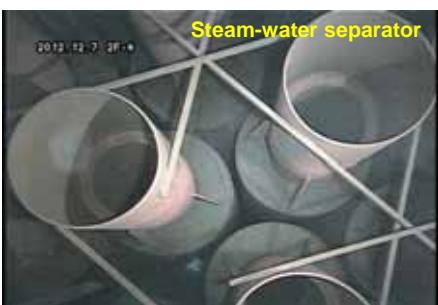
9. Steam-water separator

Photo taken in the temporary storage pit for the steam dryer and steam-water separator (December 7, 2012)

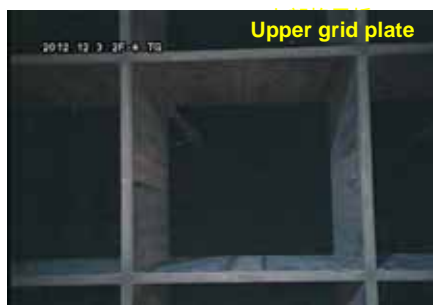
10. Upper grid plate

Photo taken in the reactor (December 3, 2012)

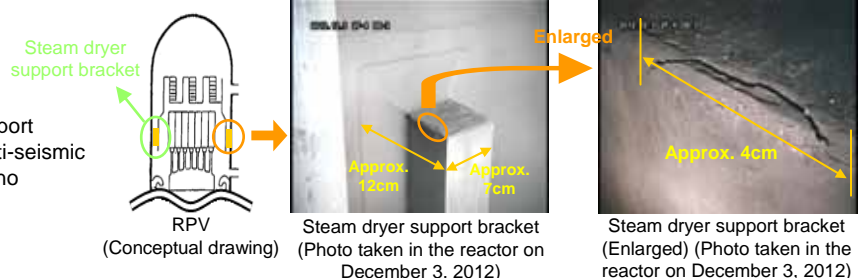
Problem found at the inspection

During inspection of the inside of reactor, a small damage (crack) was found on the upper part of the steam dryer support bracket (installed at 184 °). (Announced on our home page on December 5, 2012 [Discussed at the Noncompliance Management Committee on December 4]) It was judged that the damage (crack) found has no impact on equipment soundness. The damage is assumed to have occurred at the steam dryer installation (when the bracket contacted the anti-seismic block) which took place after the 16th regular inspection (June-October 2011), not due to the earthquake.

* In response to this incident, the steam dryer support brackets (installed at 4 °, 94 ° and 274 °) and anti-seismic blocks (at 4 locations) in other areas. As a result, no problem was found.
