Nuclear Safety Reform Plan

Progress Report

(FY2013 1st Quarter)

Tokyo Electric Power Company, Inc.

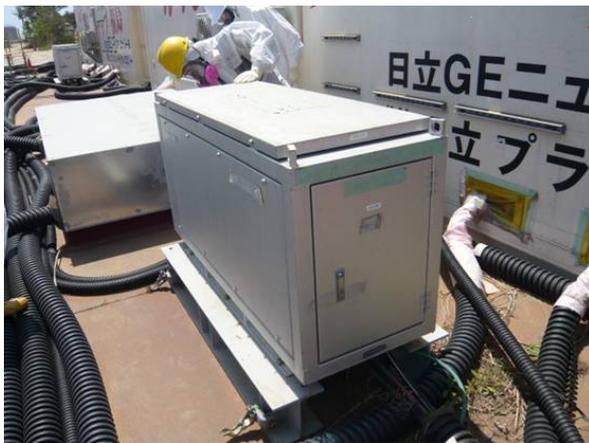
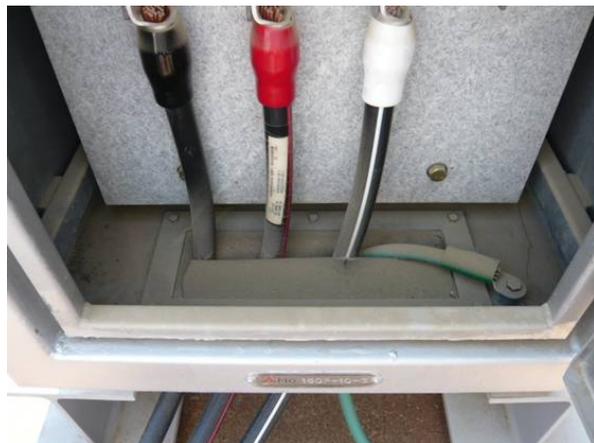
Example of site survey: An opening for incoming cable lines as shown in the right picture was found as a result of transformer internal inspection. The opening was closed.

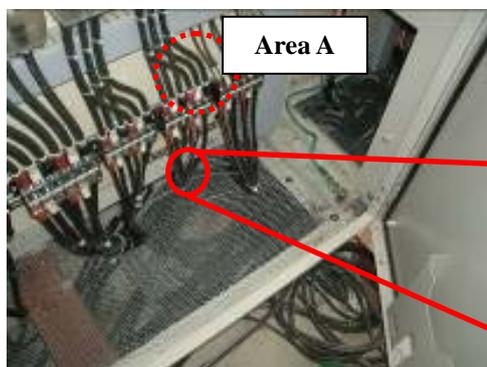
Wire installed inside control panel

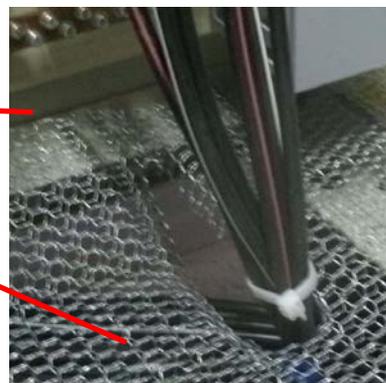
Enlarged view of an opening in wire net

(Cut made in the wire net for a cable to pass through.)

The excess opening is closed using wire string)

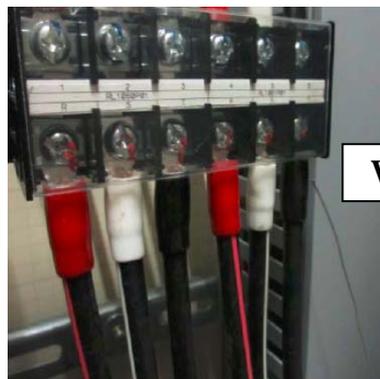
Area A

Wire tip slipping through the gap between the terminal block and the acrylic cover touched junction metal and caused short-circuiting

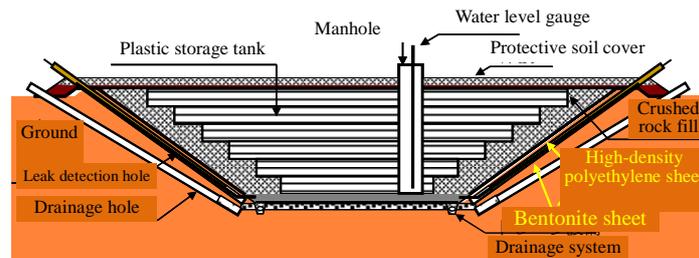
Structure of underground water storage tank

The leaked underground water storage was designed to use double layered high-density polyethylene sheet for water shielding with sheet joints carefully confirmed. It was, however, no experience of storing radioactive water in storage of such design.

In preparation for leakage from the high-density polyethylene sheet, a bentonite sheet was bedded as a hazard for water penetration (though it does not have an ability to seal water), and a detection hole was created between the high-density polyethylene sheet and the bentonite sheet.

Nevertheless, since groundwater infiltration started from the outer surface of the bentonite sheet and it

diffused into the detection hole, we could not find contaminated water leakage simply by the presence of water in the detection hole, but by concentrations of chlorine and other elements in the hole water, which was measured only weekly.

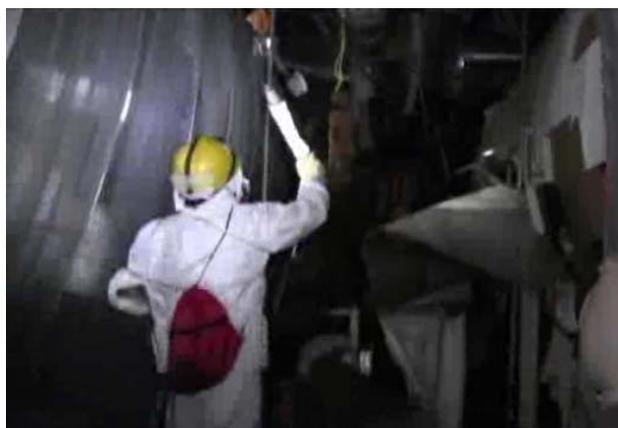
Investigating the side of isolation condenser unit at Unit 1 (October 18, 2011)

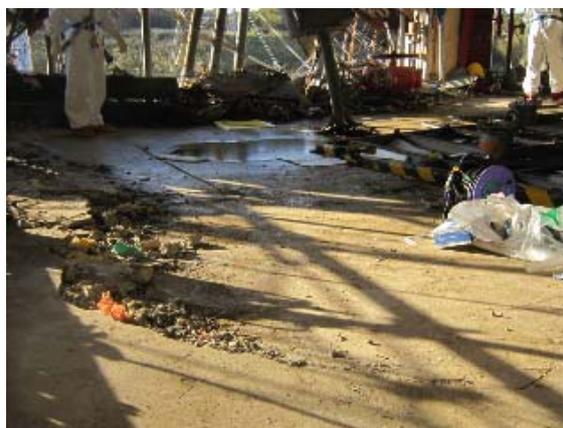
Investigation of condition of 4th floor of Unit 4 R/B
Floor surface has caved in, and it is estimated that the explosion occurred on the 4th floor.
(November 10, 2011)
