Evaluation of the situation of
cores and containment vessels of
Fukushima Daiichi Nuclear Power Station
Units-1 to 3 and examination into unsolved
issues in the accident progression

Progress Report No. 1

December 13, 2013

Tokyo Electric Power Company, Inc.

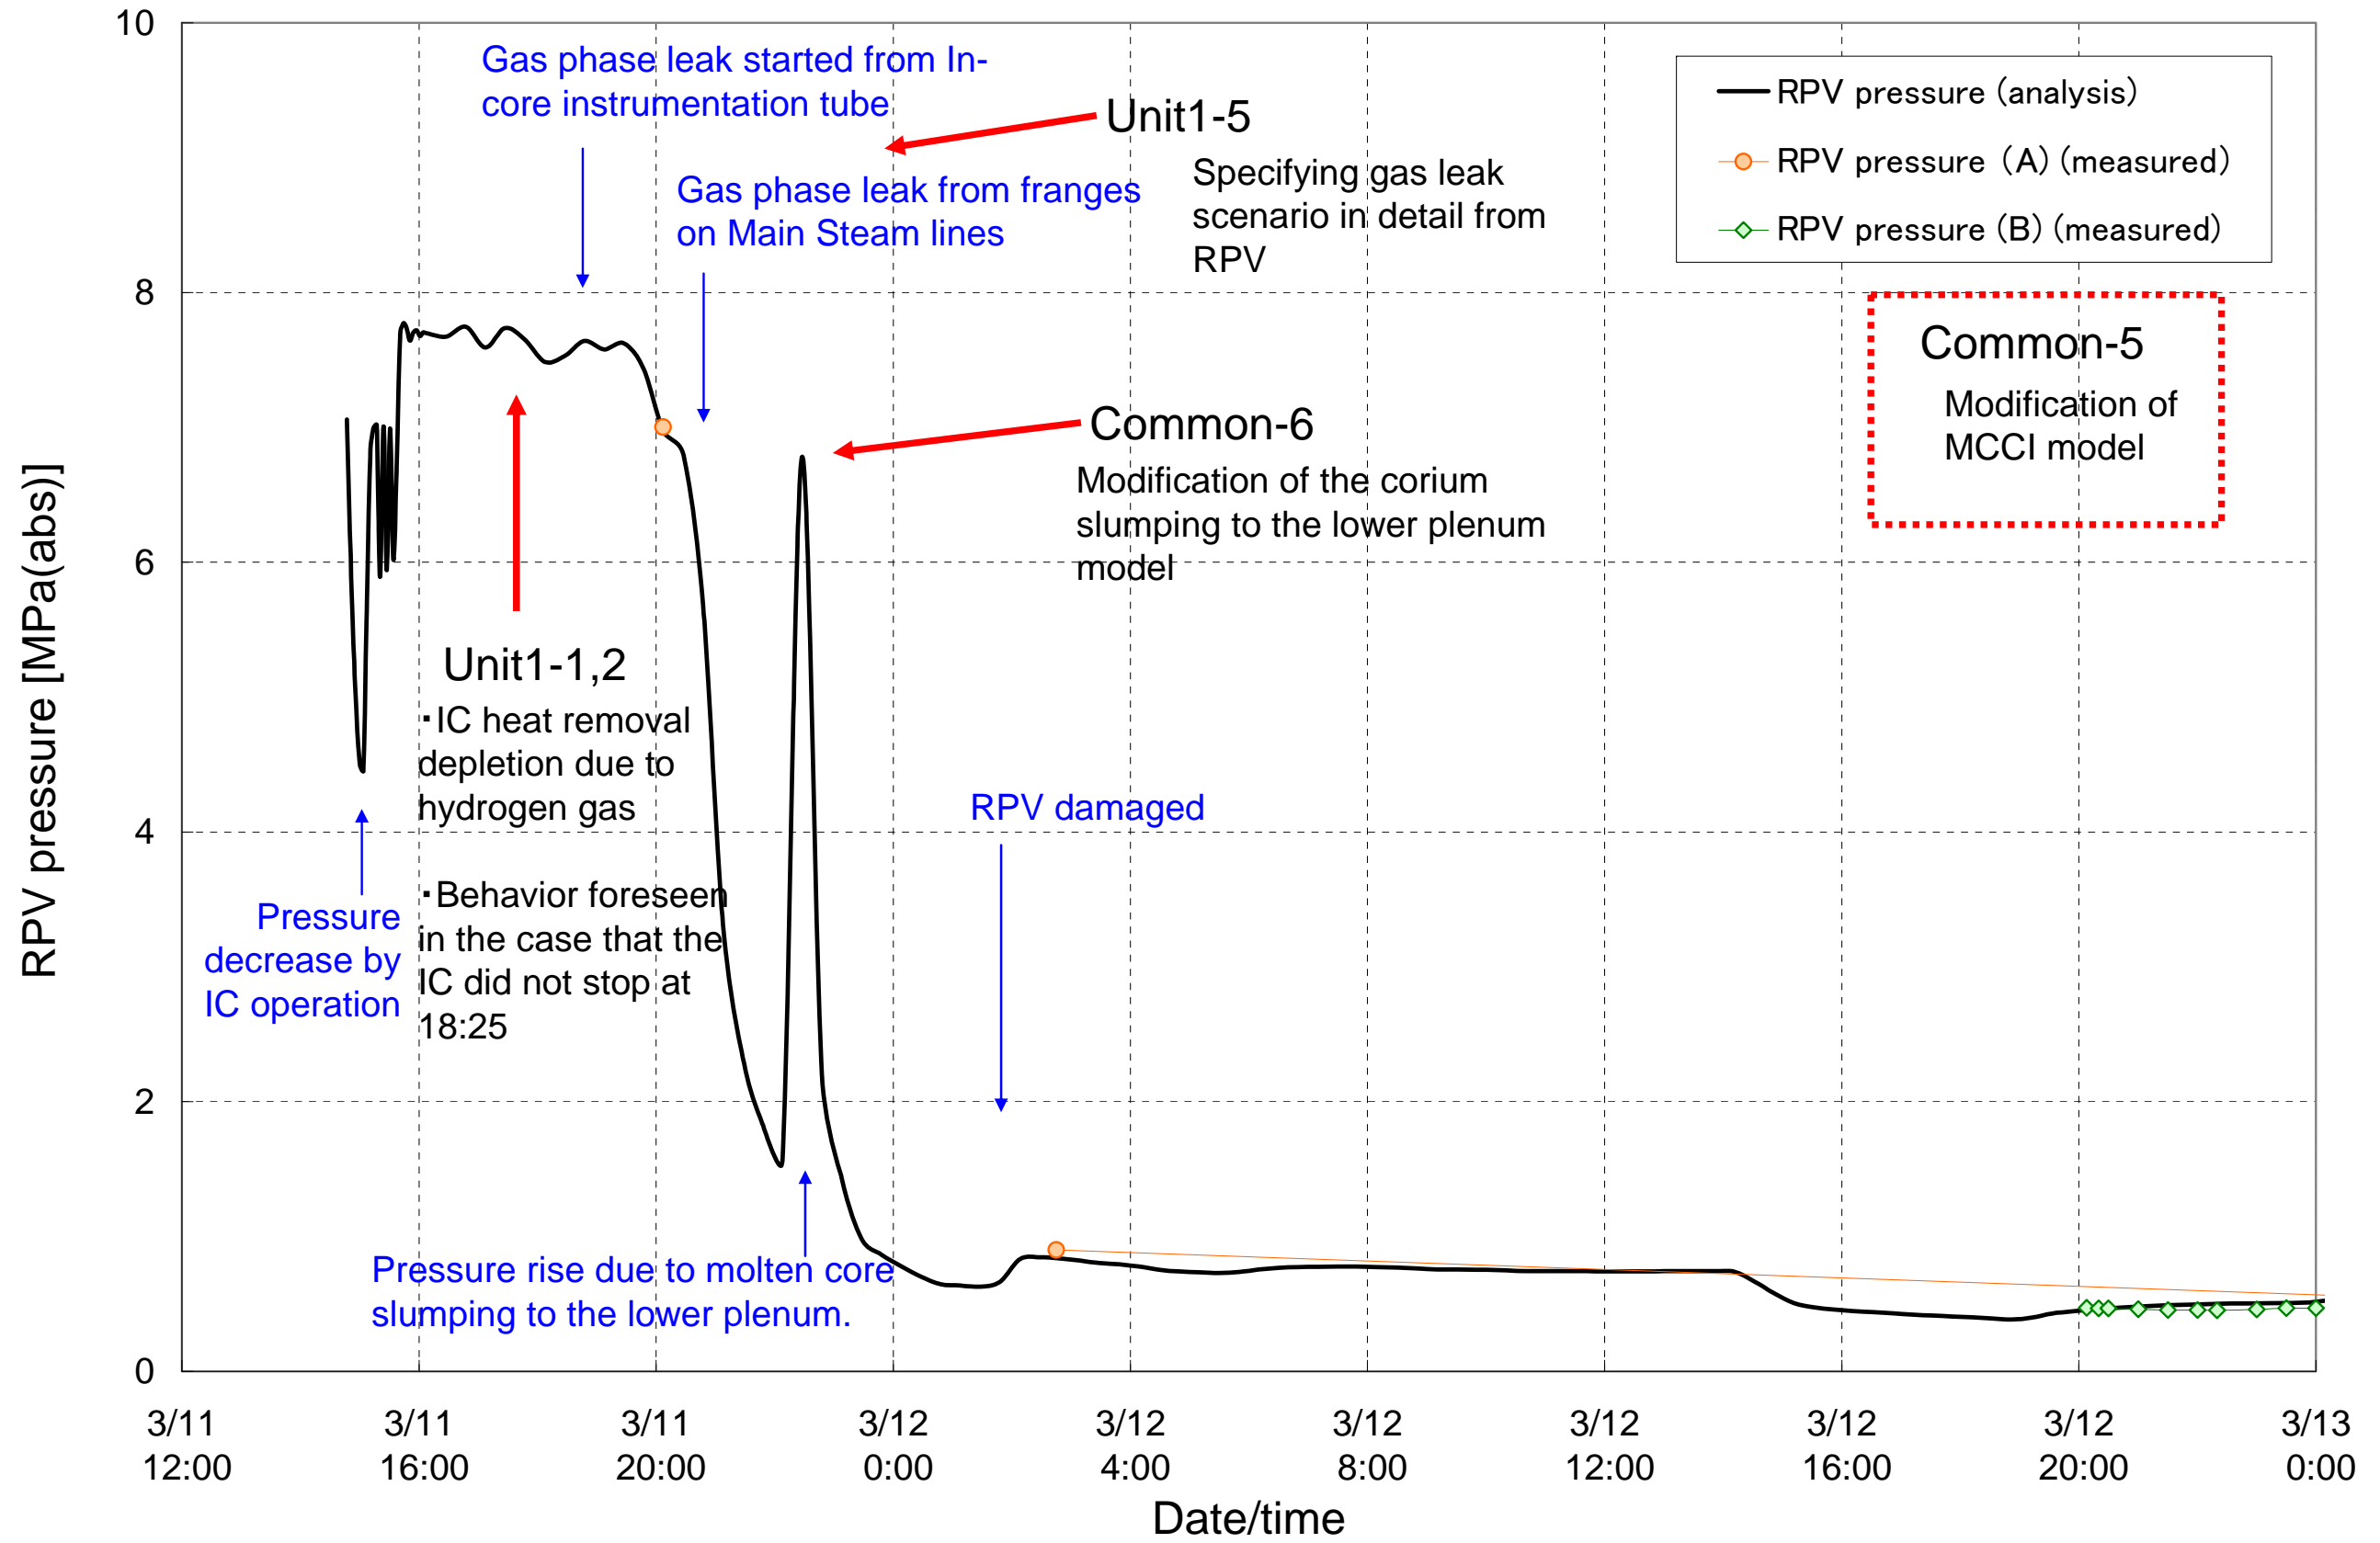
Figure 3.2.2 Issues derived from reactor pressure changes of Unit-1

The reactor pressure of 7.0MPa[abs] was measured at 20:07 on March 11th, and D/W pressure of 0.6 MPa[abs] at about 23:50; on March 12th, the D/W pressure of 0.84 MPa[abs] was measured at 02:30 and the reactor pressure of 0.9MPa[abs] at 02:45. In the meantime, although the exact timing is unknown, it was observed that at a certain time after 20:00 on March 11th, the PCV pressure showed a sharp rise and the reactor pressure decreased despite no depressurization actions.

In order to reproduce this pressure changes, a scenario was assumed in the analysis that steam had leaked to the D/W via in-core instrumentation dry tubes or main steam pipe flanges due to temperature rises in the vessel caused by overheating of uncovered fuels and fuel melting. But no direct evidence has been obtained showing any actual leaks at

these locations, from either the measured parameters or the observed facts. Further examinations are needed (Unit-1/Issue-5).

In the analysis results, the reactor pressure showed a sharp peak at about 22:00 on March 11th. It came from a model used in the MAAP analysis that the molten core collects and stays for a while on the core support plate, and then drops down after the plate is damaged to the lower plenum at one sweep, thus generating a big amount of steam. The relocation mechanism of molten fuel to the lower plenum is based on the knowledge of the TMI accident. As it is difficult to say that the model well simulates the complicated BWR structures, further examinations are needed to evaluate the molten BWR fuel relocation mechanism (Unit-1/Issue-6).

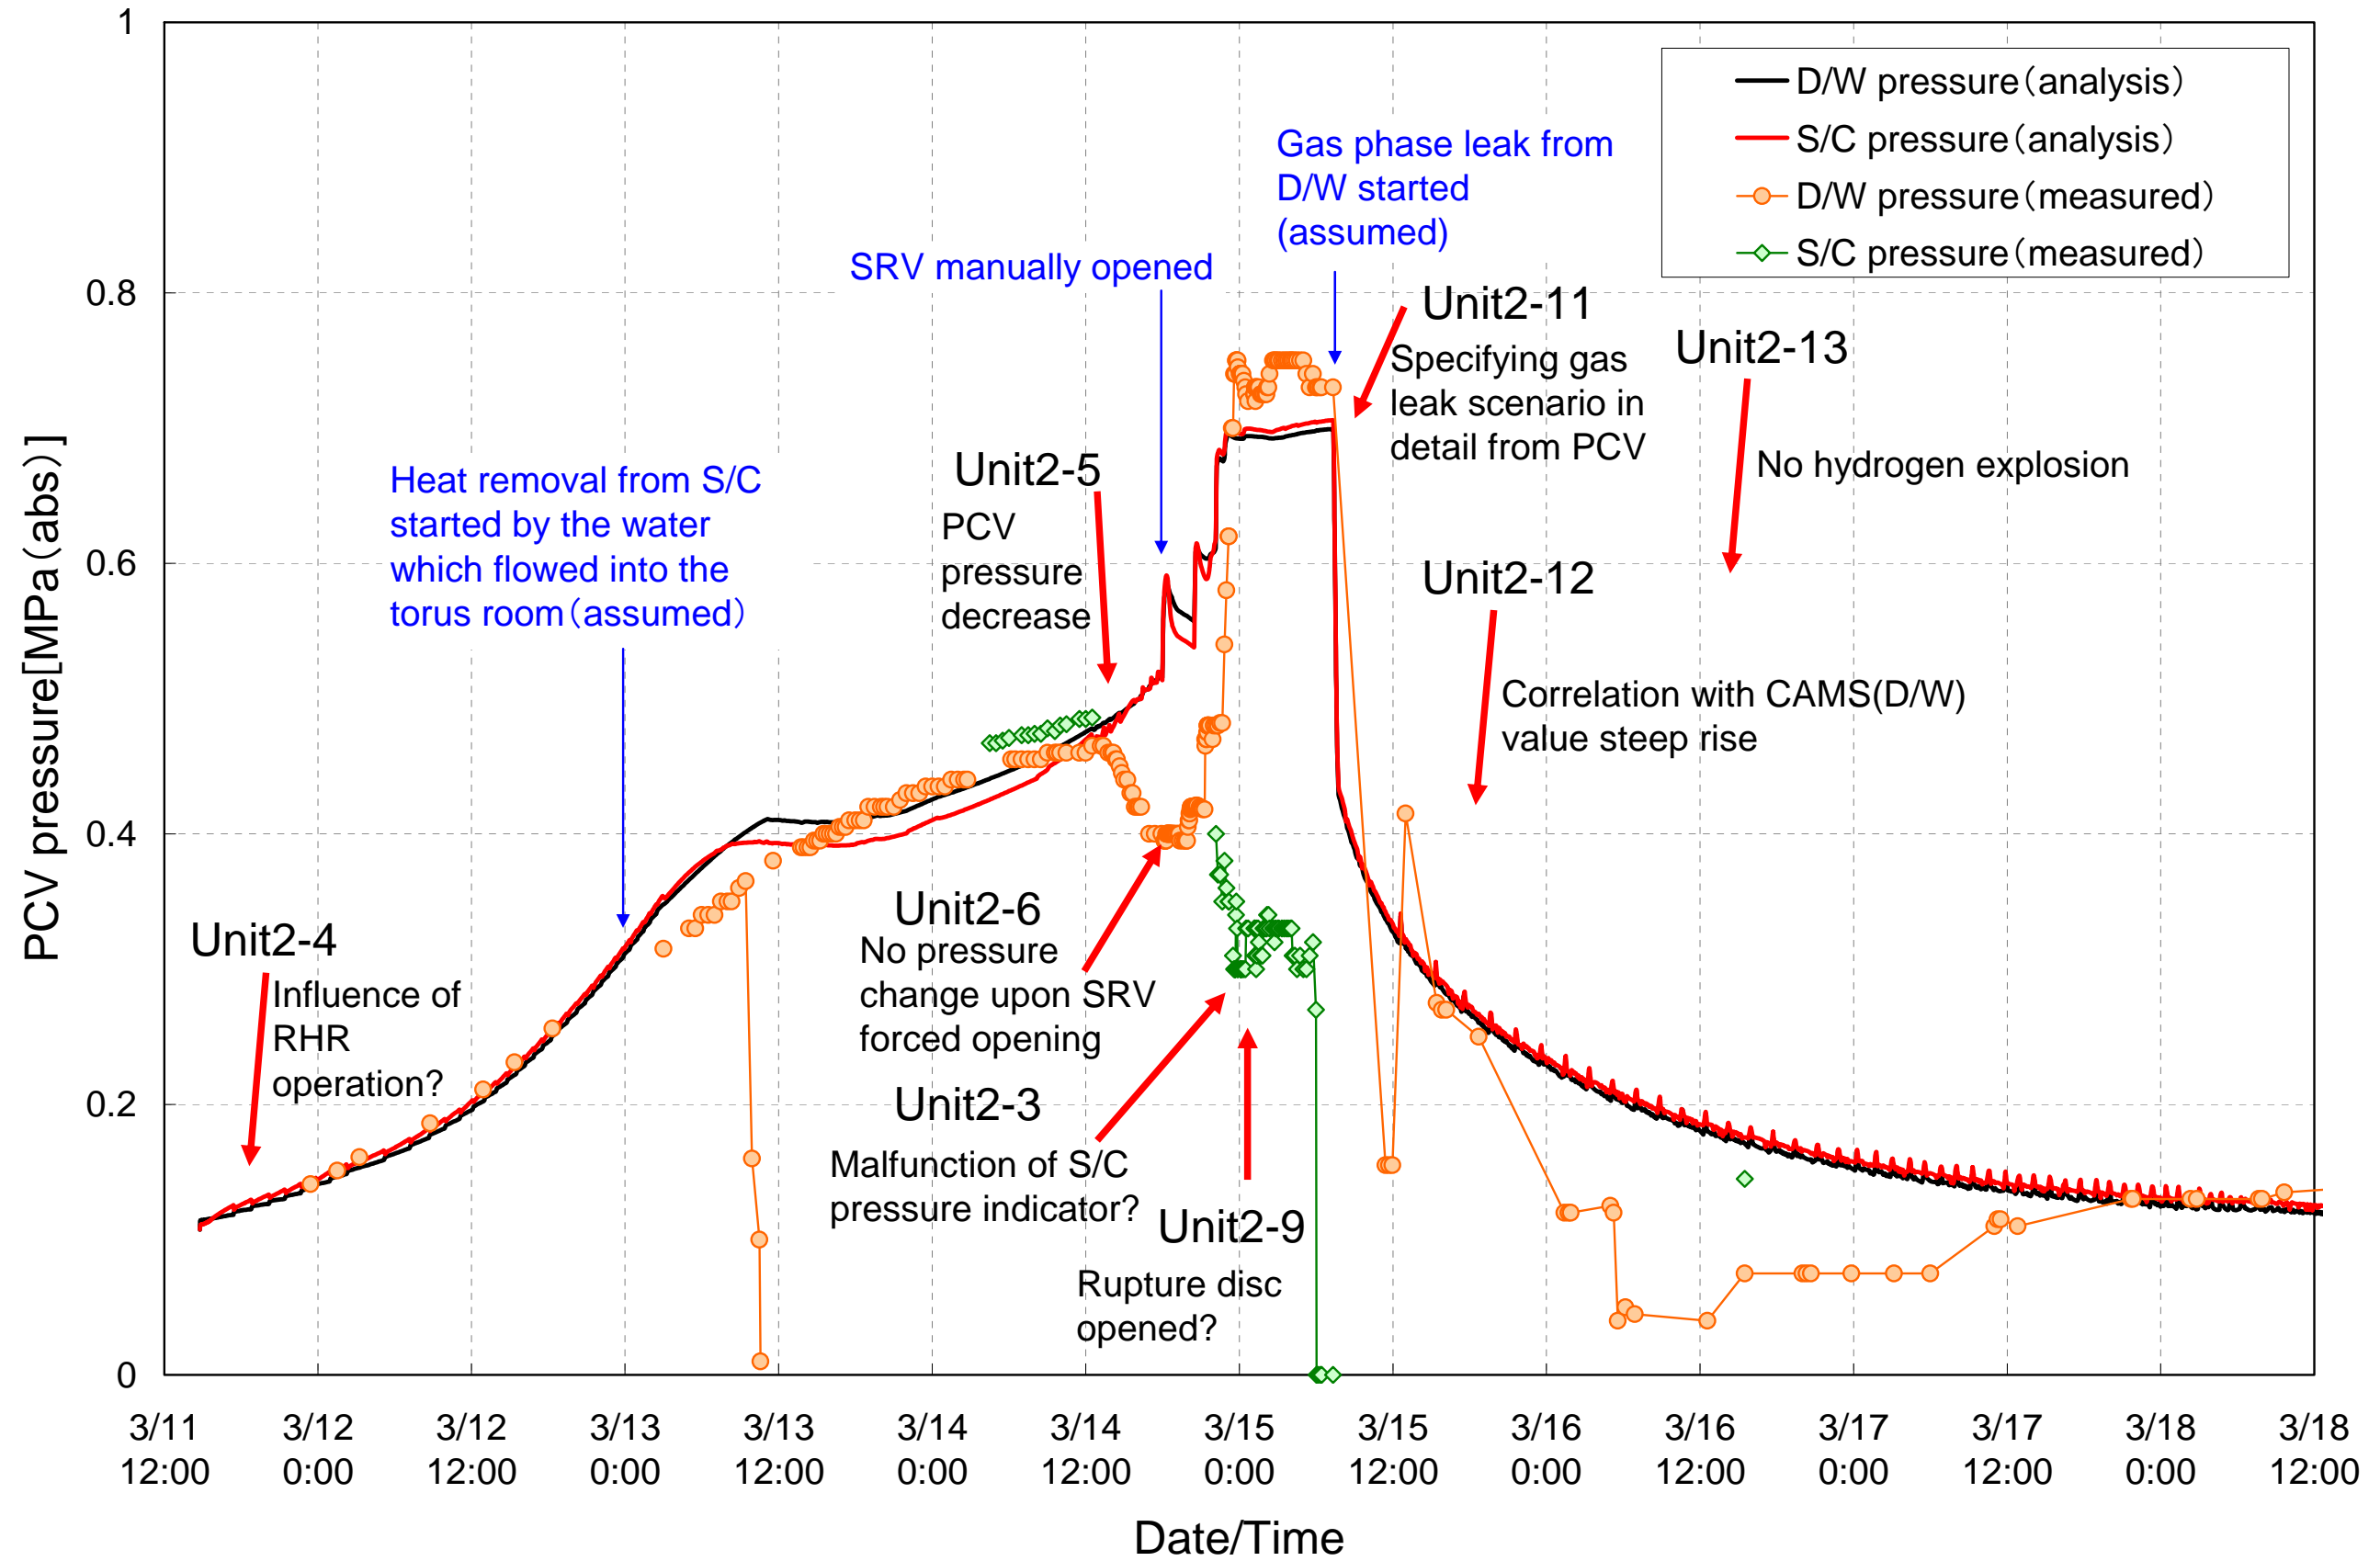
Figure 4.2.3 Issues derived from the containment pressure changes at Unit-2

During this period the D/W pressure was increasing but the analysis results provided lower values of increase and could not reproduce the pressure behavior observed until

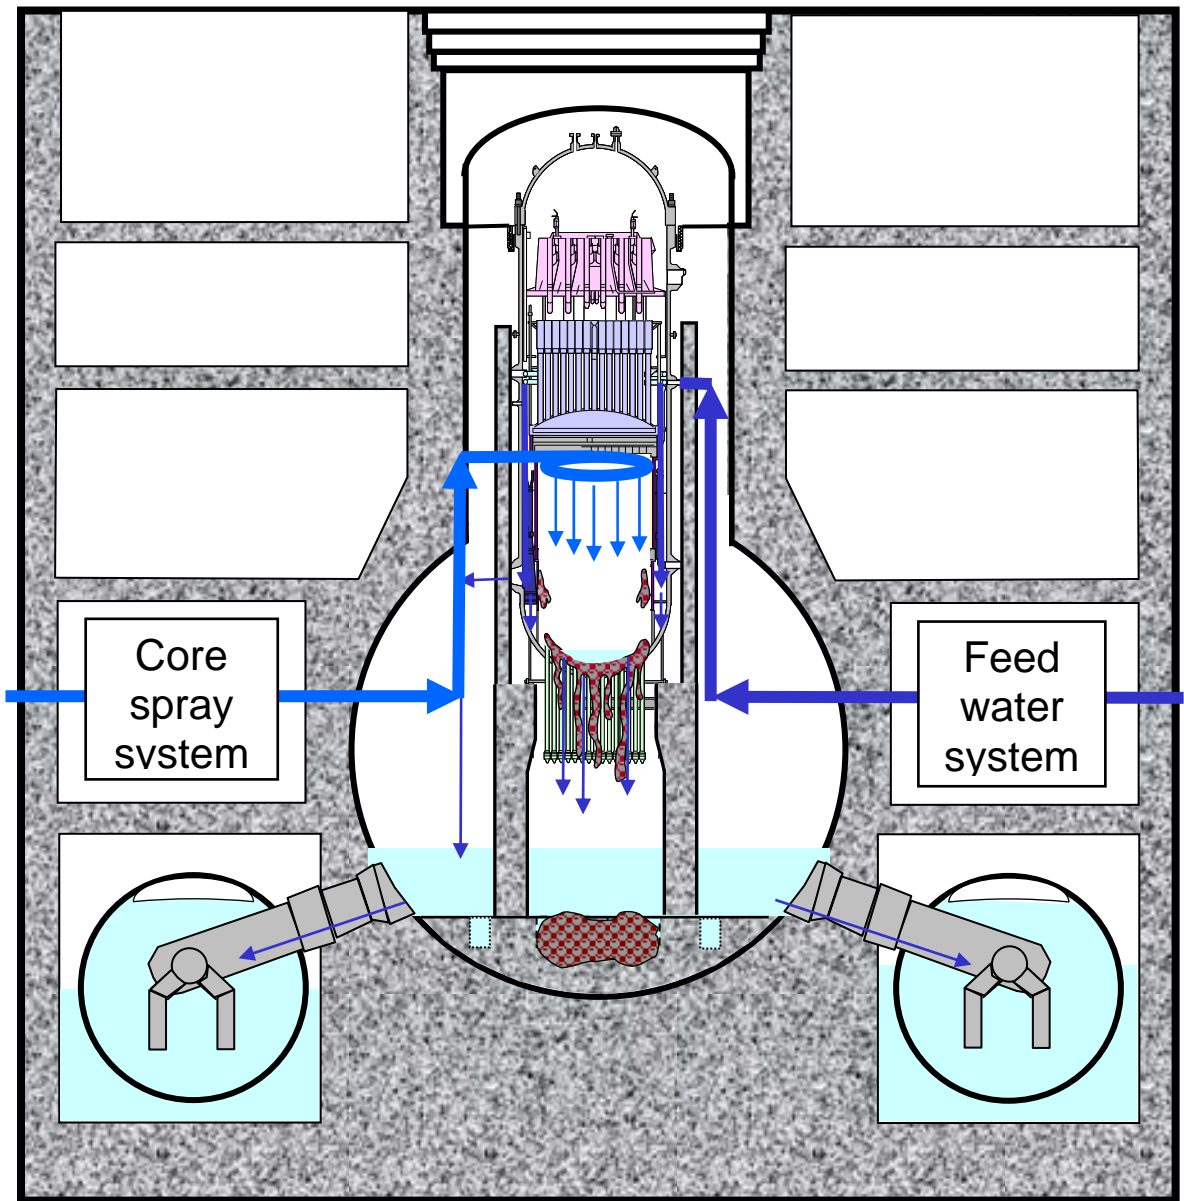
Figure 6.1.1 Estimated conditions of the core and PCV of Unit-1

pressure vessel or to the PCV pedestal. Some of the fuel may remain in the original core location. It has turned out, however, that there had been a situation of not sufficient water injection possibly due to HPCI manual shutdown by the operators. This indicates the accident progression was faster than the earlier estimation. In the figure, more fuel than before is assumed to have dropped to the PCV. On this matter, further detailed examinations are needed, including the molten core concrete interaction (MCCI) development behavior.

No measured values are available so far concerning the D/W water level. But it could be estimated to be about 5.5 to 7.5m above the floor by converting the S/C pressure to water head. The S/C pressure was obtained from its existing pressure indicators, not calibrated since the accident, so they do not have high accuracies but they could be reliable as a trend to a certain extent because they have followed the pressure changes according to the water injection.
