Impacts of the earthquake on Unit-1

1. Overview of the incident and subjects for examination

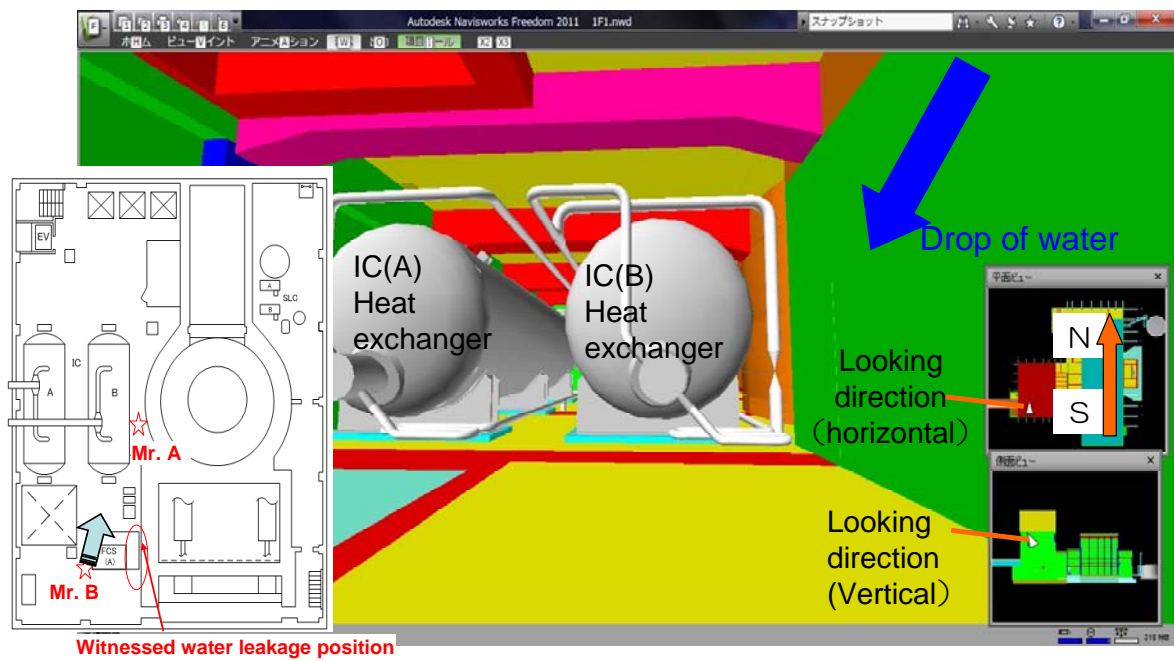
The actual positional relations on the site can be estimated as illustrated in Figures 1 to 3 from the statements of Person B, who confirmed water leaking from the nearest position, and Person A, who confirmed water leaking in the direction of Person B. As can be seen in Figure 1, Person B stood immediately next to the hatch of the opening of the carrying-in entrance, was able to see the IC in front of him, and confirmed water leaking from the upper right. Person A, on the other hand, as can be seen in Figure 2, was hiding between the IC and containment vessel, from where he confirmed water leaking from his upper left in the direction toward Person B. Statements of these two people concerning the leak position (arrows) illustrated in Figures 1 and 2 are consistent. Therefore, it seems certain that the water was leaking from an elevated position of the east wall, as shown in Figure 3. According to a document ^{*1)} of the Nuclear Regulatory Authority (NRA) of Japan, Person A stood between the IC (A) tank and IC (B) tank. In whichever position he was confirming the water leakage at the time, there is no difference in the direction of the water leakage.

Figure 1 Situation of Person B at the time

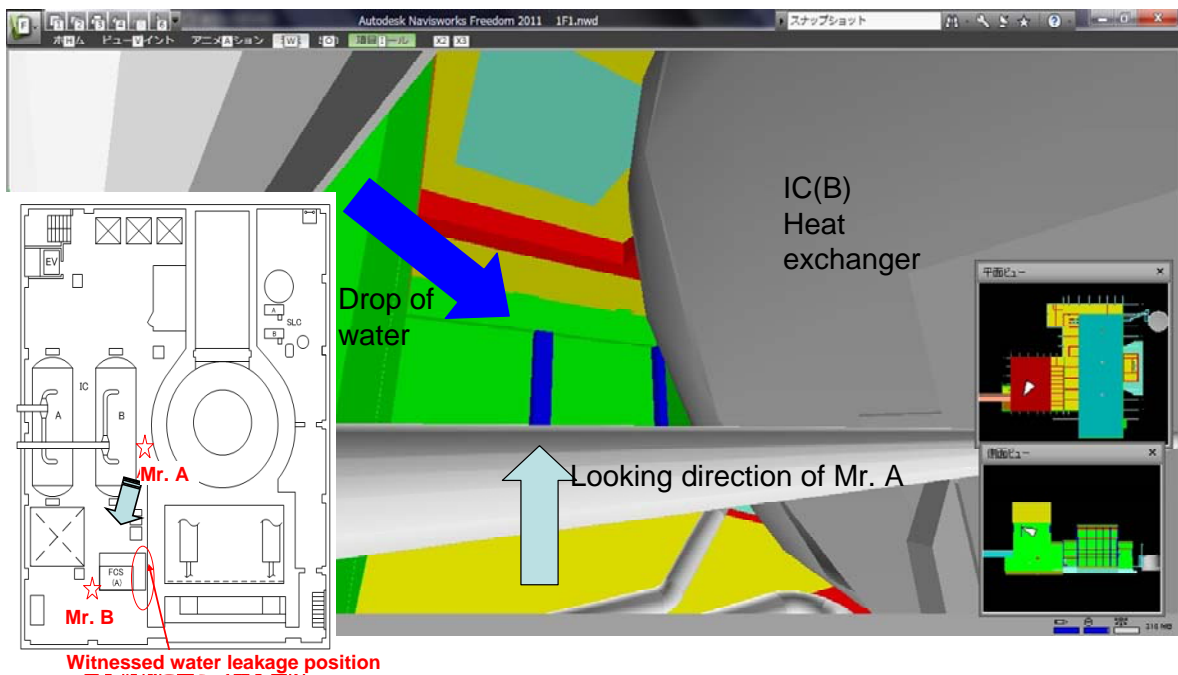
Figure 2 Situation of Person A at the time

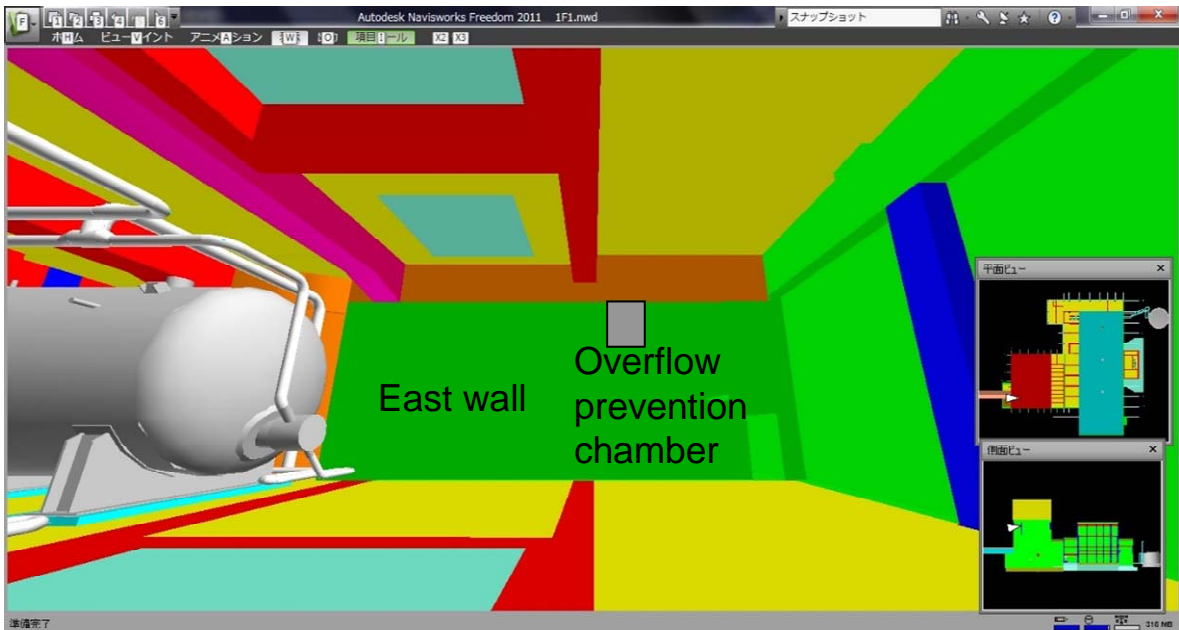
As clearly understood, the water leakage was confirmed not from the IC itself but from some other direction. It is difficult to assume the water leaked was the steam, which flowed into the IC, or the condensate for return.

Figure 3 Position of water leak

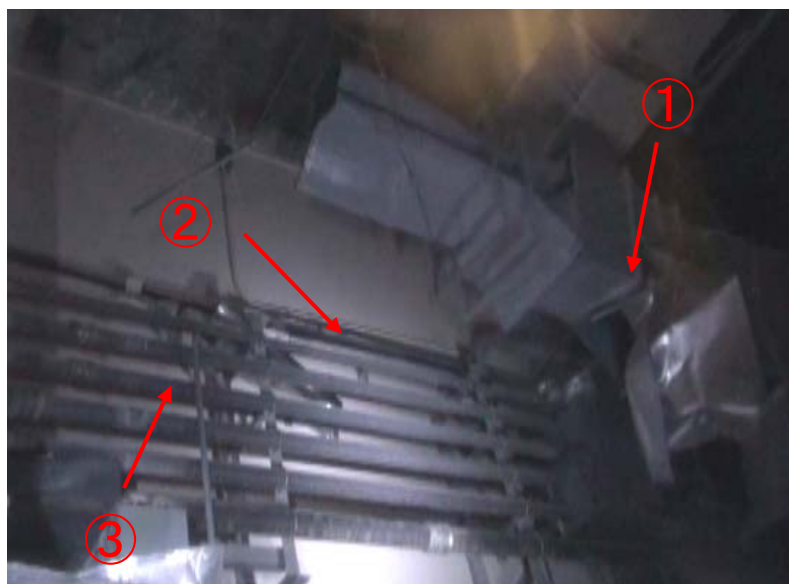
On the east wall, from where water was leaking, there were pipes and ducts, as shown in Figure 4. Among them, those pipes which could have contained water or steam were the overflow prevention chamber (①) and the IC steam venting line (②). Other multiple pipes (③) are for electric cables and contain no fluid in them.

The overflow prevention chamber was connected to a duct which took in air from the surface of the spent fuel pool and discharged it to the outside. In the case that water of the spent fuel pool flowed into the duct, this overflow prevention chamber was installed to receive the water first and then drain it via a drain line. But at the time of an earlier earthquake, an incident had been experienced in which water of the spent fuel pool flowed into a duct due to sloshing, the water was too much to be drained by the drain line, part of that water flowed further into another duct downstream, and leaked outside the radiation control area. Based on this lesson, modification work had been done to isolate the overflow prevention chamber and the duct downstream by a diaphragm.

The IC steam venting line had a role to prevent water hammers in the IC steam line. To this end, steam was constantly circulated during normal plant operations in order to warm the steam line. Once the IC started up, this venting line was isolated by a valve and no more steam was circulated. Although it is not known whether the IC was operating when the water leaked, because it is not known when the water leakage was observed, but at any rate the leakage from this path does not last long, i.e., a LOCA scenario does not exist on this path.

The fluid of the IC steam venting line was steam, and no liquid water leaked but high temperature steam of high pressure would have blown out even if a pipe break occurred. The statements are quite different from this situation. The on-site investigation conducted in later days found no pipe damage on this line, either. The overflow prevention chamber was completely destroyed so had not kept its original shape, perhaps due to the hydrogen explosion. However, from the following reasons, the water confirmed leaking on the 4th floor could be assumed to have come to the overflow prevention chamber from the spent fuel storage pool and leaked out for some reason.

Figure 4 Pipes on the east wall

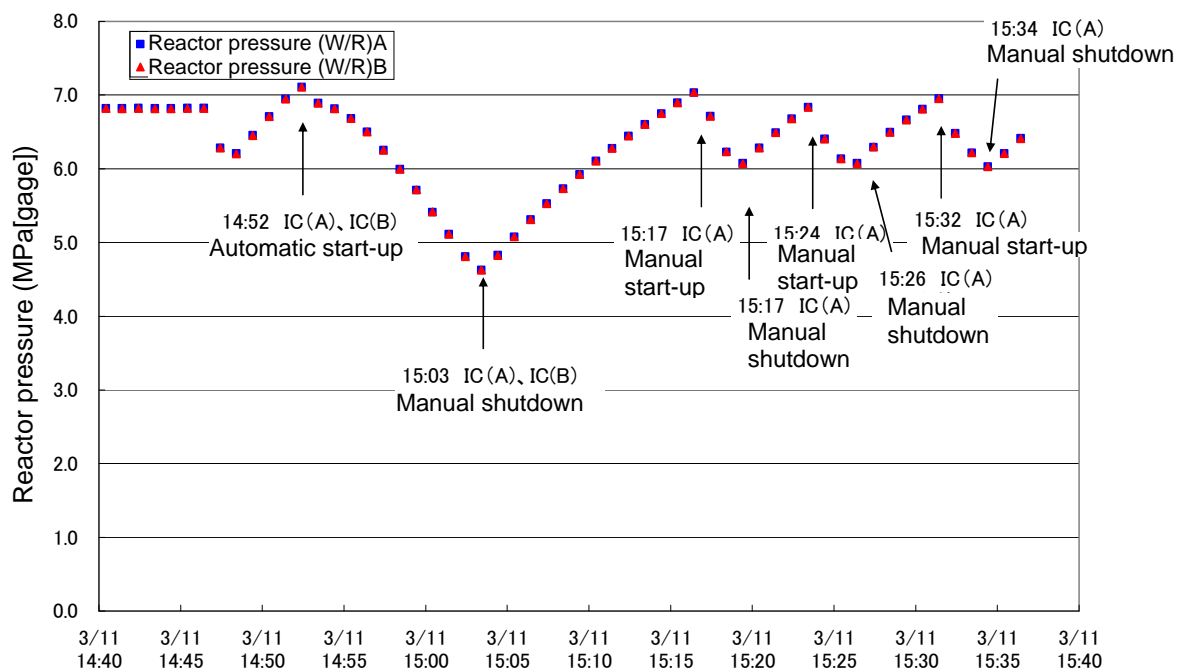
Figure 6 presents the reactor pressure changes and the IC maneuvering actions by the operators. At 14:47 on March 11th, the earthquake occurred and Unit-1 was scrammed by the “large seismic acceleration” signal. The reactor pressure decreased a little at the time of the scram, but started to increase thereafter due to steam production by decay heat. IC (A) and IC (B) were automatically started up at 14:52 when the reactor pressure reached the preset level for automatic IC start-up. It should be noted that the preset pressure for automatic IC start-up was lower than the SRV working pressures and therefore SRVs did not work when the ICs were started up.

After IC (A) and IC (B) started up, the reactor pressure started to decrease by their cooling effects and pressure was cut to 5MPa in about 10 minutes. This means that the coolant temperature in the reactor dropped about 20 deg C in about 10 minutes, because the

saturation temperature of reactor coolant is about 285 deg C in normal operations with about 7MPa, while about 265 deg C when the pressure drops to about 5MPa. This temperature change rate exceeded the upper limit of the rate allowed for normal cooling at reactor shutdown, which is 55 deg C per one hour. For negating the possibility of a leak causing at the rapid pressure decrease, and for reducing the cooling speed (temperature decrease rate) and controlling the reactor pressure, the operators manually shut down IC (A) and IC (B).

The pressure started to increase again and reached about 7MPa. Thereafter, three times the operators repeated manual start-up and manual shutdown. In all actions, the pressure increase and decrease were under the operators' control.

Figure 6 Reactor pressure change prior to tsunami arrival, and operators' IC maneuvering actions.
