**Fukushima Daiichi Nuclear Power Station  
Leakage from the Contaminated Water Storage Facility RO Concentrated  
Water Reservoir  
(Final Report)**

Filed, June 2014  
Revised, October 2014  
Tokyo Electric Power Co., Inc.

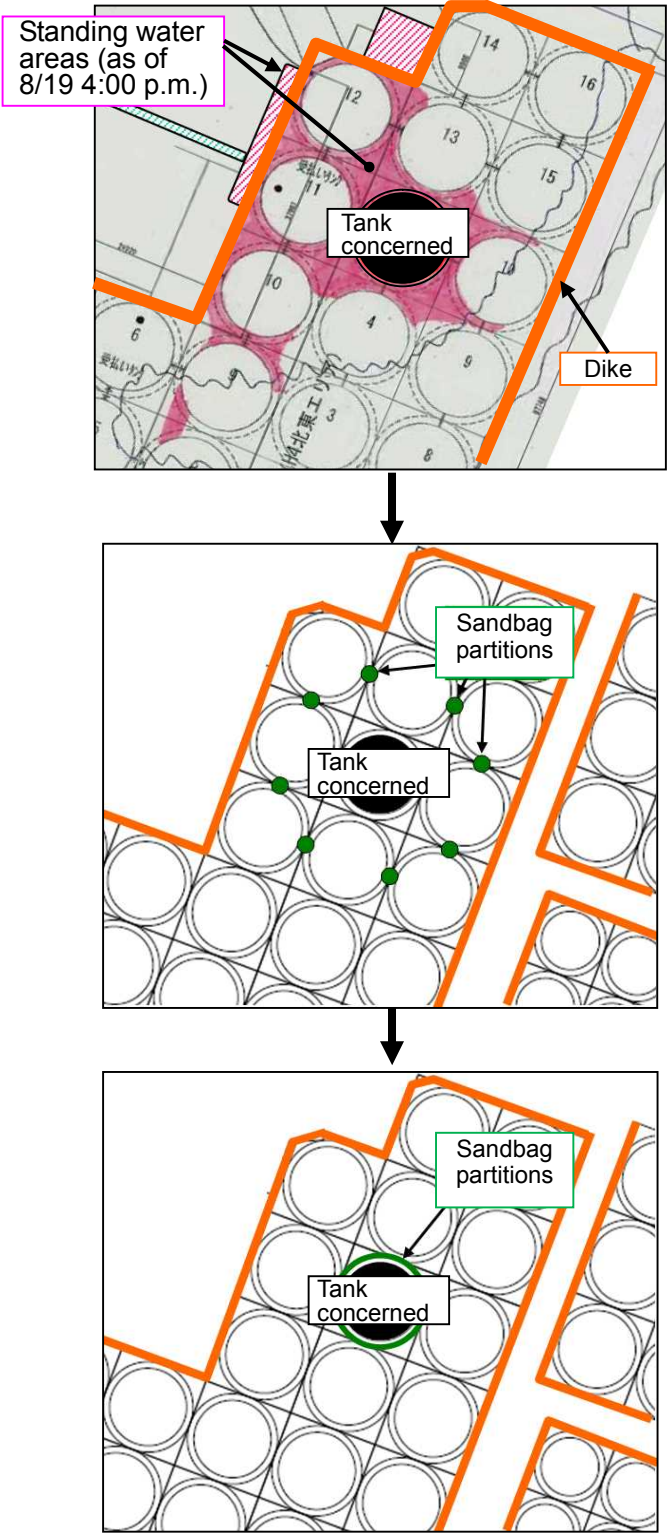
**Fig. 1 Water leak locations**

- : Areas with standing water (as of 8/19 4:00 p.m.)
- : Drain valve and catch basin where an outflow was confirmed
- : Nearby drain valve that was closed and its catch basin

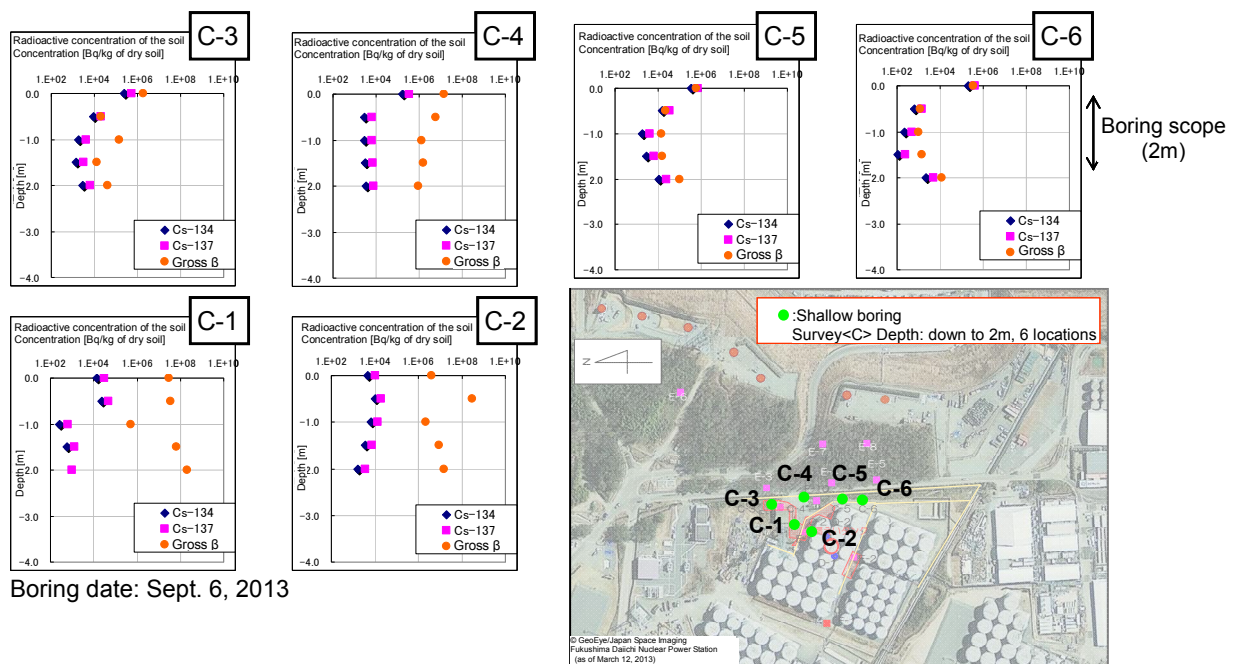
- At locations C-1, C-2, C-3 and C-4 on the northeast side of the tanks in area H4 where contaminated water has leaked, soil was contaminated with a high concentration of radioactive material. Not only cesium, but gross  $\beta$  radiation concentrations were also high, as the impact of the contaminated water.
- At location C-3 far from the dike, gross  $\beta$  radiation concentrations were low compared to locations C-1 and C-2 near the dike, indicating that a relatively small amount of contaminated water reached that distance.
- On the other hand, at locations C-5 and C-6 on the southeast side of the dike, the ground surface showed a high concentration, but the concentrations of cesium and gross  $\beta$  radiation were about the same, probably as a result of the cesium  $\beta$  dose that adhered near the ground surface after the accident.

Fig. 1 Results of a shallow boring survey

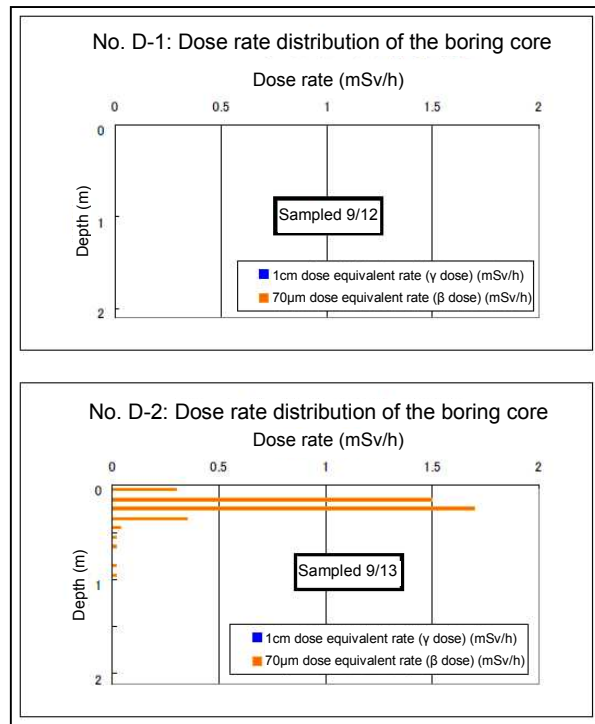
Fig. 1 Results of a boring survey directly under the leaking tank (measurement of dose equivalent rate)

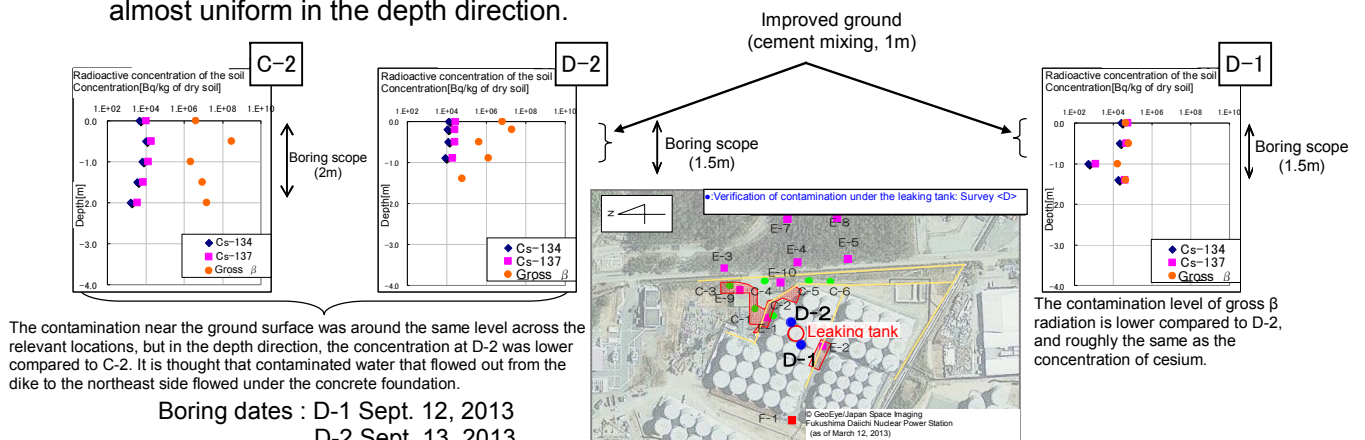
- The soil beneath the concrete foundation had been improved (stirred) down to a depth of 1m at the time the ground was developed in the tank area. It is thought that this made the cesium concentration almost uniform in the depth direction.

Fig. 2 Results of the boring survey under the leaking tank (nuclide analysis)

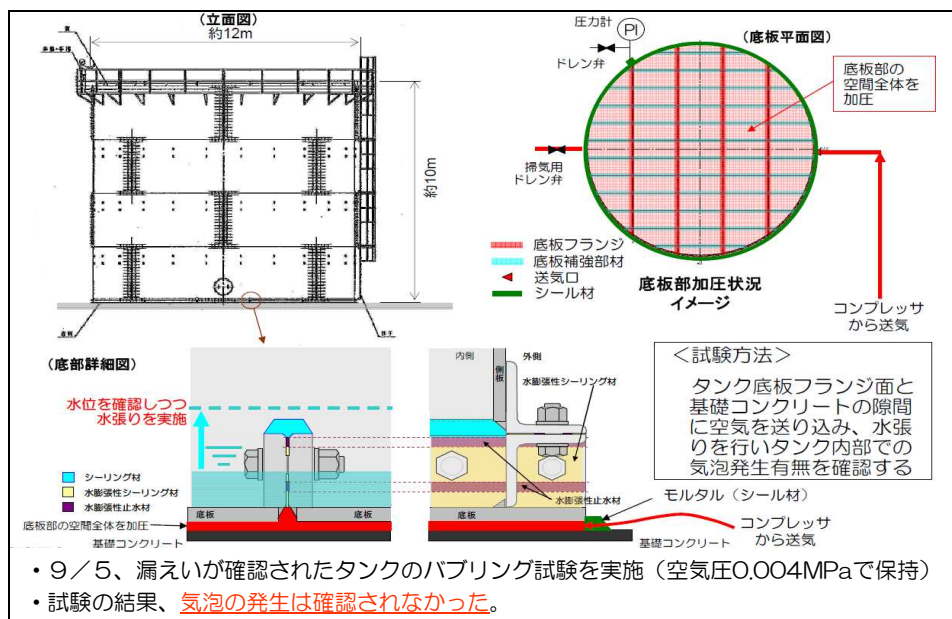
Fig. 2 Investigation Results (1) (baseplate bubbling test results)

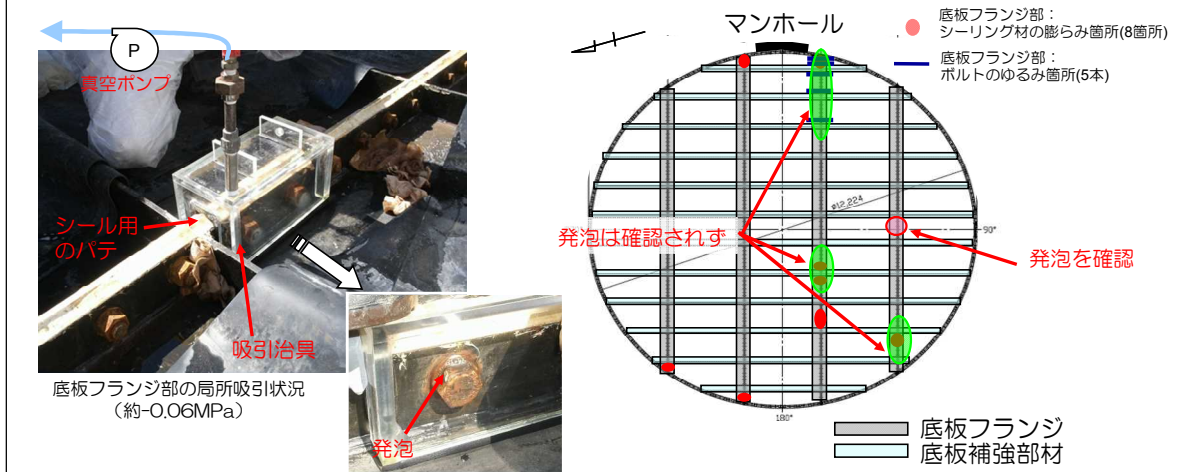
- 底板バキューム試験にて泡が吸い込まれた箇所、ボルトの緩みが確認された箇所、シーリングの膨らみが確認された箇所（代表部）に対し、局所バキューム試験を実施したところ、泡が吸い込まれた箇所から発泡を確認した。また、ボルトの緩み部、シーリングの膨らみ部については、発泡は確認されなかった。

Fig. 4 Investigation Results (3) (localized vacuum test on baseplate)

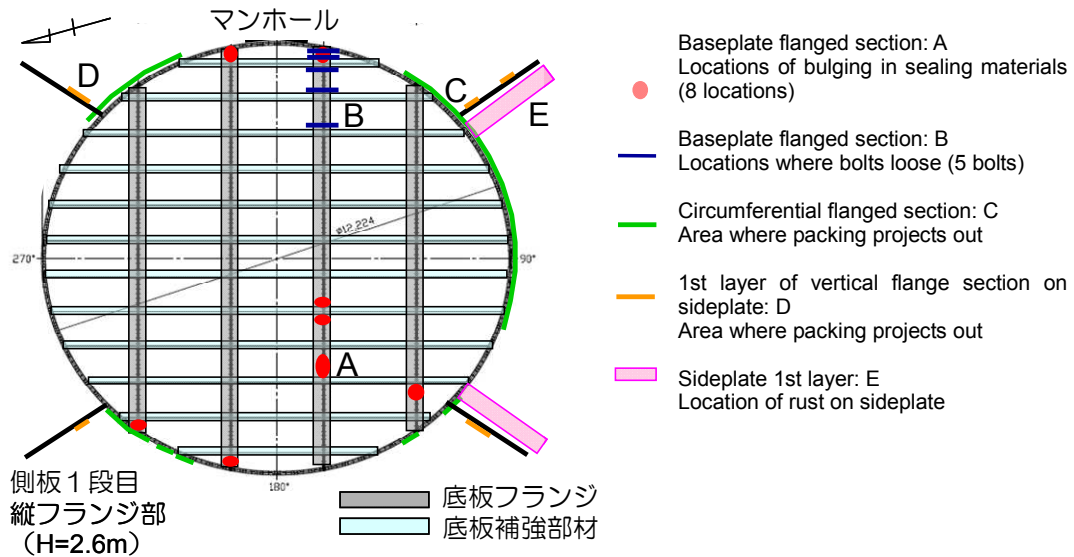
- A visual check of inside the tank was performed, confirming there were deformations and damage in the sealing material on the flanged section between the sideplate bottom part and baseplate, as well as that on the flanged section of the baseplate (confirmed also at tank No. 10 where there was no leakage).
- The state of fastening was checked through a bolt tapping test, confirming looseness in 5 bolts.
- Rust was confirmed running vertical on one sheet on the inner surface of the sideplate's first layer.

Fig. 5 Investigation Results (4) (results of bolt tapping and visual checks)

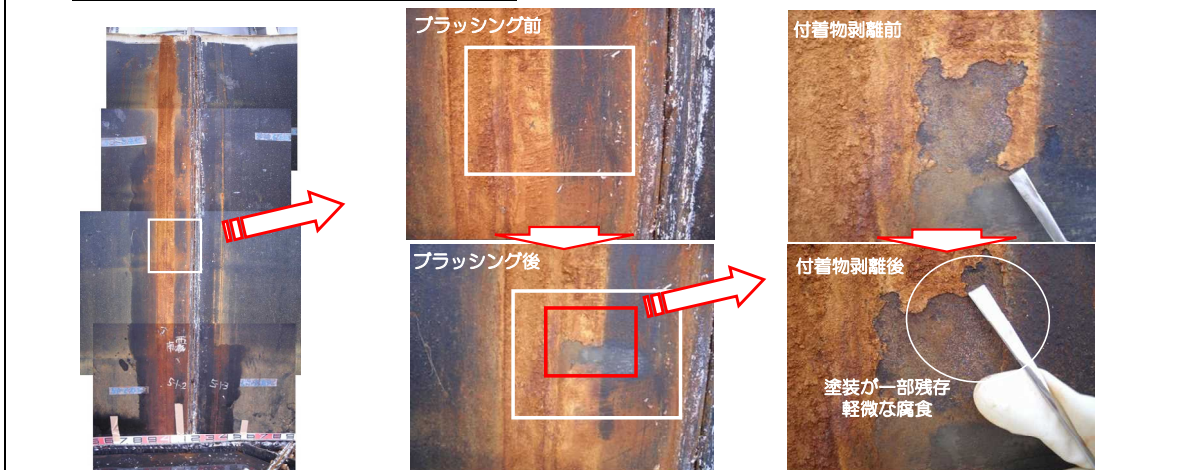
- The coating for the most part remains below the discoloration, with corrosion under the coating only slight. It is not thought to be something that will affect integrity.

Fig. 7 Investigation Results (4) (rust outbreak confirmed on inside sides)

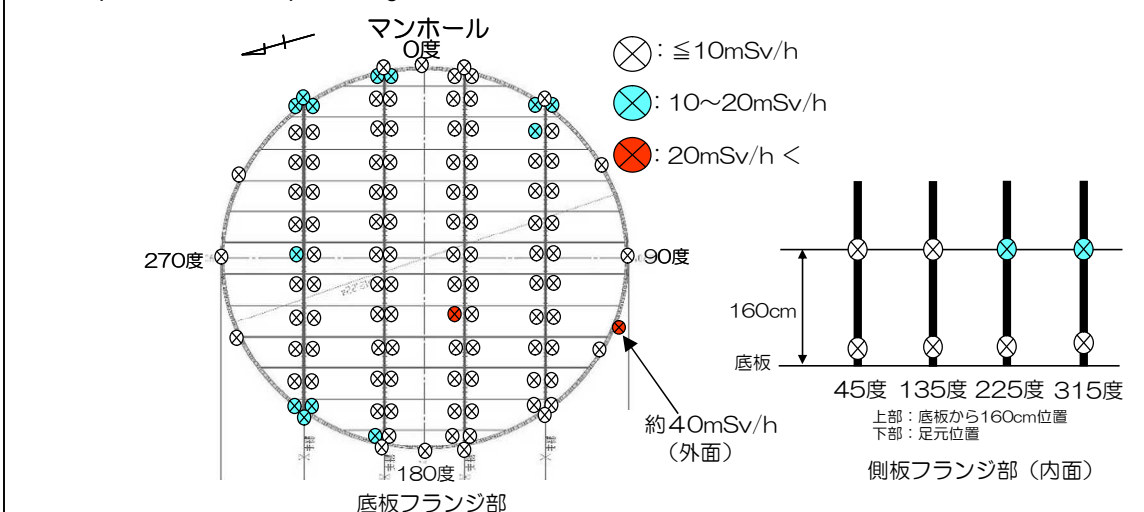
- The results of the dosage measurements for the flanged sections on the tank's inner surfaces were largely 10 mSv/h or less (beta: 70  $\mu$ m dose equivalent rate) with a maximum of approximately 22 mSv/h (beta: 70  $\mu$ m dose equivalent rate).
- The results of the dosage measurements on the tank's outer surfaces (sideplate 1st layer and baseplate periphery) were 10 mSv/h or below for the most part, but one location (rusted section) with relatively high radioactivity (approx. 40 mSv/h) was confirmed near the welded section connecting the sideplate and the sideplate flange.

Fig. 8 Investigation Results (5) (radiation dosage measurements)

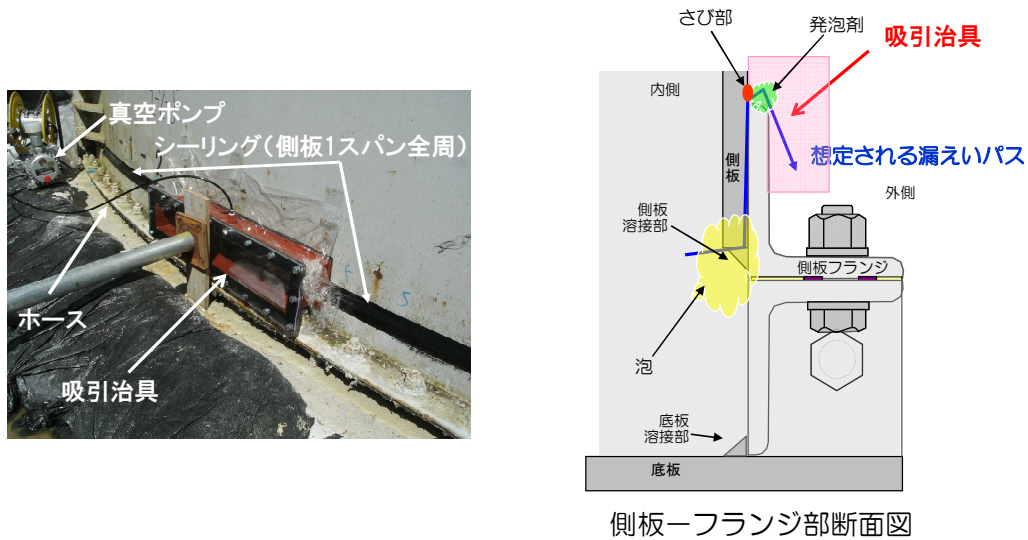
- Localized suction (-0.06 MPa) was applied (9/19) to the location (rusted section) where relatively high radioactivity was detected near the welded section connecting the sideplate and sideplate flange.
- The bubbling agent applied to the section in question did not produce continuous foaming. Foam coated on the inside of the tank likewise was not suctioned in.

Fig. 9 Investigation Results (6) (vacuum test on sideplate)

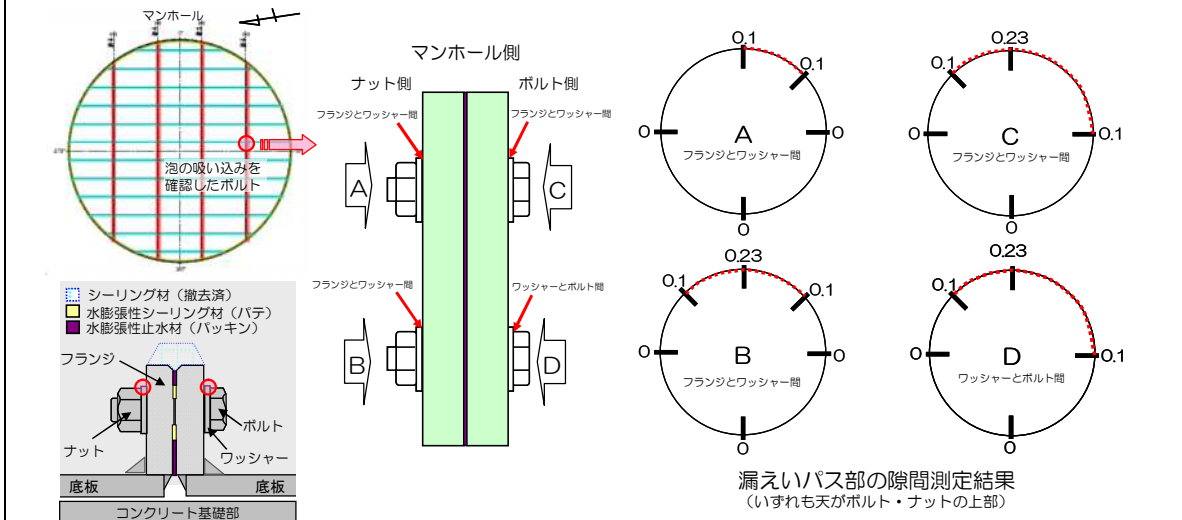
- For those bolts where possible leakage paths were detected in the baseplate vacuum test, the gaps at sites of leakage paths (those between flanges and washers, and washers and bolts) were measured using a feeler gauge confirming the maximum gap to be approx. 0.23 mm.

Fig. 6 Investigation Results (5) (measurements of gaps at bolts)

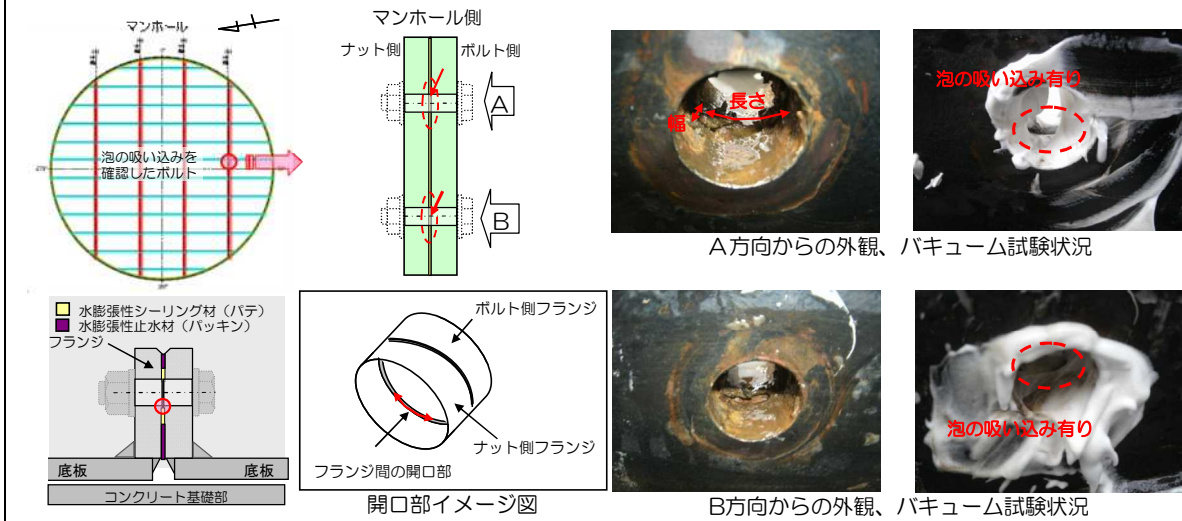
- The 2 baseplate bolts confirmed to be leakage paths were removed and both a visual check of external appearance and baseplate vacuum test were performed.
- The external appearance visual check confirmed that in the lower part of the gap between flanges at the bolt holes had opening that were approx. 3 mm wide and 22 mm long at the bolt to the east side and approx. 2 mm wide and 11 mm long at the bolt to the west.
- The baseplate vacuum test confirmed that foam was suctioning in from the confirmed opening.

Fig. 7 Investigation Results (6) (check of baseplate flange bolt holes)

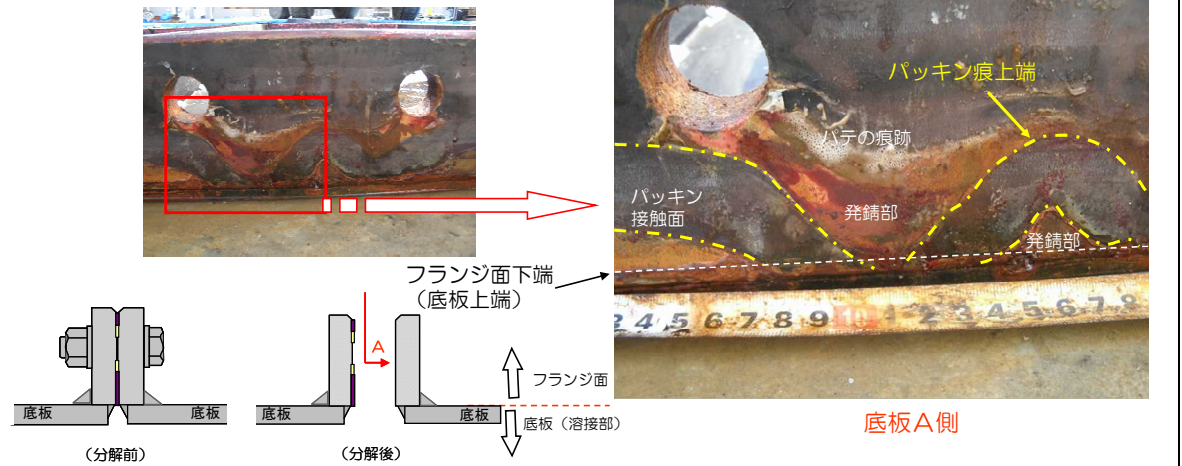
- A check of the flange surfaces found that the surfaces at the point of contact with packing at leakage path locations were considerably askew, and that the upper edge of packing traces was penetrating through the lower edge of the flange surface.
- Rust outbreaks were discovered between the putty and upper edge of the packing traces on the flange surface, as well as on the outer surface of the tank baseplate.
- The rust outbreaks on the flange surface and outer surface of the baseplate are thought to be corrosion produced by water that got into the gap that emerged between the putty and upper edge of the packing and went through to the bottom.

Fig. 10 Investigation Results (8) (leakage path inspections)

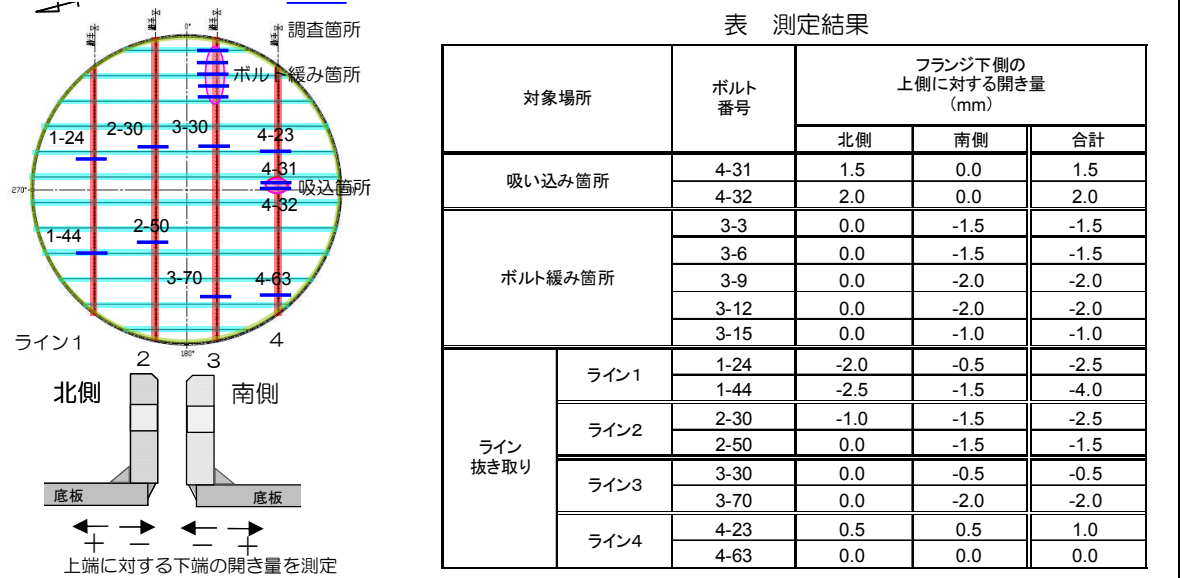
- The openings at flanges (the opening of the lower edge with respect to the upper edge) were measured for those flanges that had leakage locations.
- Openings on the bottom sides of the flanges were confirmed at those locations with suctioning and on line 4, but they were slight (on the order of 1 to 2 mm) compared to the separation between the upper and lower edges (approx. 116 mm).

Fig. 11 Investigation Results (9) (measurements of openings at baseplate flanges)

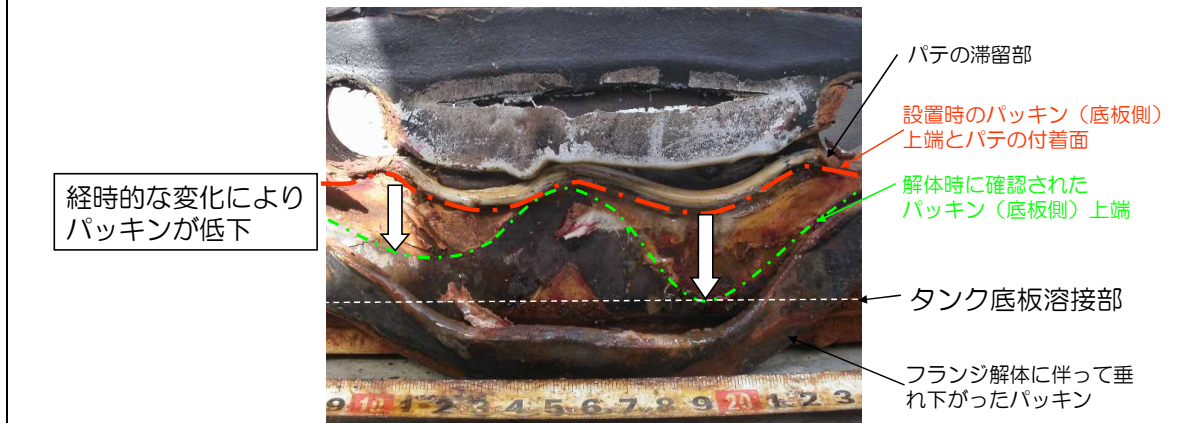
- 漏えい部のフランジ接合面におけるパテの残存状況から、ボルト締め付け時にパッキン（底板側）に若干うねりが生じた可能性はあるが、概ね水平に設置されていたと推定。
- なお、タンク設置時の水張試験において、水位に変化がないこと（漏えいがないこと）を確認。
- 最終的なパッキン（底板側）上端の痕から、ボルト締め付け時以降、気温変化等によるフランジの熱膨張、収縮とタンク水圧等により徐々に落下し、最終的に底部に抜けて開口に至ったものと推定。

Fig. 1 Surmises regarding the process by which leakage paths formed

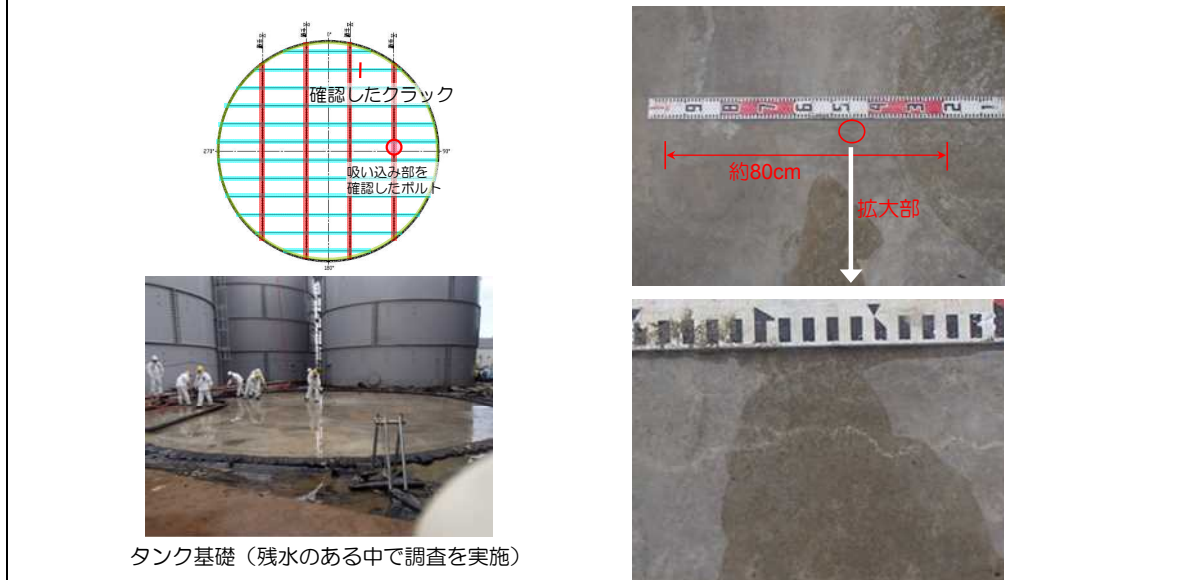
- タンク底部解体後に若干の残水（水深数mm）がある状況の中、コンクリート基礎の調査を実施した結果、非常に微細で、かつ密着したクラック（幅0.03mm以下、長さ約80cm）を1箇所確認
- なお、当該タンク付近の溜まった雨水の水位が低下する傾向はみられていない

Fig. 1 Visual check of concrete foundation
