Evaluation of the situation of
cores and containment vessels of
Fukushima Daiichi Nuclear Power Station
Units-1 to 3 and examination into unsolved
issues in the accident progression

Progress Report No. 3

May 20, 2015

Tokyo Electric Power Company, Inc.

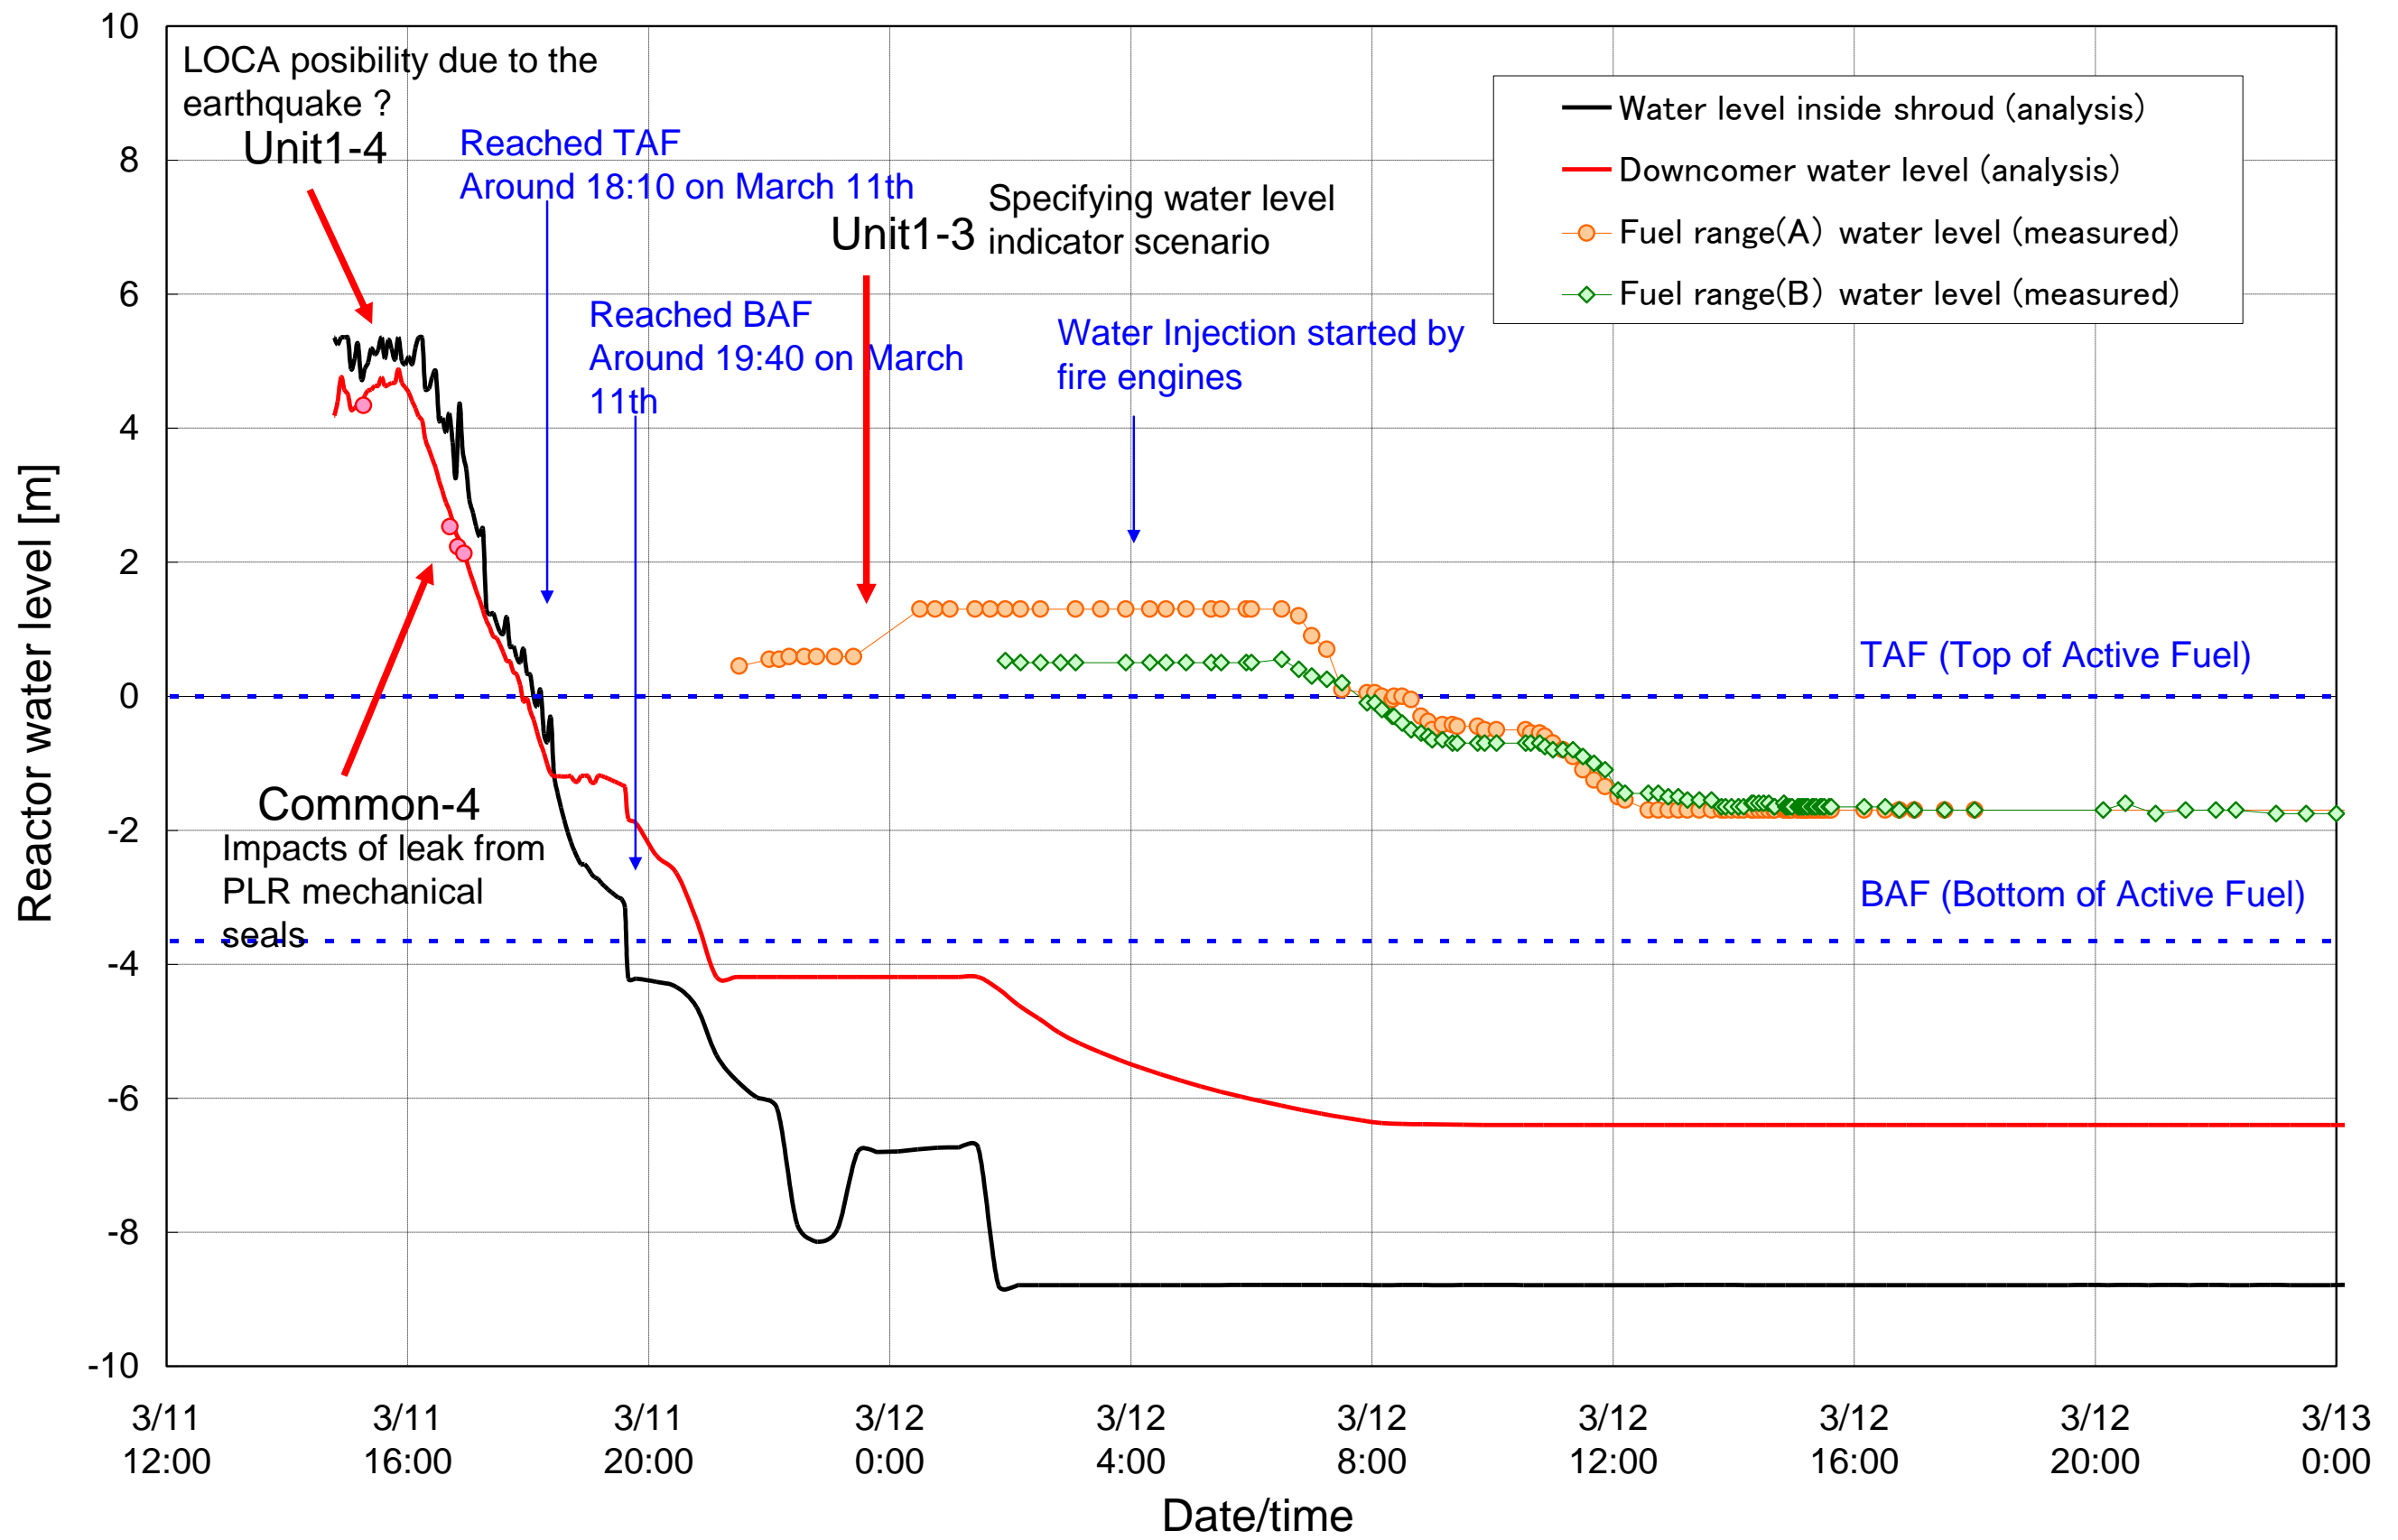
Figure 3.2.1 Issues derived from reactor water level change of Unit-1

The issues derived above are shown in Figures 3.2.1 to 3.2.3. They are also described in parallel in Attachment 2. The examination results obtained so far from among the issues extracted as unsolved are compiled in the Attachments and they are summarized briefly in the following section 3.3.

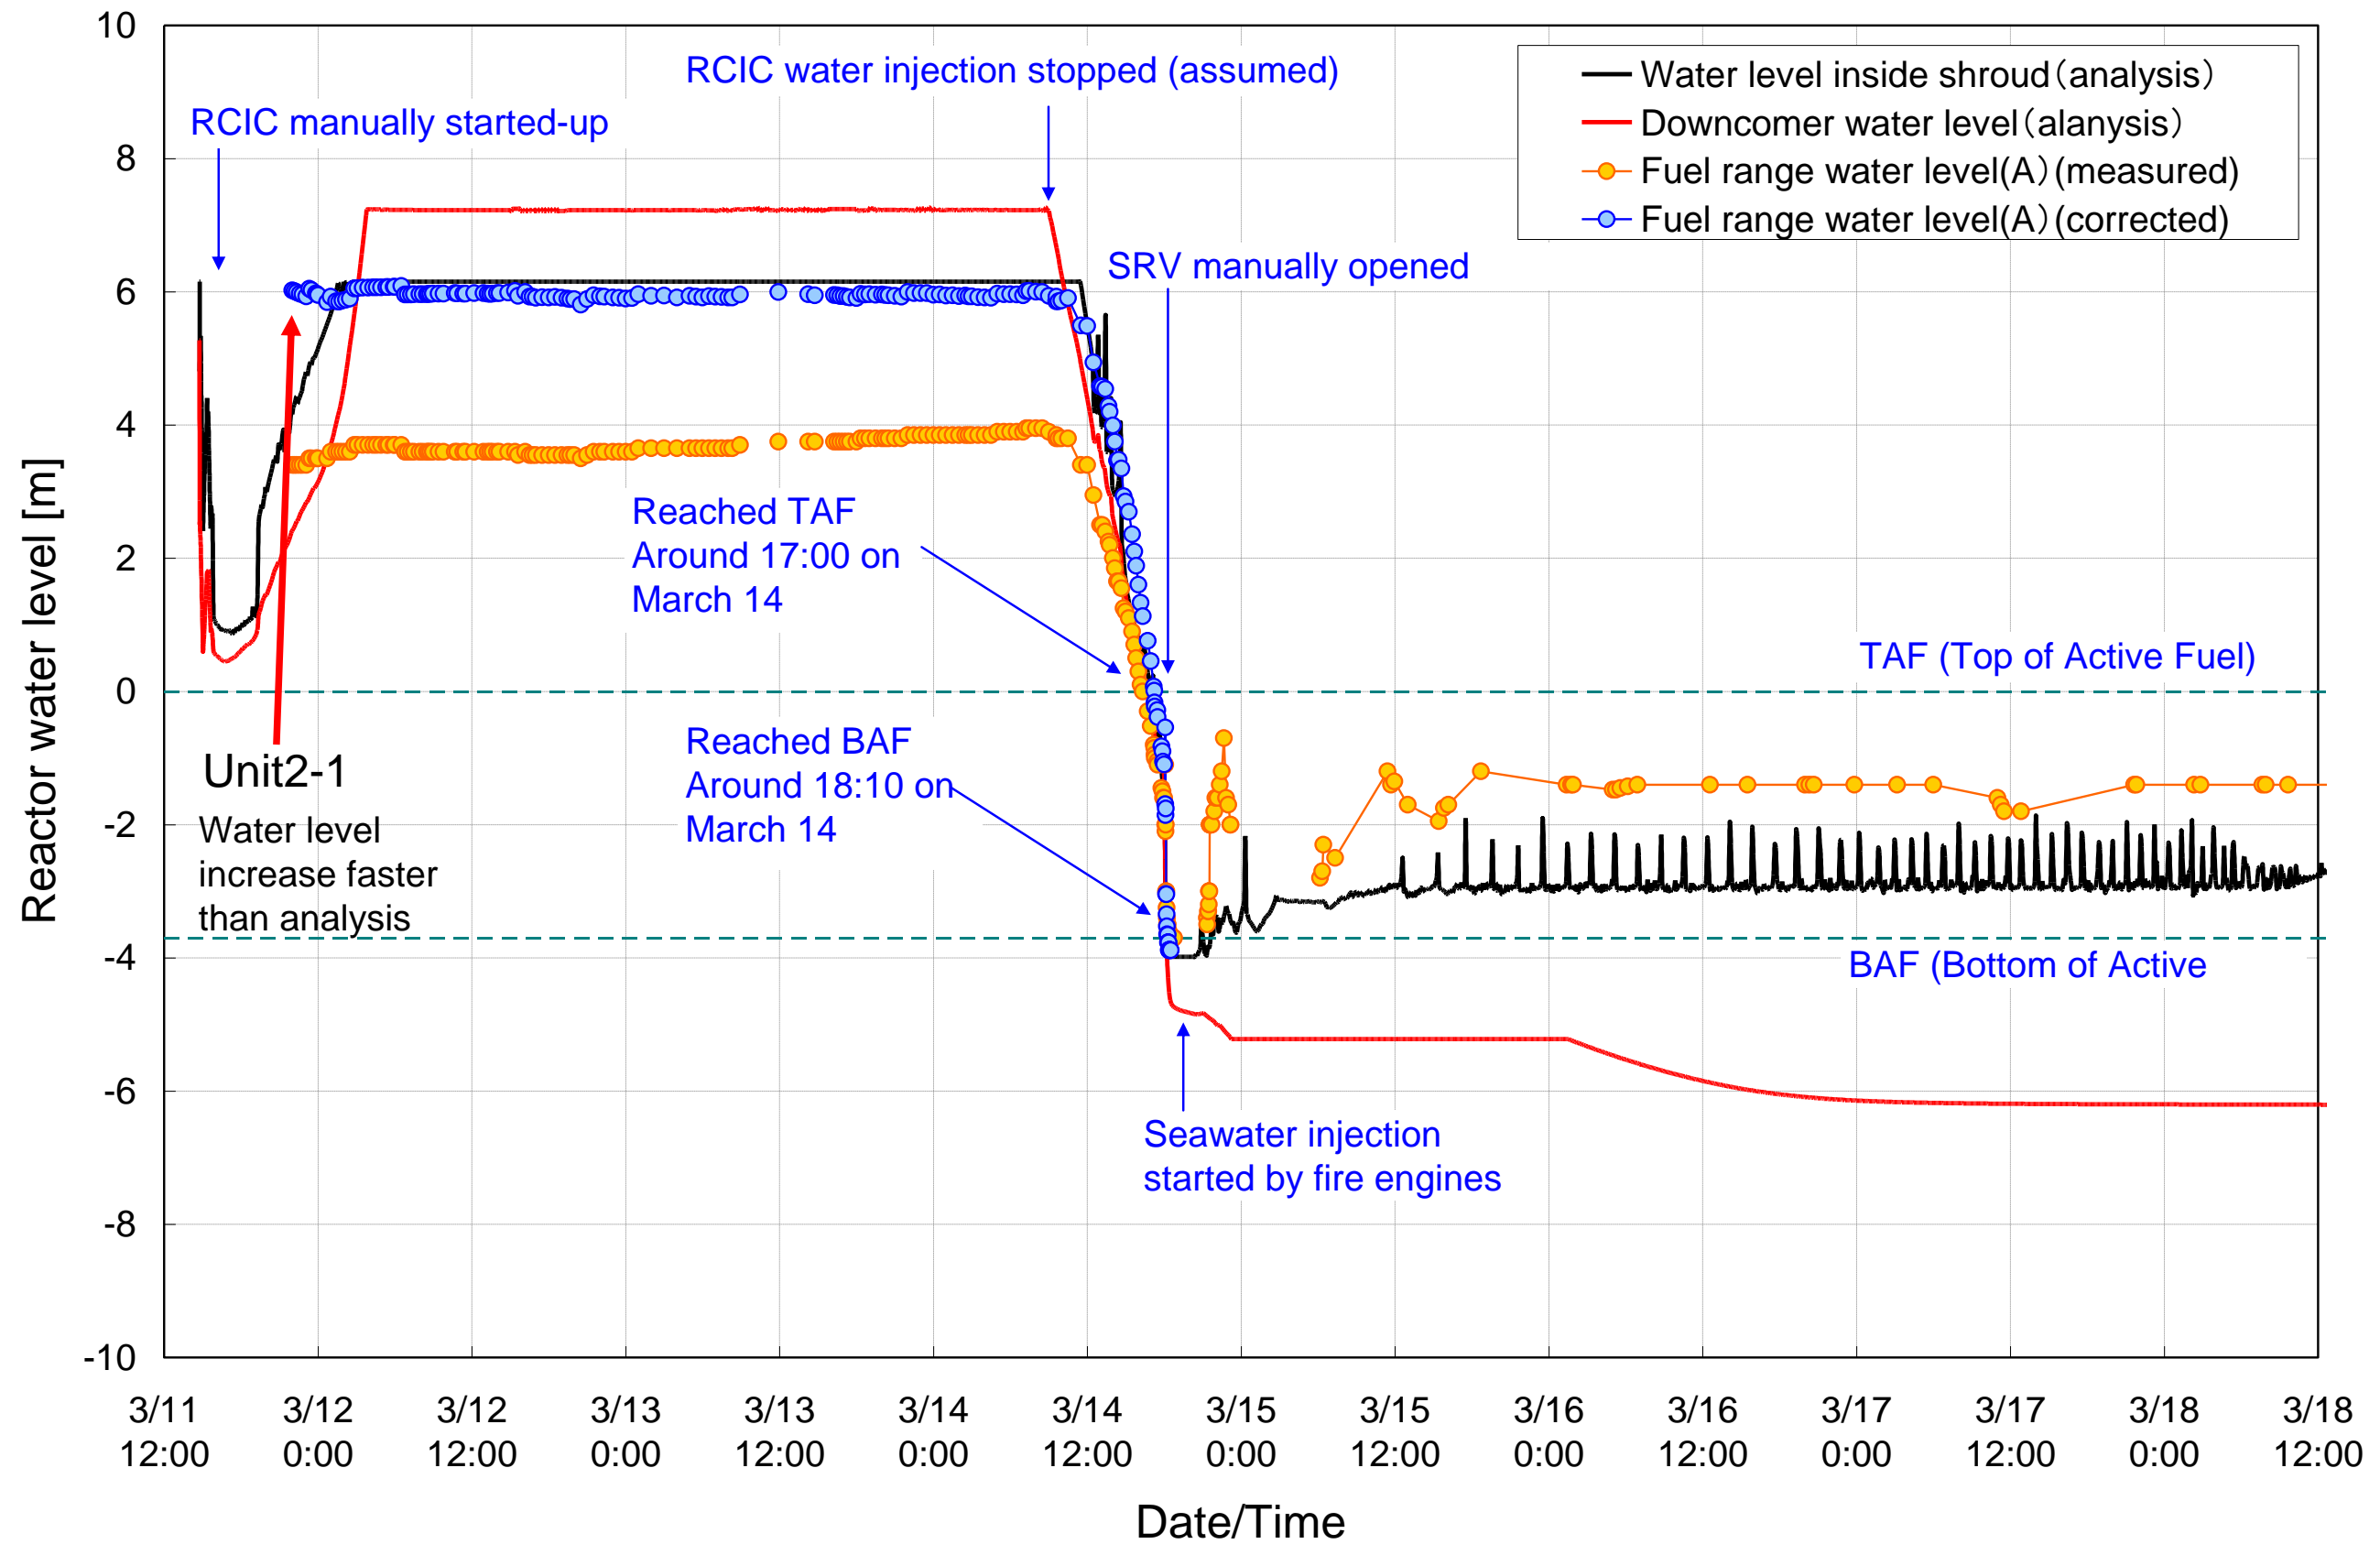
Figure 4.2.1 Issues derived from the reactor water level changes at Unit-2

The issues derived above are shown in Figures 4.2.1 to 4.2.3. They are also described in parallel in Attachment 2. The examination results obtained so far from among the issues extracted as unsolved are compiled in the Attachments and they are summarized briefly in the following section 4.3.

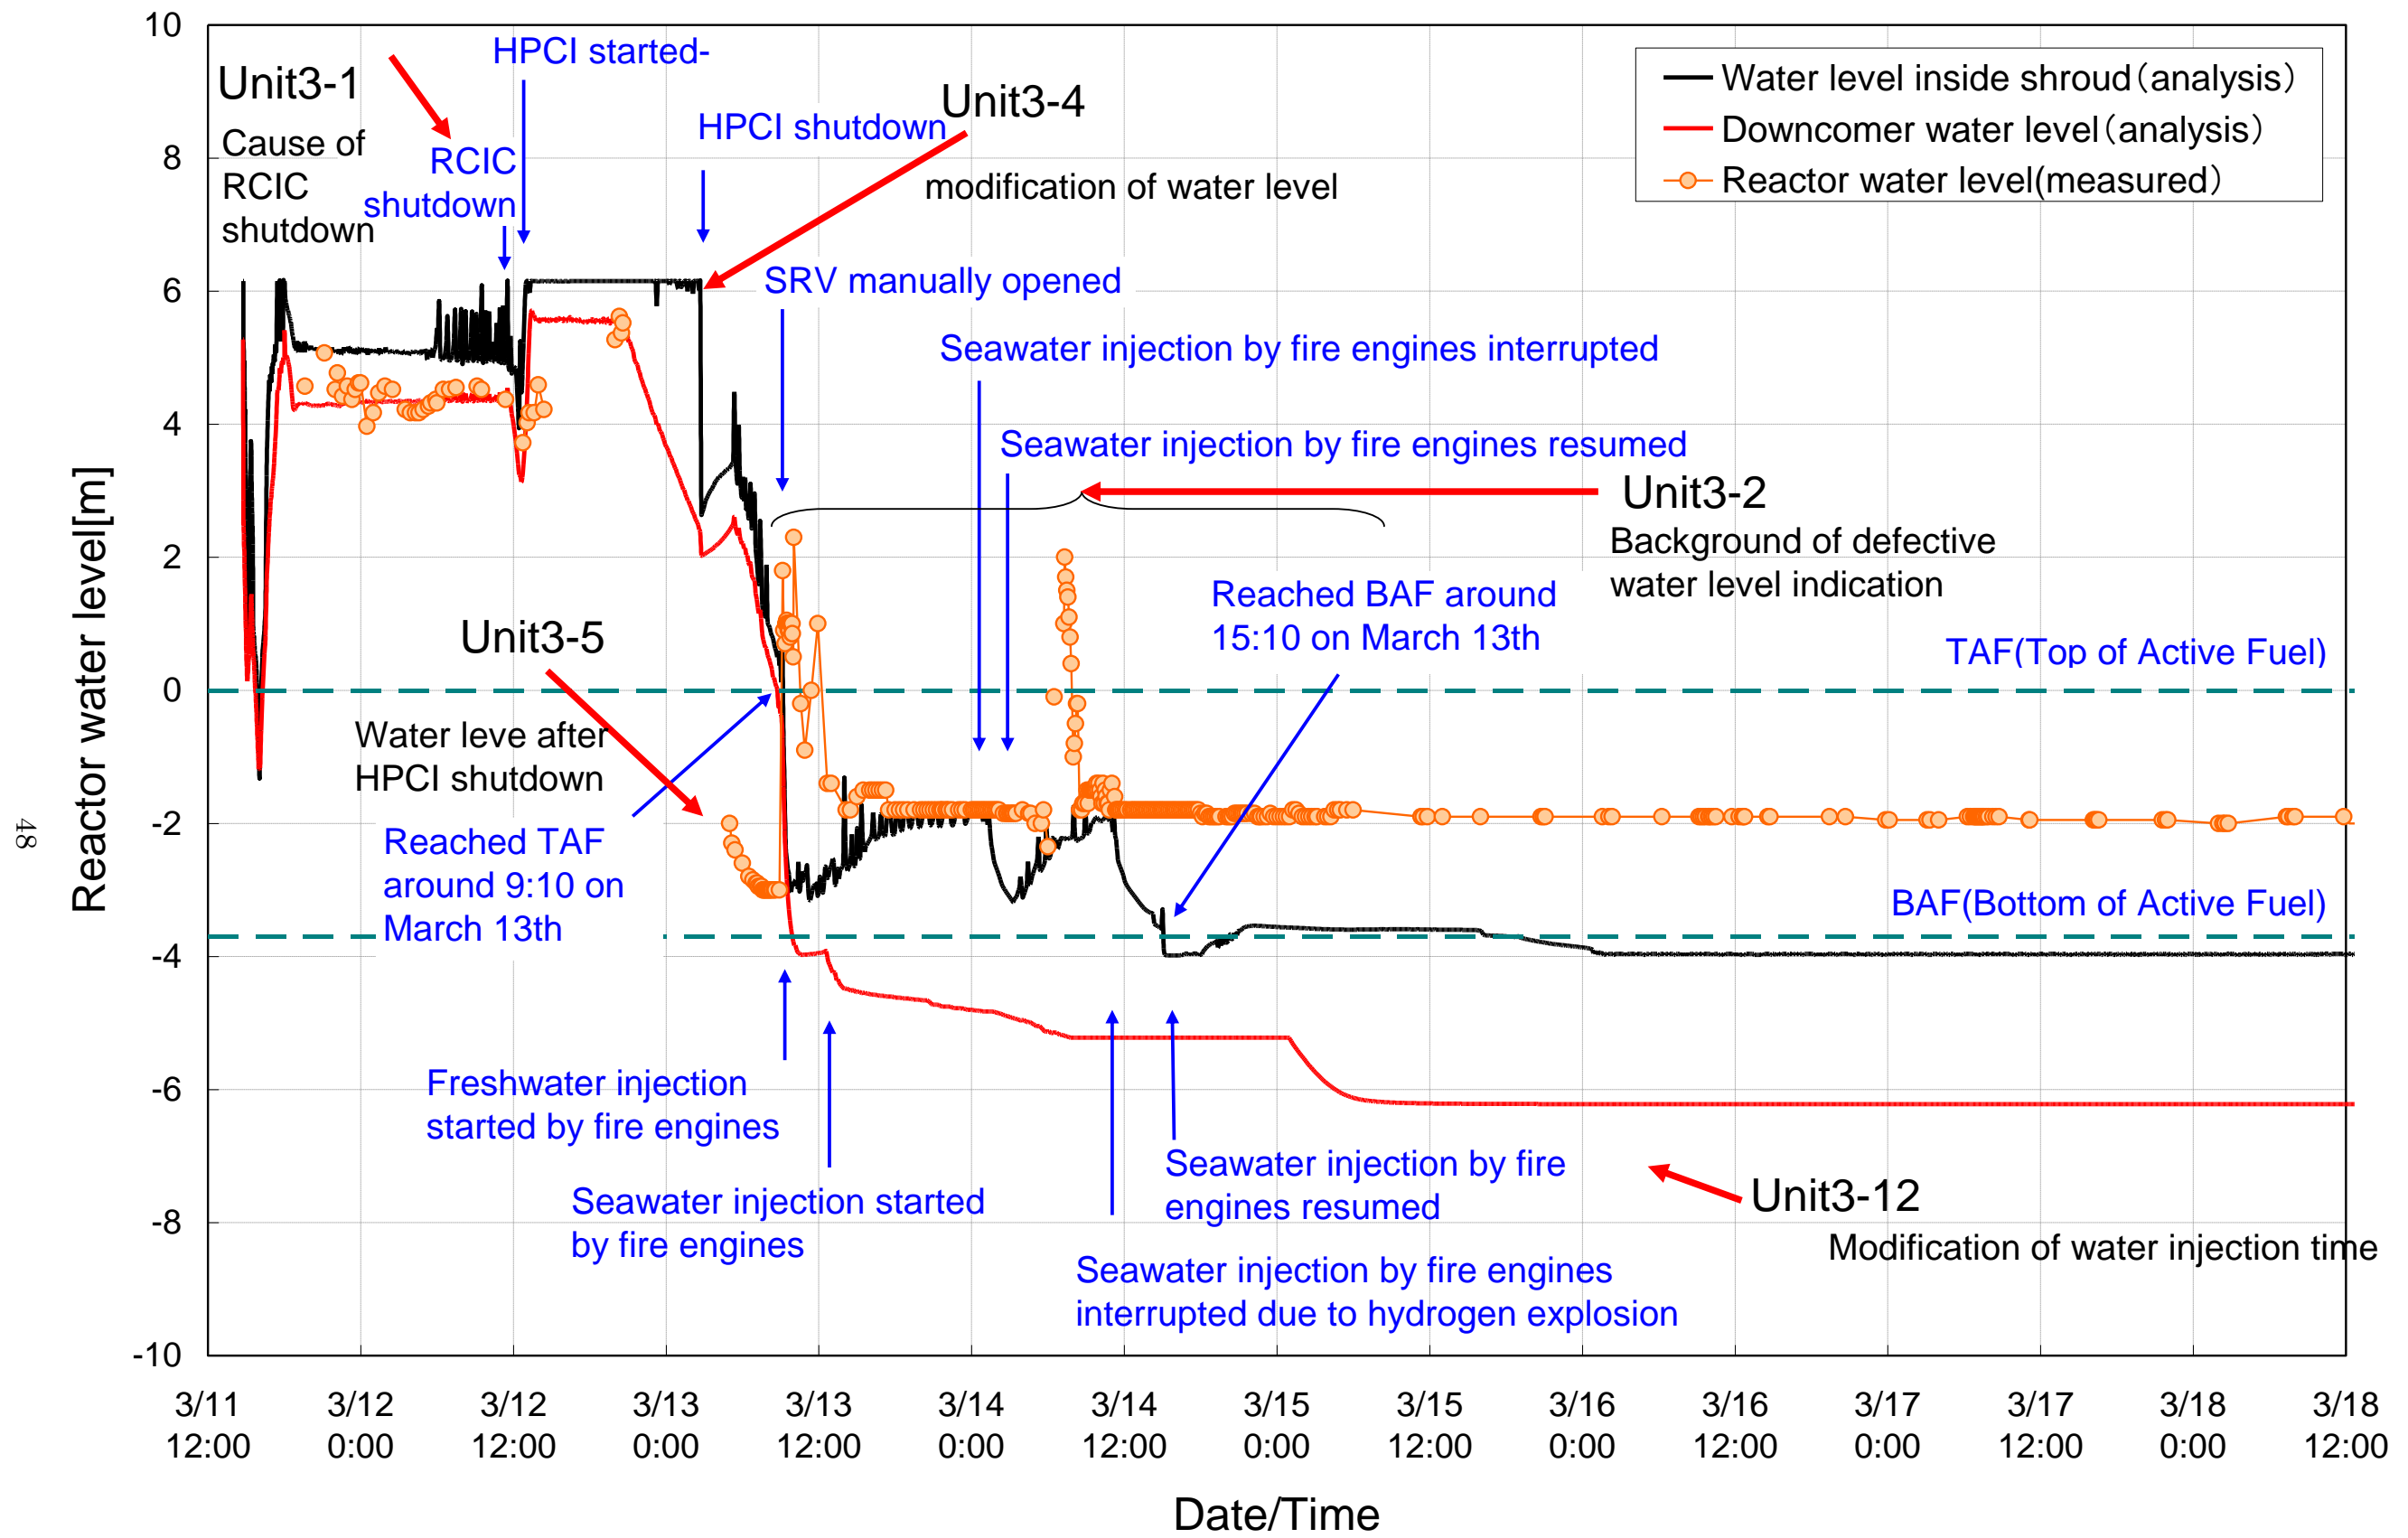
Figure 5.2.1 Issues derived from the reactor water level changes at Unit-3

The issues derived above are shown in Figures 5.2.1 to 5.2.3. They are also described in parallel in Attachment 2. The examination results obtained so far from among the issues extracted as unsolved are compiled in the Attachments and they are summarized briefly in the following section 5.3.

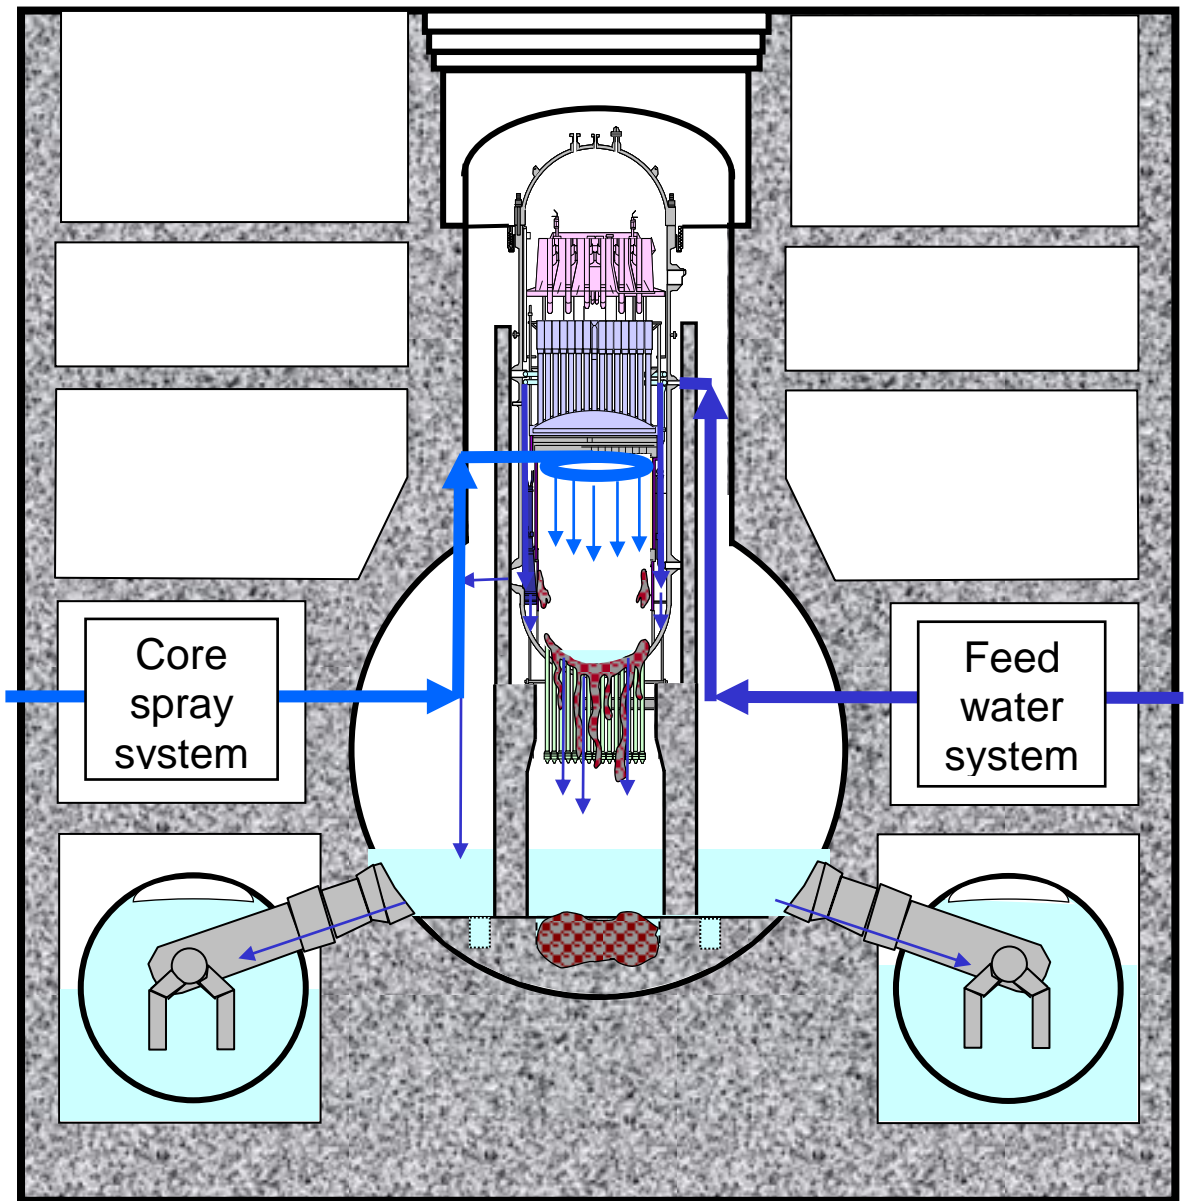
Figure 6.1.1 Estimated conditions of the core and PCV of Unit-1

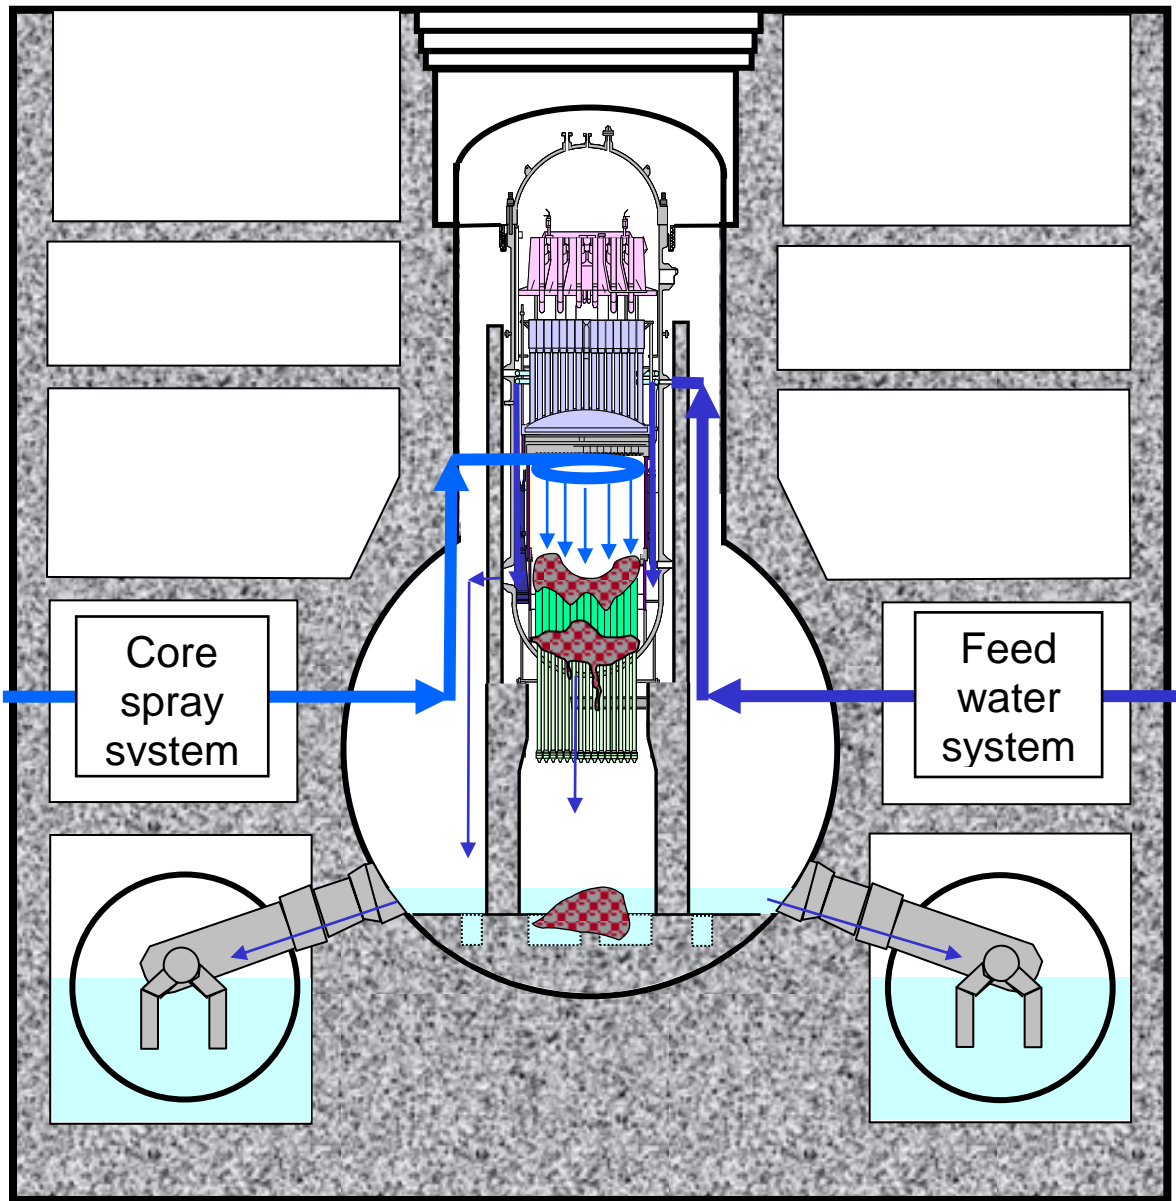
Figure 6.2.1 Estimated conditions of the core and PCV of Unit-2

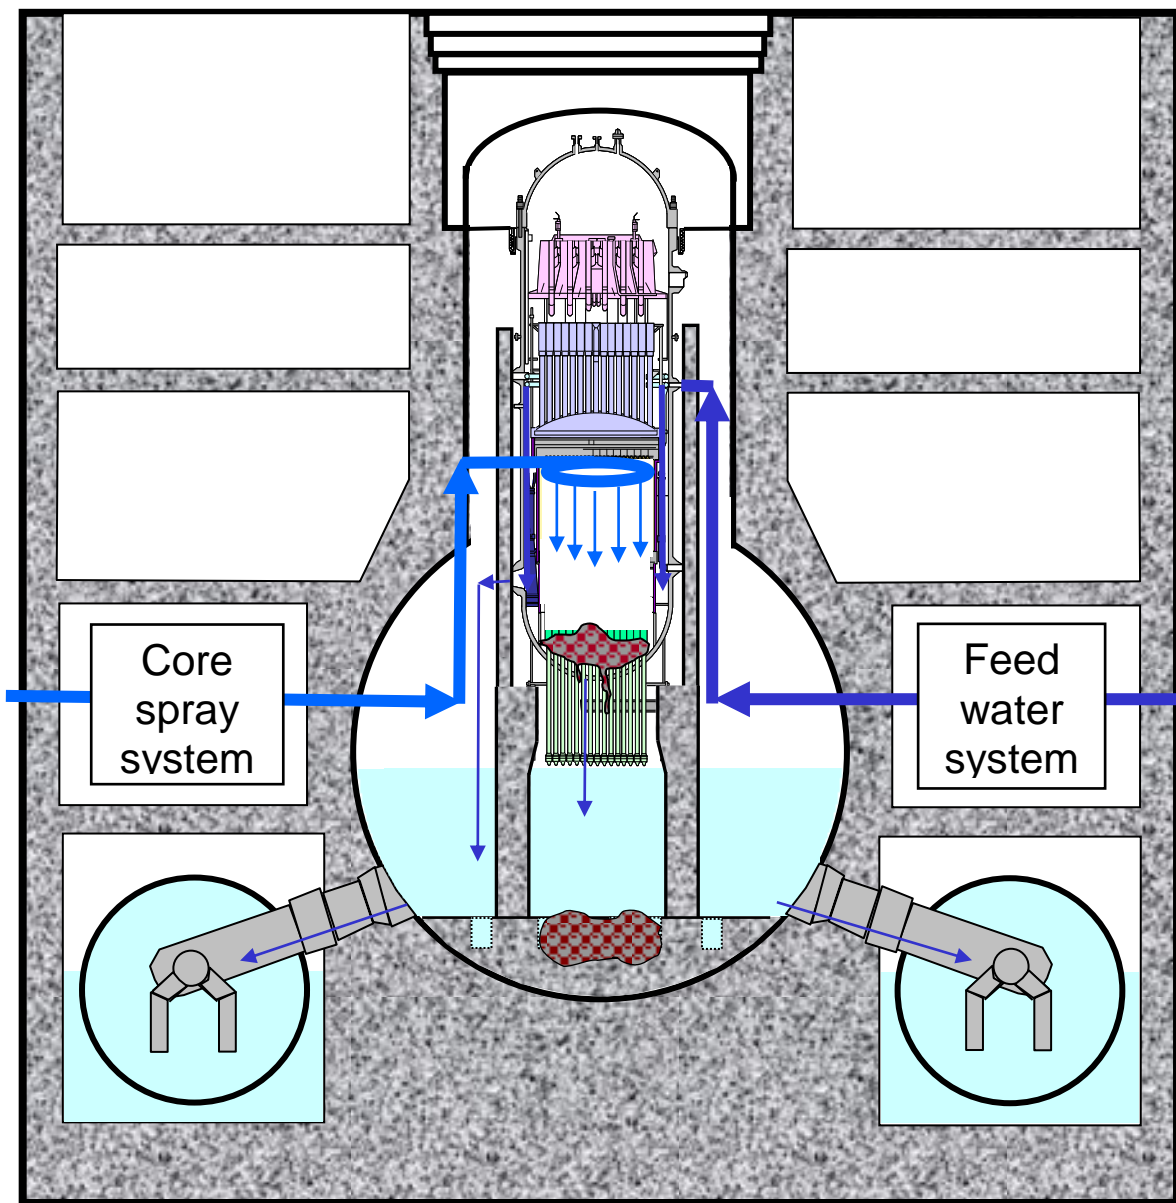
accident progression was faster than the earlier estimation. In the figure, more fuel than before is assumed to have dropped to the PCV. On this matter, further detailed examinations are needed, including the molten core concrete interaction (MCCI) development behavior.

No measured values are available so far concerning the D/W water level. But it could be estimated to be about 5.5 to 7.5m above the floor by converting the S/C pressure to water head. The S/C pressure was obtained from its existing pressure indicators, not calibrated since the accident, so they do not have high accuracies but they could be reliable as a trend to a certain extent because they have followed the pressure changes according to the water injection. In May 2014, water leaks were witnessed around the expansion joint at the PCV penetration of main steam piping D. This point is at the same elevation as the estimated water level in the containment vessel. This indicates most water leaks from the containment vessel occurred at this point.

Figure 6.3.1 Estimated conditions of the core and PCV of Unit-3
