Report on the Investigation and Study of
Unconfirmed/Unclear Matters
in the Fukushima Nuclear Accident
Progress Report No.3

May 20, 2015

Tokyo Electric Power Company, Inc.

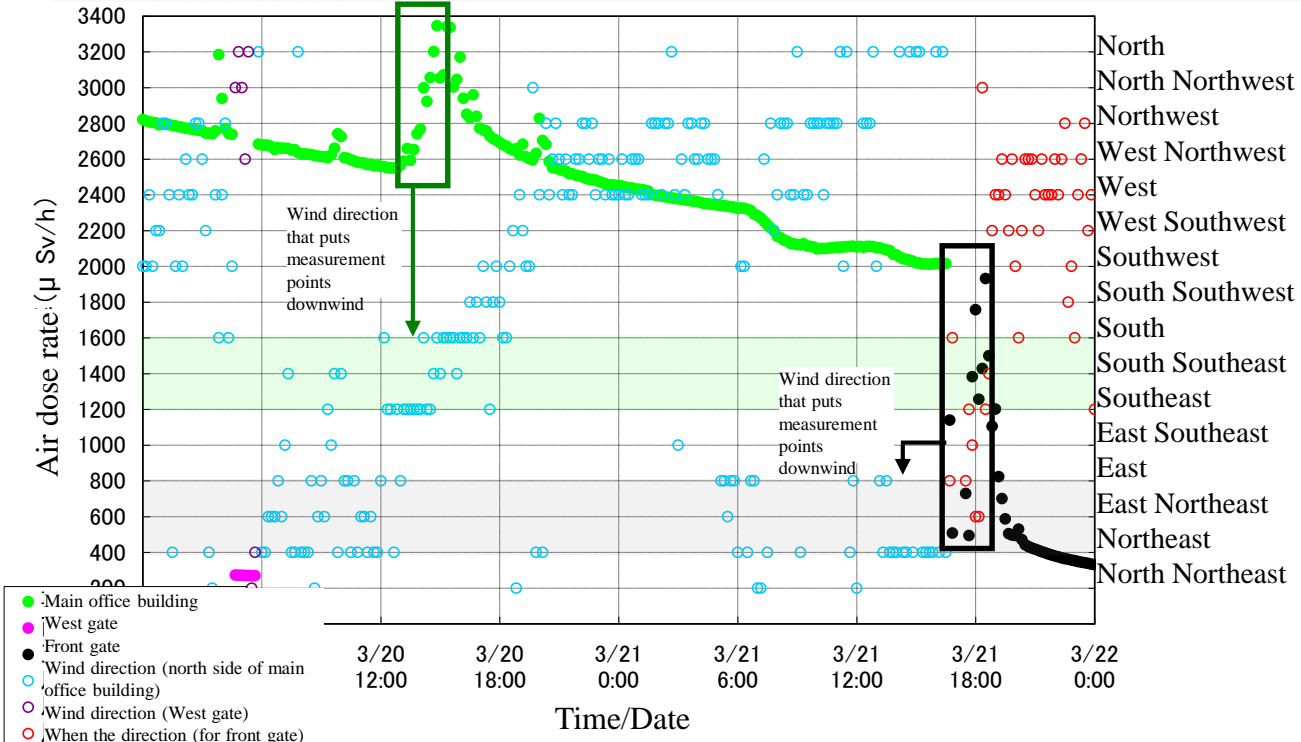
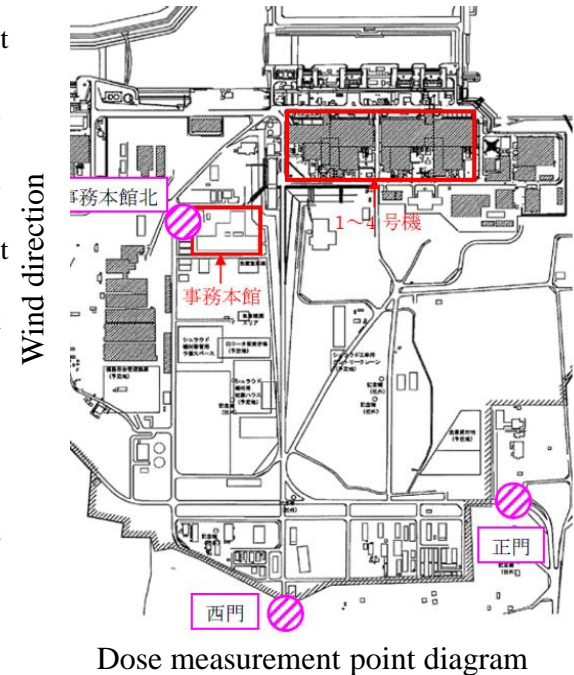
Fukushima Daiichi NPS Site Dose Measurement Results and Wind Direction at Each Measurement Point

The results of the analysis show that a large percentage of the measurement points were downwind during the increase in dose levels, and in contrast when the dose levels decreased most of the measurement points were not downwind.

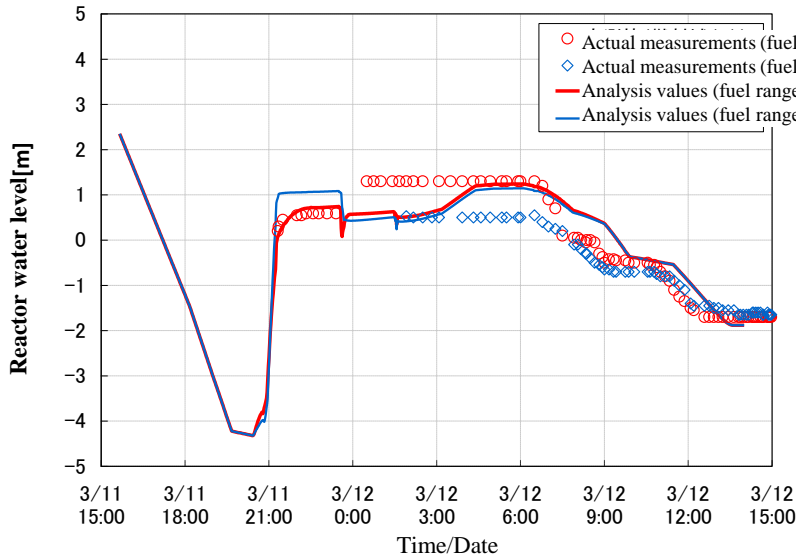
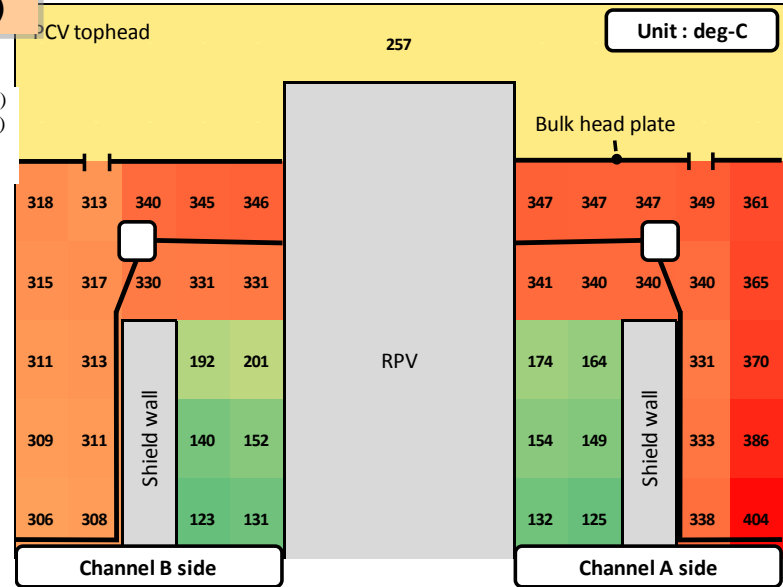
【Case 1】Leak location : Near bottom of Containment vessel (SRV)

The analysis showed that the temperatures inside the containment vessel increased evenly by and large, and the water level differences between System A and System B indicated by the actual measurement data were not seen.

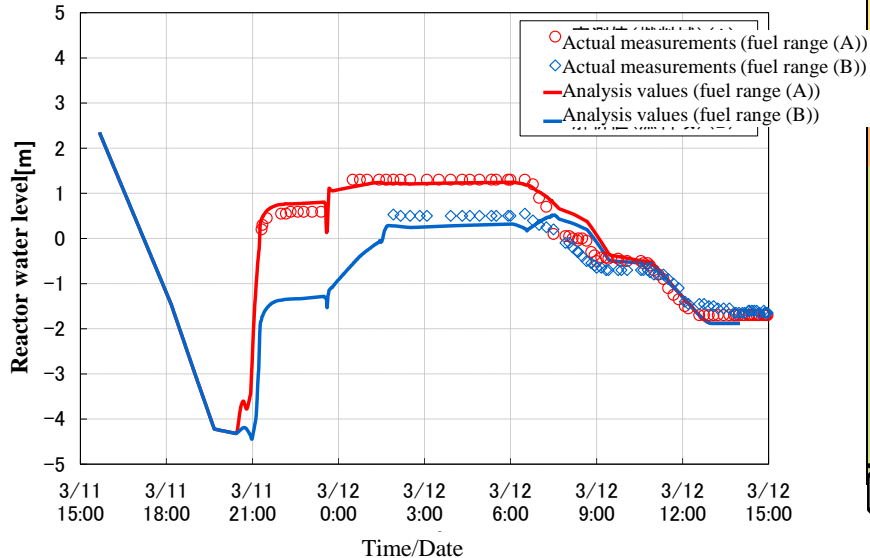
【Case 2】Leak location: Top of Containment vessel

The analysis showed that temperature increases are localized at the top of the containment vessel and that a decrease of water levels inside the water level meter reference leg side piping on one side can cause actual measurements to indicate a water level difference between System A and System B.

This suggests that the leak from the reactor pressure vessel to the containment vessel (D/W) occurred at the top of the contaminant vessel.
 This possibility will be further examined by revising analysis conditions as we continue to unravel the chain of events that happened during the accident.
