Leaks from Unit-3 PCV and steam release in a large amount

1. Background

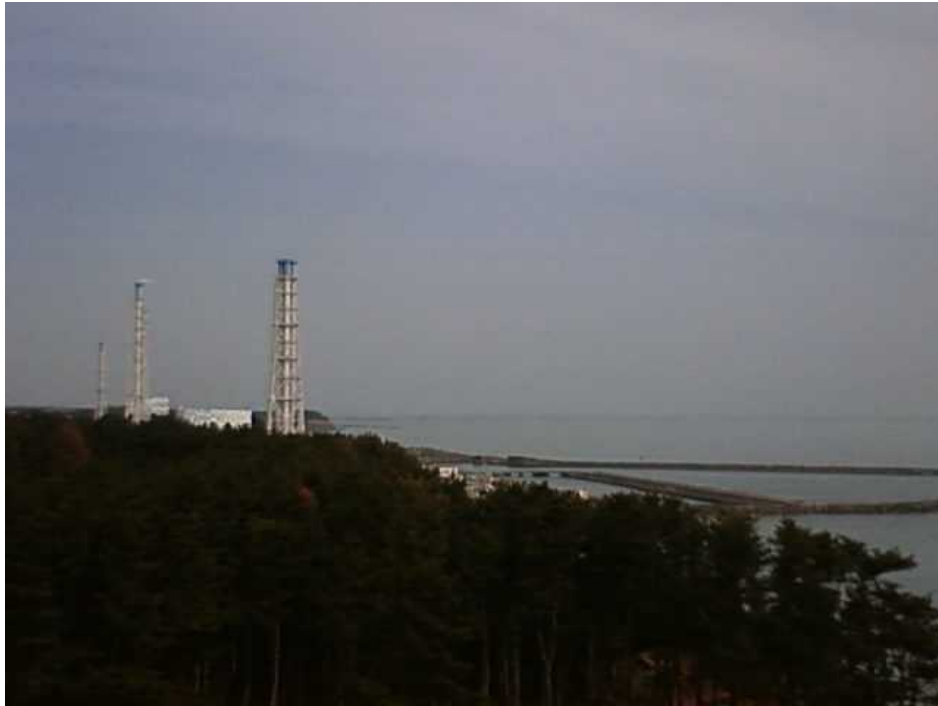
Unit-3 is considered to have been successfully vented at about 09:20 on March 13th and Figure 2 shows a photo live camera taken at 10:00, about 40 minutes after the venting. As can be seen in the enlarged photo of the Unit-3/4 stack, steam was being discharging by venting. Meanwhile, no extraordinary conditions are recognized for the R/B.

Figure 2 Photos by the live camera at the Fukushima Daiichi NPS (taken at 10:00 on March 13th) (Top: Full screen view of the live camera, Center: Enlarged Unit-3/4 stack, Bottom: Enlarged R/B surroundings)

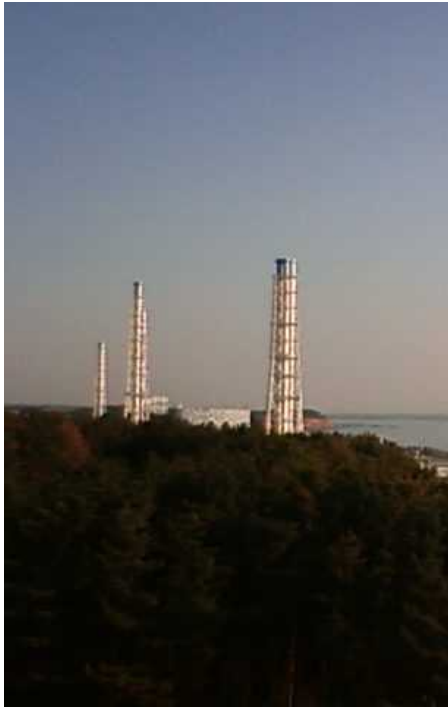
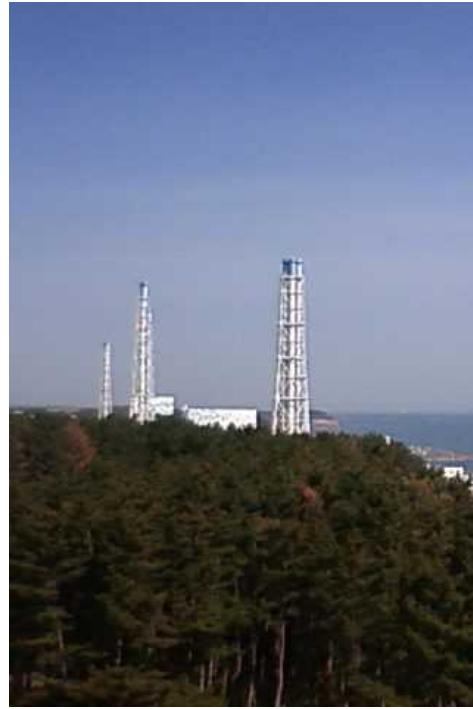
Figure 4 shows photos by the live camera at 07:00 and 10:00 on March 14th. In the records operation of the vent valve (small valve) was completed at 06:10 (fourth operation time). Steam release cannot be recognized clearly in either of these live camera photos. There is a possibility, though, that the steam released by the small vent valve operation was limited and not recognizable in live camera photos.

Figure 4 Photos by the live camera at the Fukushima Daiichi NPS (Part) (Left: taken at 07:00 on March 14th, Right: taken at 10:00 on March 14th) (Top: Live camera photos (excerpt), Bottom: Enlarged Unit-3/4 stack)

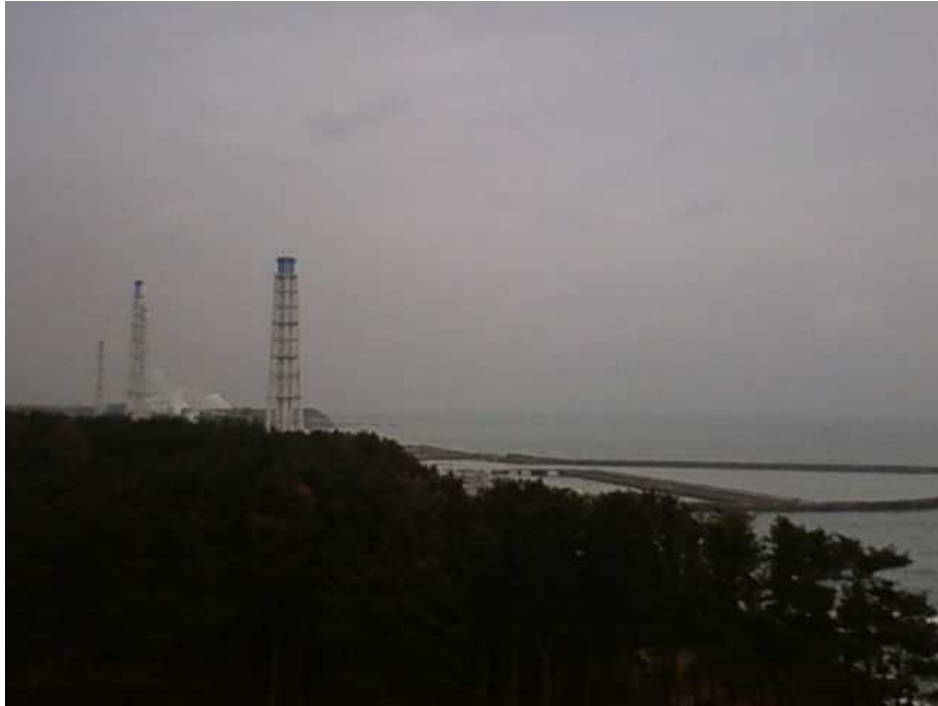
Figure 6 shows photos by the live camera at 16:00 on March 15th. At this timing, steam release from the Unit-3/4 stack cannot be recognized, but from the enlarged photos around the R/Bs, steam release, probably from the top of R/B of an unknown unit, can be recognized.

Figure 6 Photos by the live camera at the Fukushima Daiichi NPS (taken at 16:00 on March 15th) (Top: Full screen view of the live camera, Center: Enlarged Unit-3/4 stack, Bottom: Enlarged R/B surroundings)

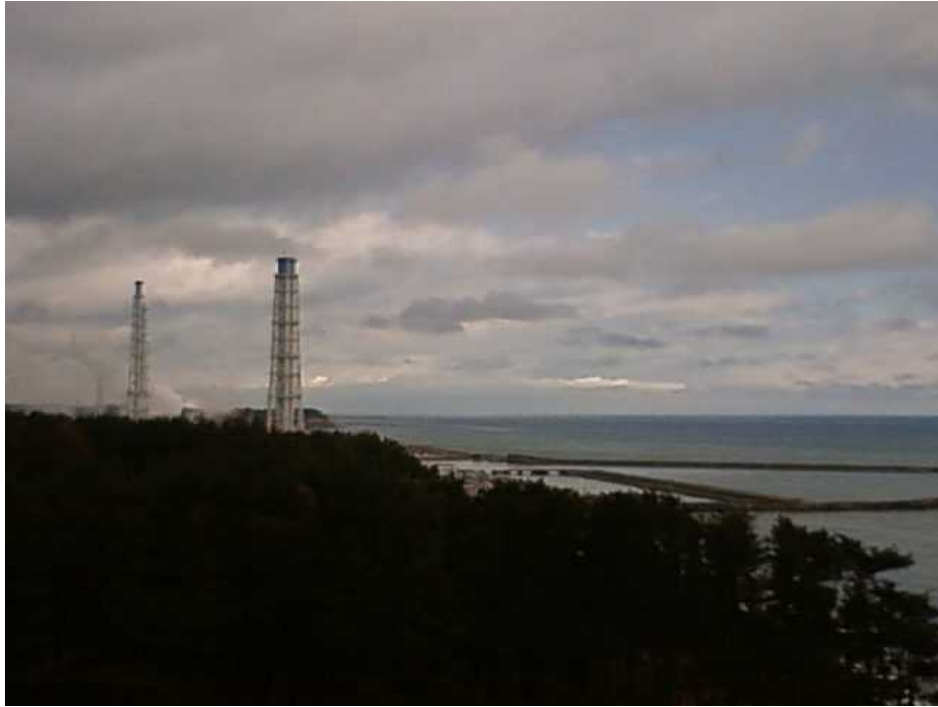
Figure 8 shows photos by the live camera at 10:00 on March 16th. At this timing, steam release from the Unit-3/4 stack cannot be recognized yet. But steam release probably from the top of an R/B can be recognized. In the earlier photos, the shape of the RW/B was clearly visible, but at this timing the RW/B was partially invisible due to the released steam. Therefore, the steam released at this timing from the R/B, i.e., leaks from PCV, can be considered as significantly large scale.

Figure 8 Photos by the live camera at the Fukushima Daiichi NPS (taken at 10:00 on March 16th) (Top: Full screen view of live camera, Center: Enlarged Unit-3/4 stack, Bottom: Enlarged R/B surroundings)

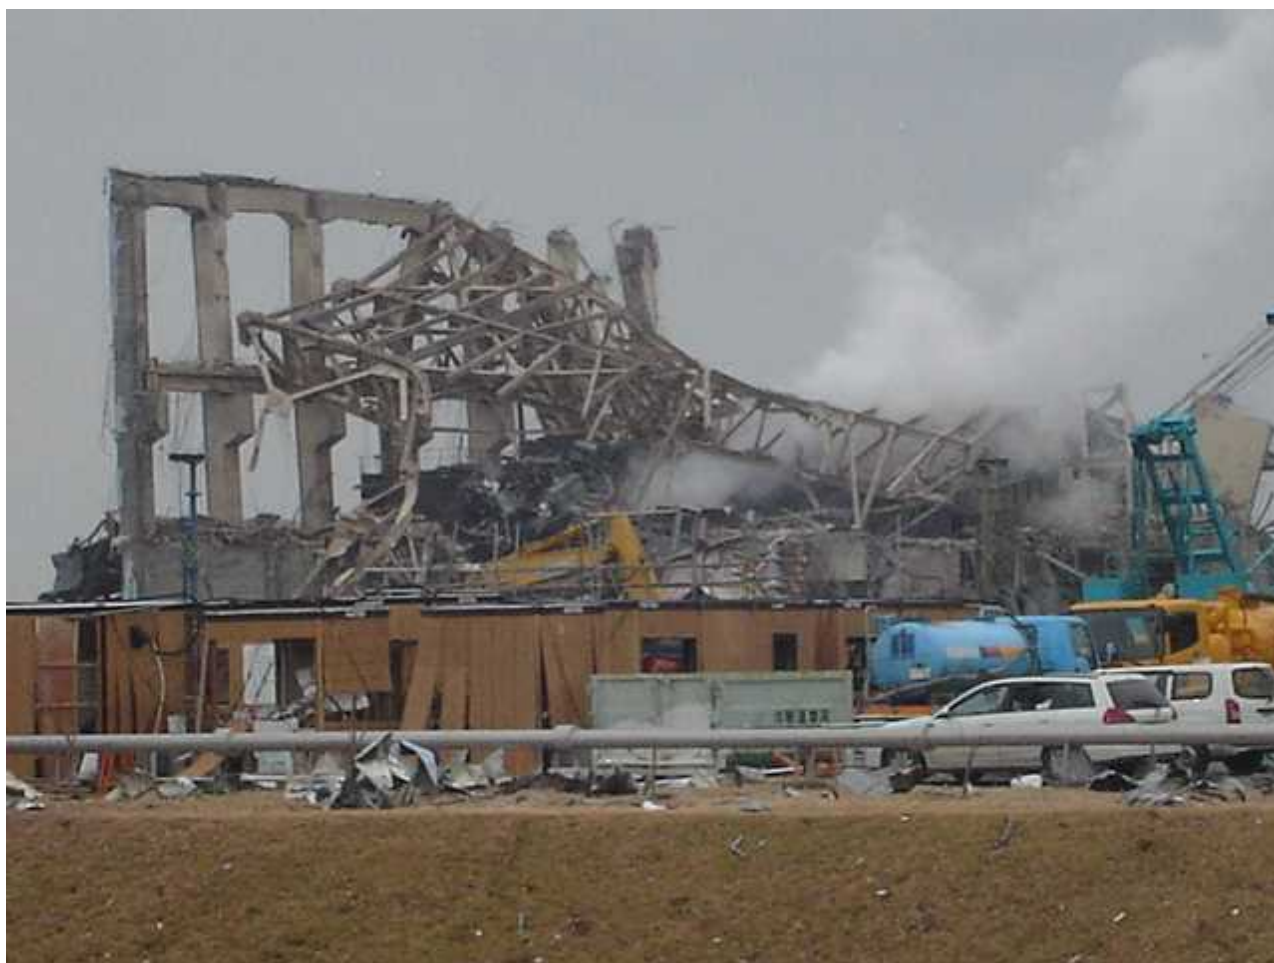
Figure 9 shows a photo taken by a digital camera in the morning of March 15th. It confirms that steam release from the top of Unit-3 R/B had started by this timing. The photo by the live camera at 07:00 on March 15th (Figure 5) also shows steam release. Therefore, the date information in the digital camera photo is roughly correct.

From the digital camera photos, steam release is confirmed in the morning of March 15th from the top of the Unit-3 R/B. At this timing, leaked gases from the PCV (including steam and radioactive materials) are considered to have been in a situation to be directly released to the environment. Meanwhile in the morning of March 15th, steam release from the blow-out panel of the Unit-2 R/B was also confirmed and radioactive materials were being released from Unit-2, too (Attachments 2-9 and 2-10).

Figure 9 Steam release from Unit-3 (photographed at 07:31 on March 15th)

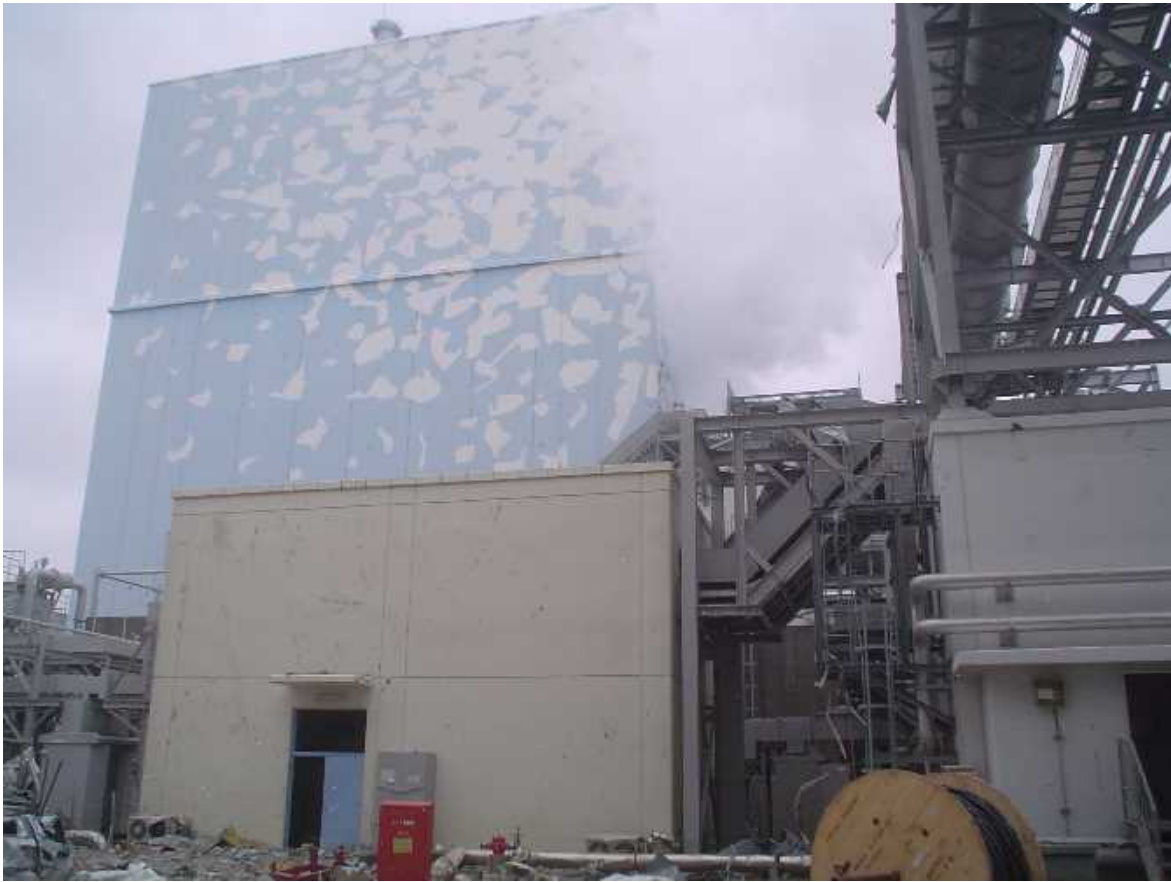
Figure 10 shows a photo of the Unit-2 R/B taken in the morning of March 15th. It is known that the blowout panel of the Unit-2 R/B opened at the time of the Unit-1 R/B hydrogen explosion and steam was being released through this blow-out panel. It is reported in Reference [1], too, that white smoke (like steam) was confirmed to be rising at 08:25 on March 15th from around the 5th floor of the Unit-2 R/B. Therefore, this date information can be regarded as roughly correct.

Figure 10 Steam release from Unit-2 (photographed at 08:58 on March 15th)

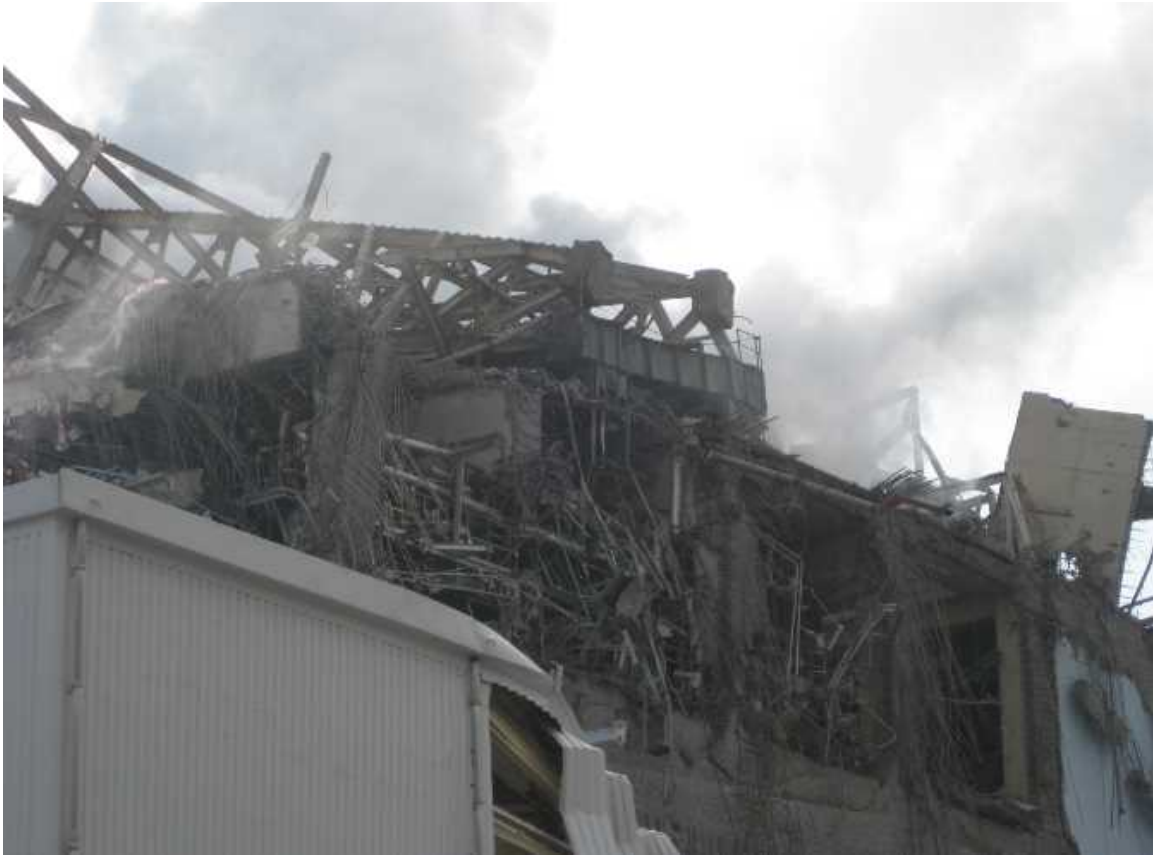
Figure 11 shows a photo taken in the morning of March 16th. It confirms that the steam release from the top of the Unit-3 R/B was still continuing. The amount of steam being

released seems larger than that on the previous day. This is consistent with the live camera feed of 10:00 on March 16th. Therefore, this date information can be regarded as roughly correct.

Figure 11 Steam release from Unit-3 (photographed at 09:51 on March 16th)

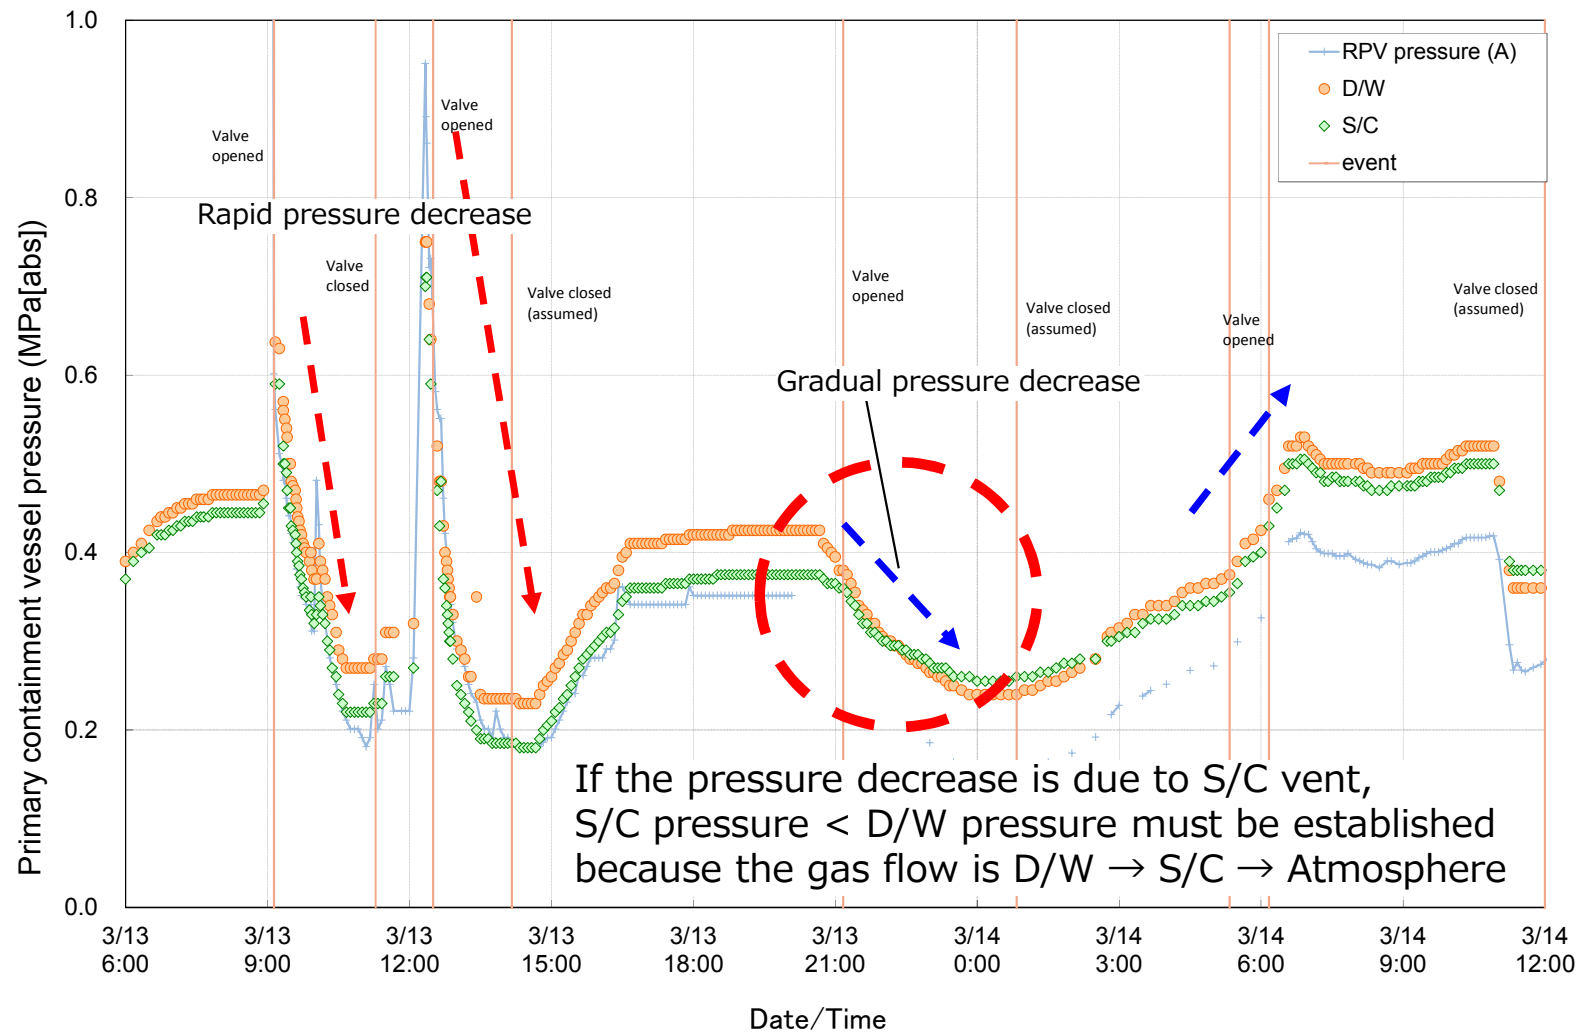
Figure 12 PCV pressure changes at Unit-3 (from 06:00 on March 13th to 12:00 on March 14th)

Figure 12 presents the PCV pressure changes over this time span. At Unit-3, the high pressure coolant injection system (HPCI) lost its water injection function before its manual shutdown (Attachment 3-3). Therefore, it is interpreted that the core was damaged by about 05:00 on March 13th and a large amount of hydrogen gas was being generated. This means the continuous PCV pressure increase till just before 09:00 is considered to be due to the inflow of non-condensable hydrogen gas into the PCV. At about 09:00 when the reactor was depressurized, the hydrogen gas in the reactor vessel was instantly released to the PCV and the PCV pressure increased high enough to activate rupture discs for venting.

At this first (1st) venting, the PCV pressure dropped fairly rapidly, about 0.4MPa in 90 minutes, that is, from 0.637MPa(D/W) and 0.590MPa(S/C) at 09:10 to 0.270MPa(D/W) and 0.220MPa(S/C) at 10:40.

At the second (2nd) venting, too, the PCV pressure dropped fairly rapidly, about 0.5MPa in 75 minutes, that is, from 0.750MPa(D/W) and 0.700MPa(S/C) at 12:20 to 0.235MPa(D/W) and 0.190MPa(S/C) at 13:35. The vent valves were judged based on the

From 19:00, at the mid-point of this time span, temporary compressors were connected for driving vent valves upon observing the PCV pressure increase. When the D/W pressure decreased at about 21:10, the vent valves were concluded to have opened (3rd venting). The PCV pressure decrease this time was very slow when compared with those of the 1st and 2nd vents: about 0.2 to 0.15MPa in 200 minutes from 0.425MPa(D/W) and 0.375MPa(S/C) at 20:40 to 0.240MPa(D/W) and 0.255MPa(S/C) at 24:00.

The relation between the D/W pressure and S/C pressure should draw more attention. At this timing the heat source is considered to exist in the D/W. It is reasonable, therefore, that the D/W pressure is higher than the S/C pressure. If gases are vented via the S/C, the gases move from the D/W to the S/C and then are released from the stack. In order to move gases from the D/W to the S/C, some pressure difference is required for the water to spill over in the S/C downcomer pipe. It is physically reasonable that there is a difference of about 0.05MPa between the D/W and S/C pressures until about 21:00. But, the pressures were reversed at 22:30 as 0.285MPa(D/W) and 0.290MPa(S/C) and at 24:00 the S/C pressure exceeded that of the D/W by 0.015MPa. If the PCV pressure had decreased by venting, gases must have moved from lower pressure points to higher pressure points, which is physically impossible.

It would be more natural, therefore, to interpret as follows: the cause of the PCV pressure decrease at the occasion assumed as the 3rd venting should be shifted to the D/W side, not by venting. Leaks from the D/W would be most probable from the PCV upper head due to deterioration of seal materials by the high temperature environment.

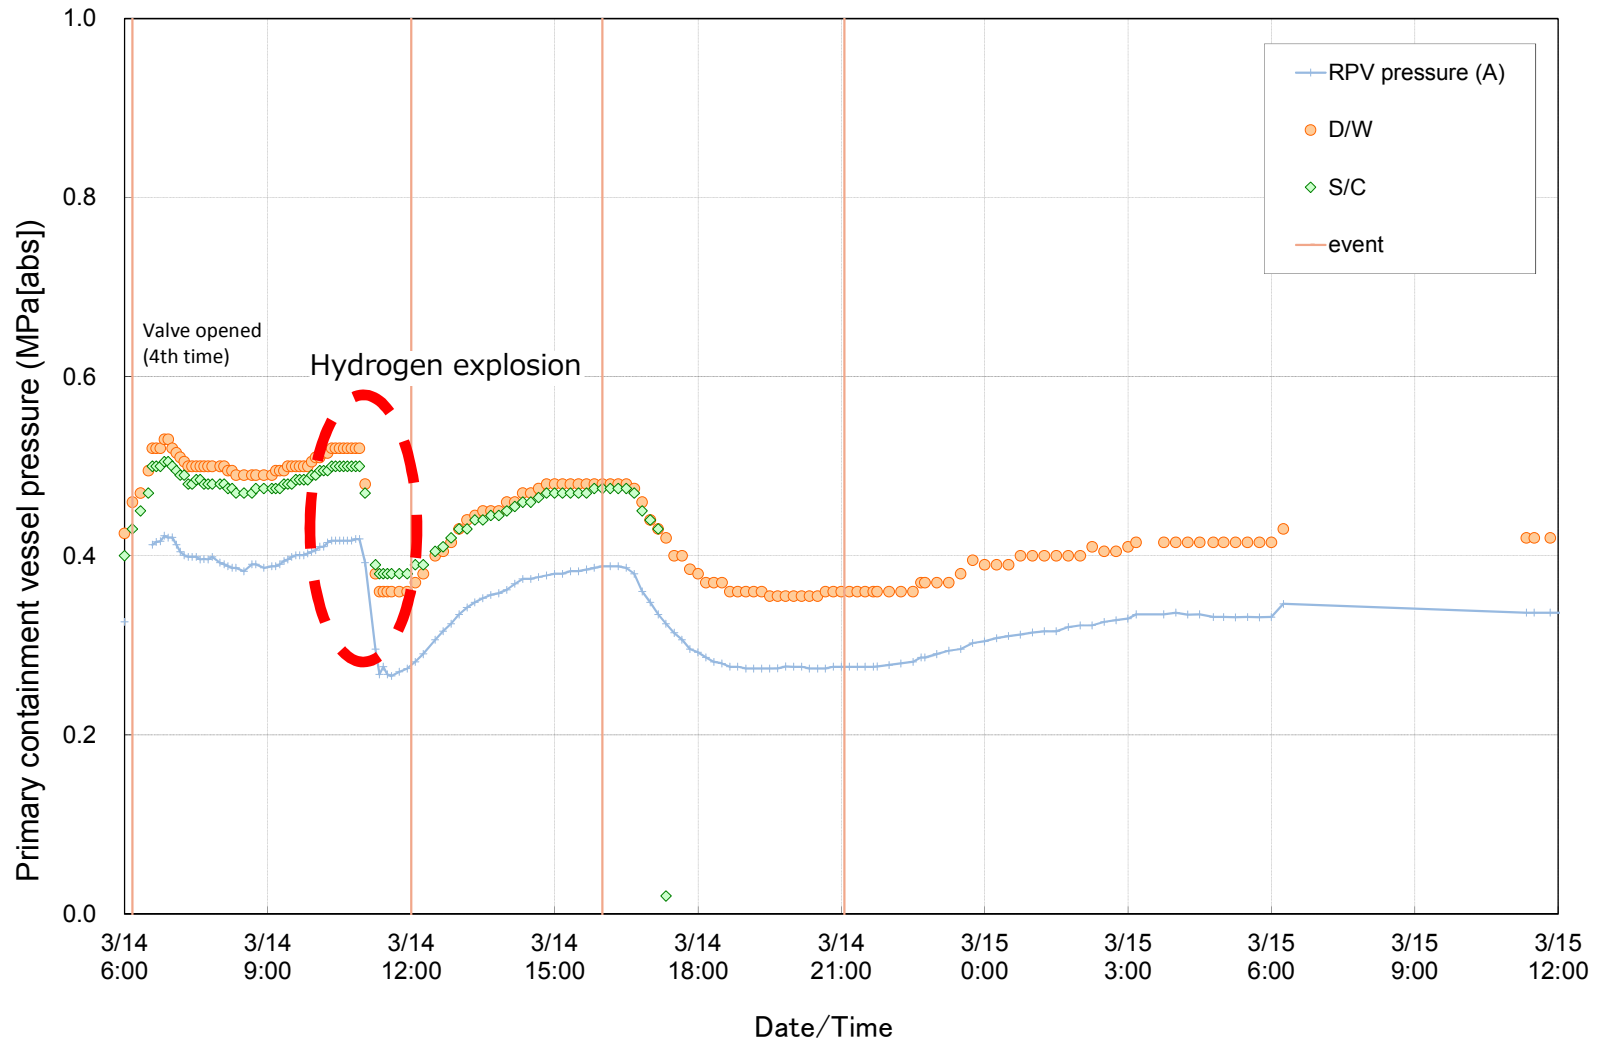
Figure 13 PCV pressure changes at Unit-3 (from 09:00 on March 14th to 12:00 on March 15th)

The pressure changes over this time span are shown in Figure 13. During this period, Unit-3 experienced the hydrogen explosion at 11:00 on March 14th. This explosion occurred due to the hydrogen gas leaked to the R/B. It is consistent with the actual accident progression to assume that the leak from the PCV to the R/B started by the time of the 3rd vent operation.

It should be noted that the PCV pressure dropped largely at the hydrogen explosion occurrence. The reason of this pressure decrease is not clarified. The D/W and S/C pressures are reversed again. If leaks occurred from the PCV, it would be from the D/W.

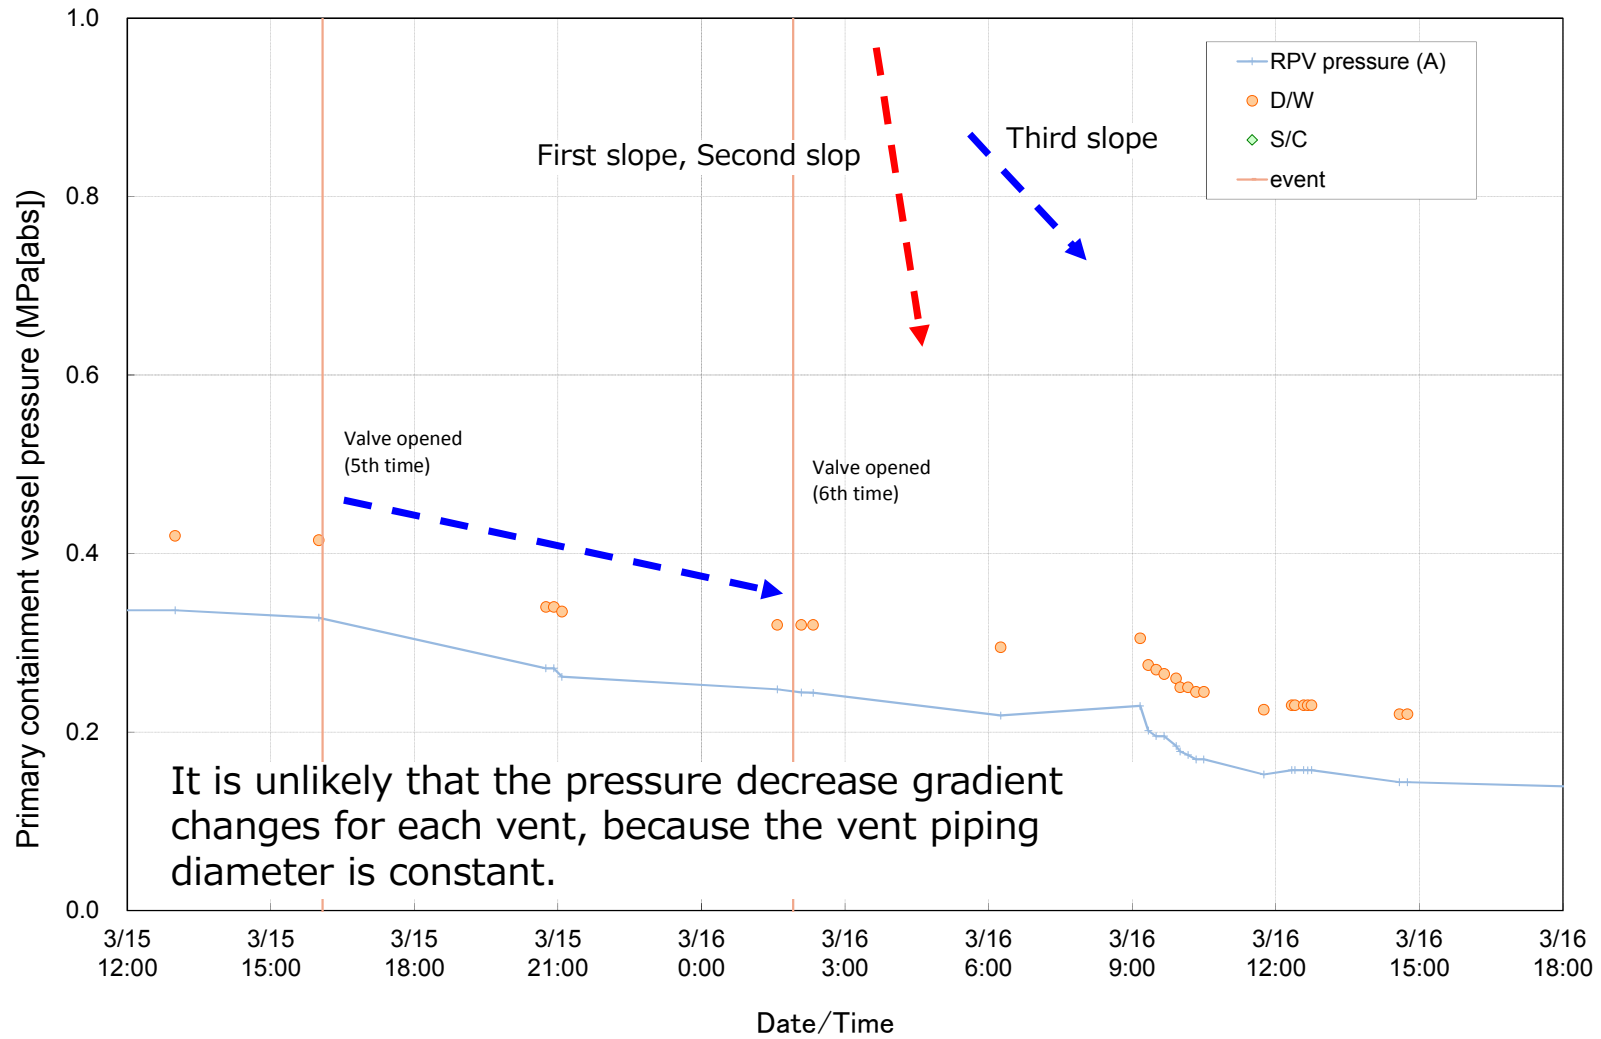
Figure 14 PCV pressure changes at Unit-3 (from 12:00 on March 15th to 18:00 on March 16th)

The pressure changes over this time span are shown in Figure 14. During this period, the 5th vent operation was implemented according to the records. The relevant part of Annex 2 to Reference [1] is cited below.

Although the opening operation of vent valves was taken, the result is not clarified. As a matter of fact the PCV pressure decrease of about 0.1MPa during 5 hours was lower than the anticipated rate by venting: from 0.415MPa(D/W) at 16:00 to 0.335MPa(D/W) at 21:05, although no data are available for the S/C pressures. From the morning of March 15th, steam release was continuously recognized from the top of Unit-3 R/B as shown in Item 2 above. Therefore, the PCV pressure decrease of this low rate probably comes from the direct release from the PCV.
