Evaluation of the situation of  
cores and containment vessels of  
Fukushima Daiichi Nuclear Power Station  
Units-1 to 3 and examination into unsolved  
issues in the accident progression

Progress Report No. 5

December 25, 2017

Tokyo Electric Power Company Holdings, Inc.

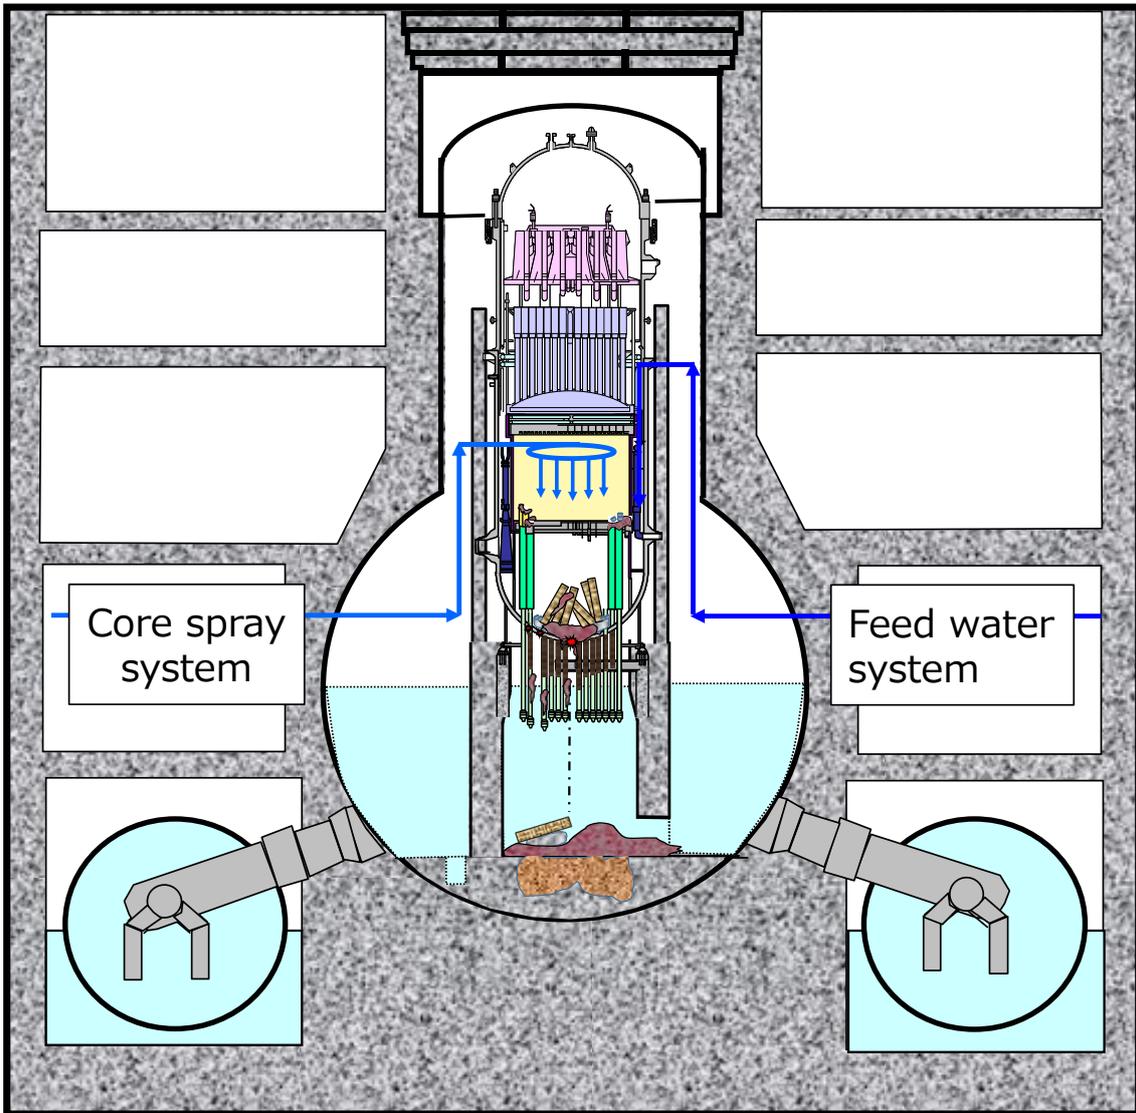
The situation of Unit-3 core estimated based on the above facts and aforementioned examination results, is illustrated in Figure. 6.3.1. As can be seen in the figure, part of the melted fuel generated in the accident fell down to the lower plenum below the reactor pressure vessel or to the PCV pedestal. Some of the fuel may remain in the original core location. It has turned out, however, that there had been a situation of not sufficient water injection possibly due to HPCI manual shutdown by the operators. This indicates the accident progression was faster than the earlier estimation. In the figure, more fuel than before is assumed to have dropped to the PCV. On this matter, further detailed examinations are needed, including the molten core concrete interaction (MCCI) development behavior.

At the in-containment investigation in JFY2015, the D/W water level was found to be about 6.3m above the D/W floor. In May 2014, water leaks were witnessed around the expansion joint at the PCV penetration of main steam piping D. This point is at the same elevation as the estimated water level in the containment vessel. This indicates most water leaks from the containment vessel occurred at this point.
